BEFORE THE HEARING BOARD
OF THE
BAY AREA AIR QUALITY MANAGEMENT DISTRICT
STATE OF CALIFORNIA

APPLICATION FOR VARIANCE

DOCKET NO. **3750**
(Assigned by Clerk)

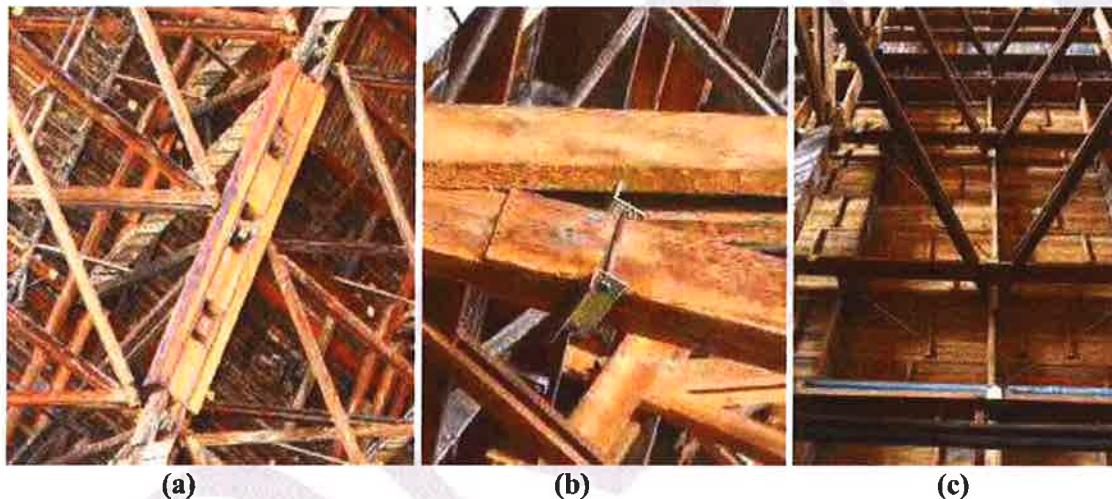
Figure 3. Retrofit techniques observed throughout Hangars 2 and 3 (a) Strengthening of arch chords by addition of glulam bypass members (b) Clamps and stitch bolts to close small cracks (c) Replacement of wood sag braces with steel cables and bolts.

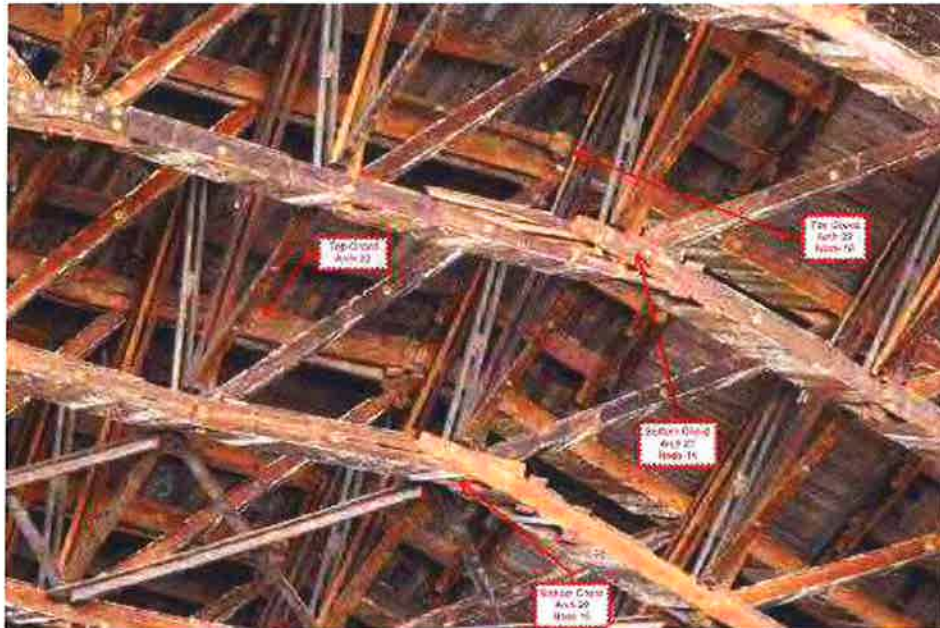
Figure 4. Observed cracks and distortion of the timber arch bottom and top chords in Hangar 3.

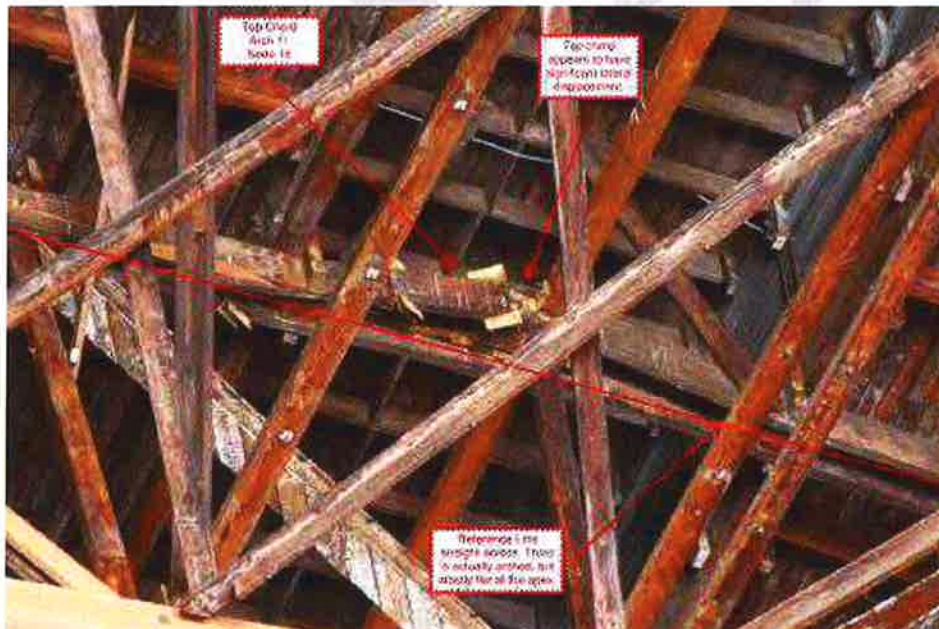
This general observation is emphasized in Figure 5 with the relative lateral displacement between the apex of the arch and a theoretical reference line connecting adjacent arch nodes. Similar results are also displayed in Figure 6 for the top chord of arch 18.

Figure 5. Relative lateral displacement between arch apex and reference line for Hangar 3 single arch.

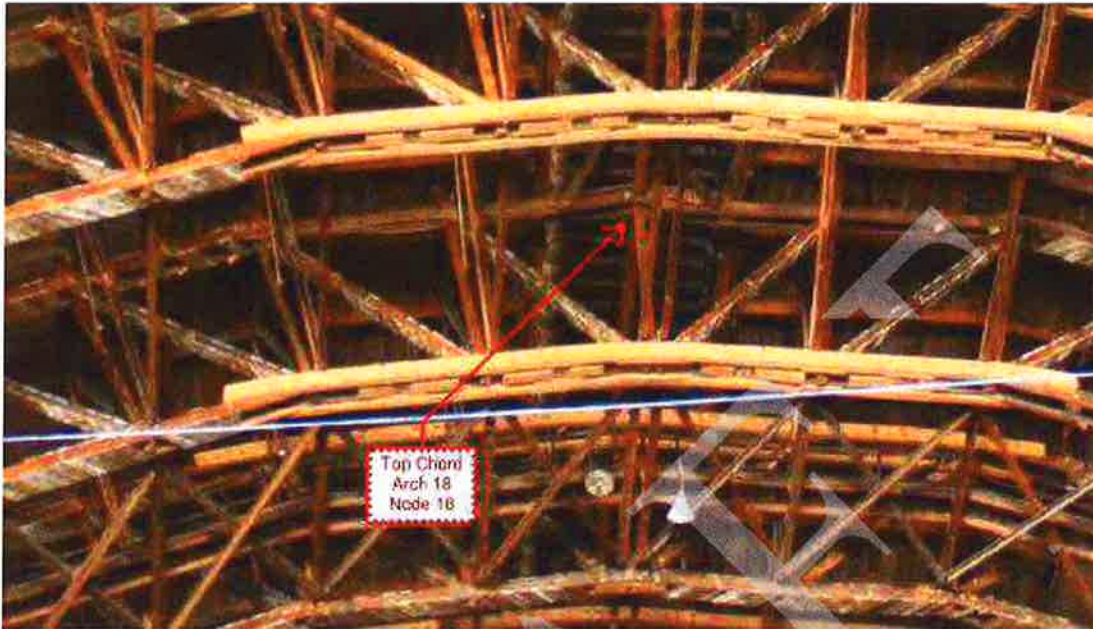
Figure 6. Observed cracks and lateral displacement of arch top chord in Hangar 3.

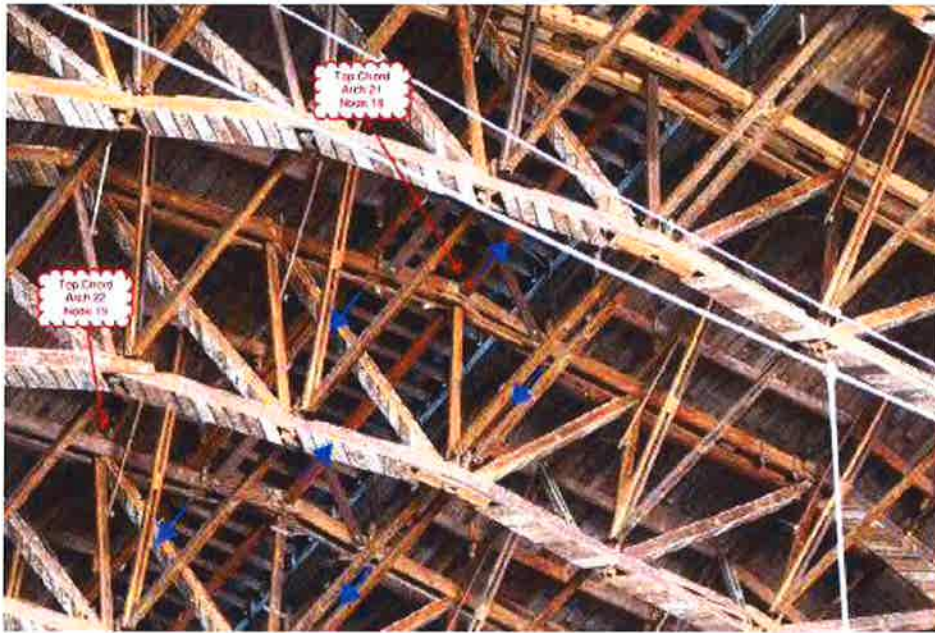
In addition, it was observed that the apex of numerous arches contain a consistent trend of node 18 displacing relative to the adjacent nodes supporting the monitor (exterior protrusion of the hangar at the apex outer chord). This is displayed in Figure 5 for arch 11, Figure 6 for arch 18, and Figure 7 for arches 21 and 22. The latter contains blue sketch-up arrows displaying the relative lateral displacement of the nodes, where node 18 appears to display south. It is unknown whether or not if all of the observed cracks and distortions propagated from the 1995 retrofits or if their origin emanated within the past couple of months.

Figure 7. General trend of relative lateral displacement at the arch apex top chord in Hangar 3.

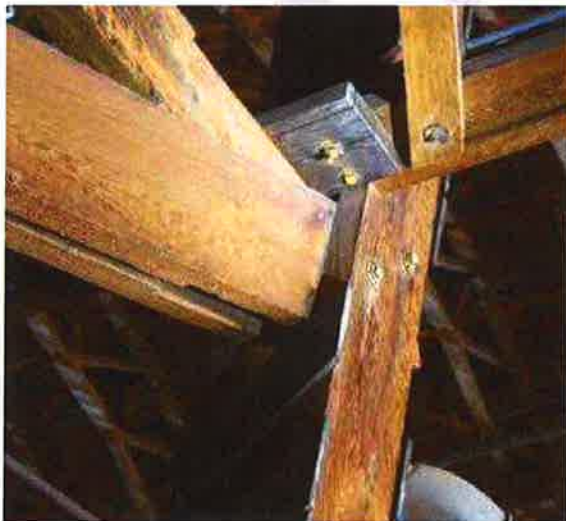
Hangar 2 did not have the extent of distress as seen in Hangar 3. There was only one location where the main arches were strengthened by glulam bypass members. This location was on arch line 14 and between nodes 28 and 30. The only visual signs of distress were observed through end splits of cross braces, as shown in Figure 8. This distress was common at locations where the fasteners were too close to the end grains.

Figure 8. Example location of end split in cross brace member within Hangar 2.

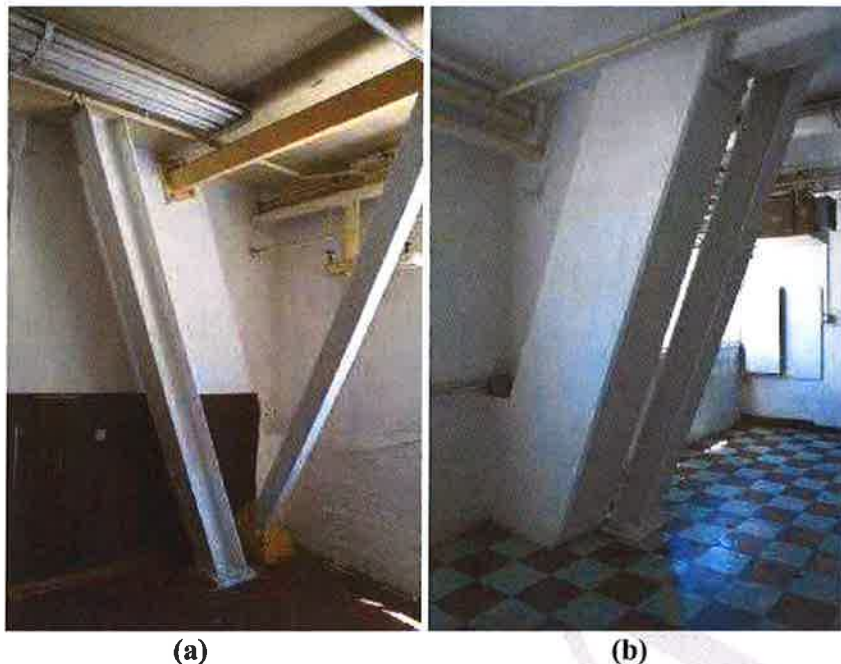
Turnbull (2006). However, wide flange steel shapes were also observed for additional reinforcement of the concrete bents in the strong axis, as shown in Figure 9.

Figure 9. Hangar 2 office space retrofits (a) Longitudinal HSS and Lateral I-Shape bracing (b) Lateral I-Shape and HSS bracing.

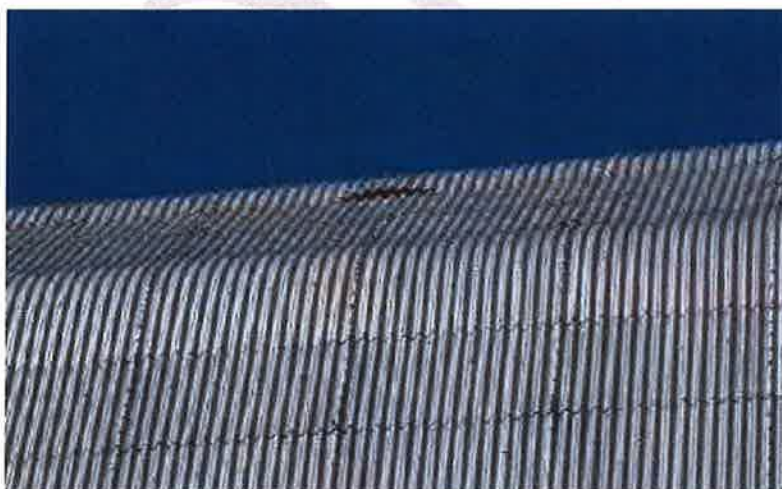
While on the recent site visit, it was also observed that the doors on the southwest corner of Hangar 3 were open while all other doors between both hangars were closed. Therefore, future observations must verify if the doors are operable. In addition, the existing corrugated aluminum sheathing was detached at various locations along the roof of Hangars 2 and 3, as shown by example in Figure 10.

Figure 10. Example location of detached corrugated aluminum sheathing on roof exterior of Hangar 2.

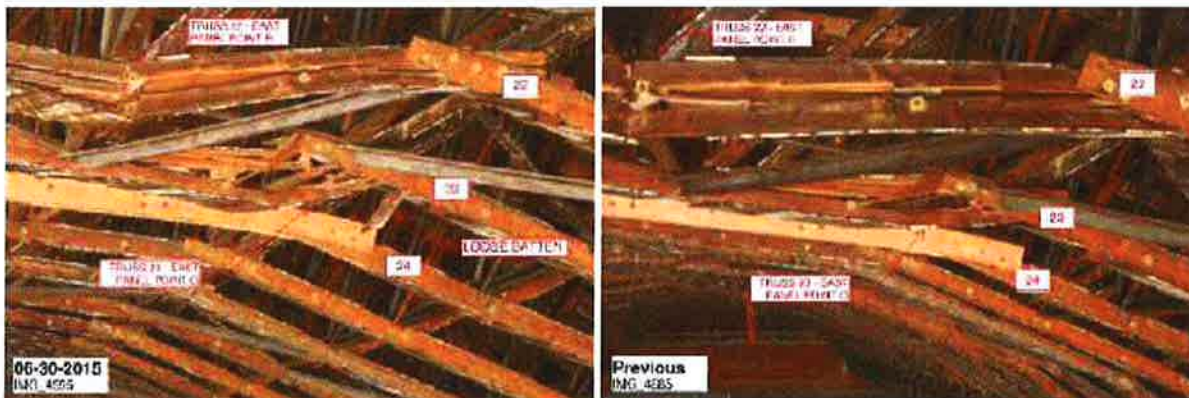
Figure 1. Truss damage progression at Trusses 22 and 23 East near Panel Points R and O.

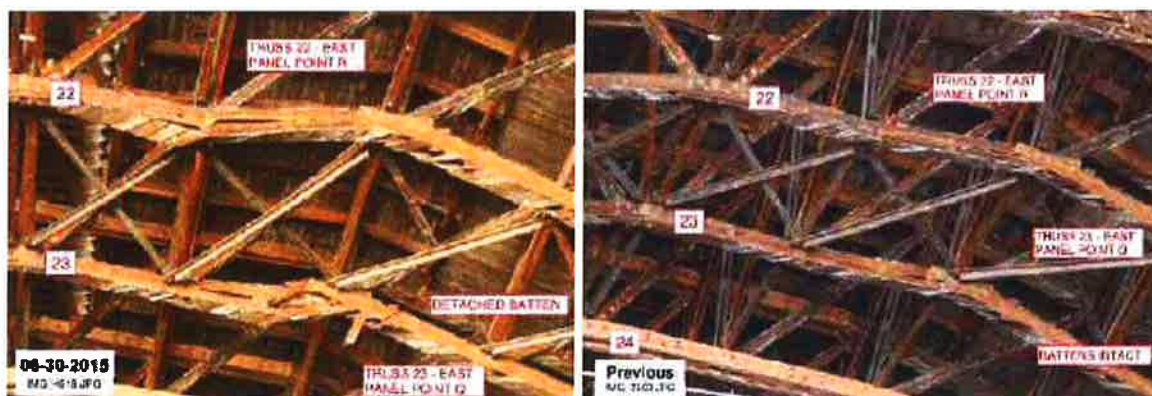
Figure 2. Truss damage progress at Trusses 22 and 23 East near Panel Points R and Q.

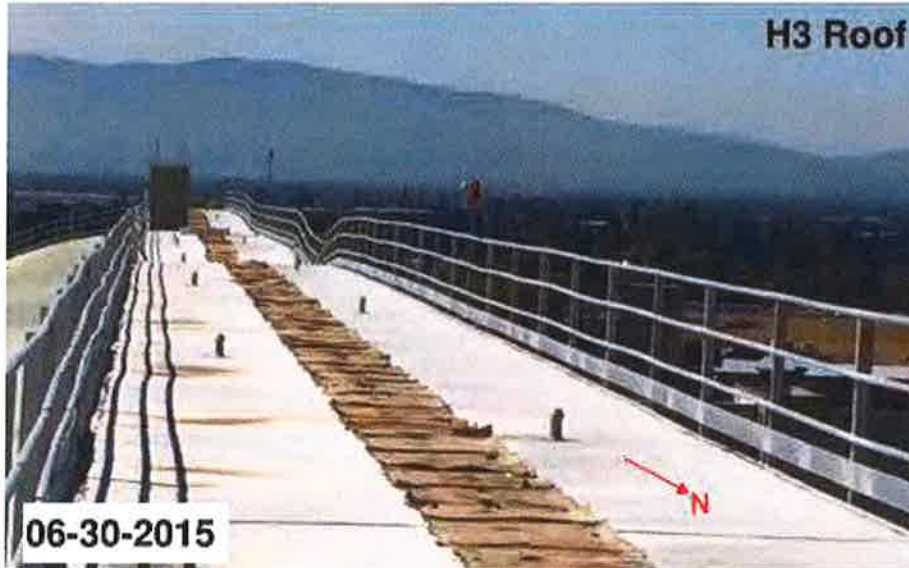
Figure 3. Damage observable at ridge line from building exterior.

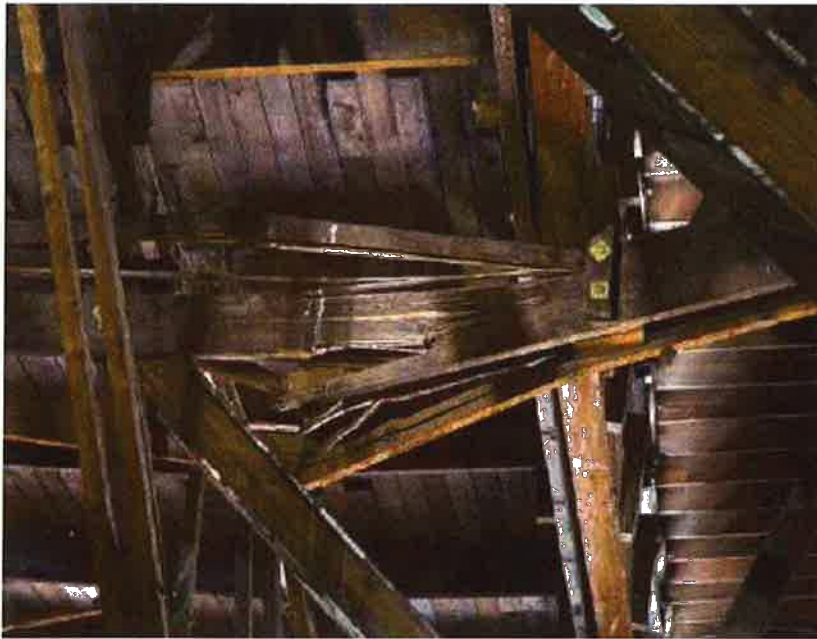
The following photos (Figure 5, Figure 6) demonstrate the severity of existing damage and the immediate danger of partial structure collapse.

Figure 5. Broken top chord near roof monitor at top of truss

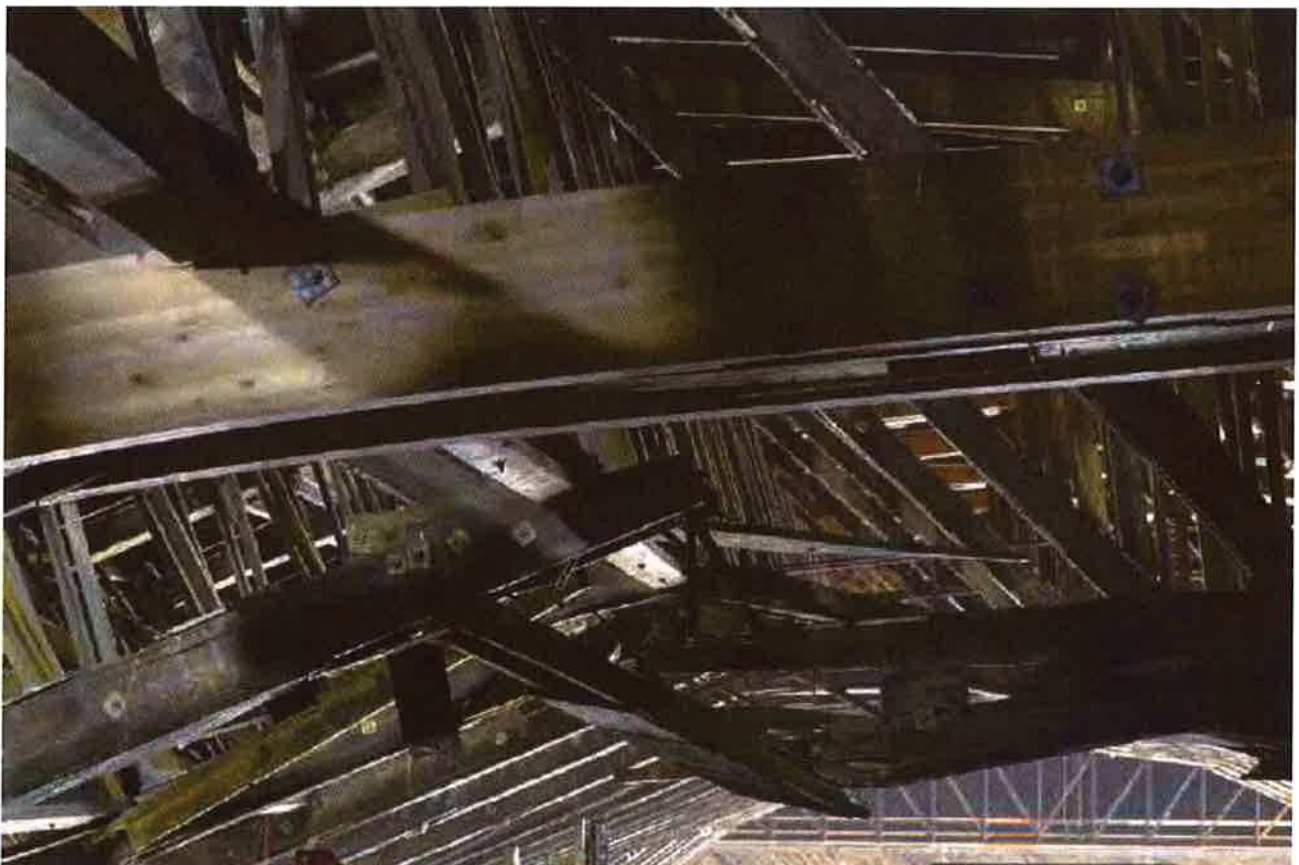
Figure 6. Broken bottom chord near top of truss.

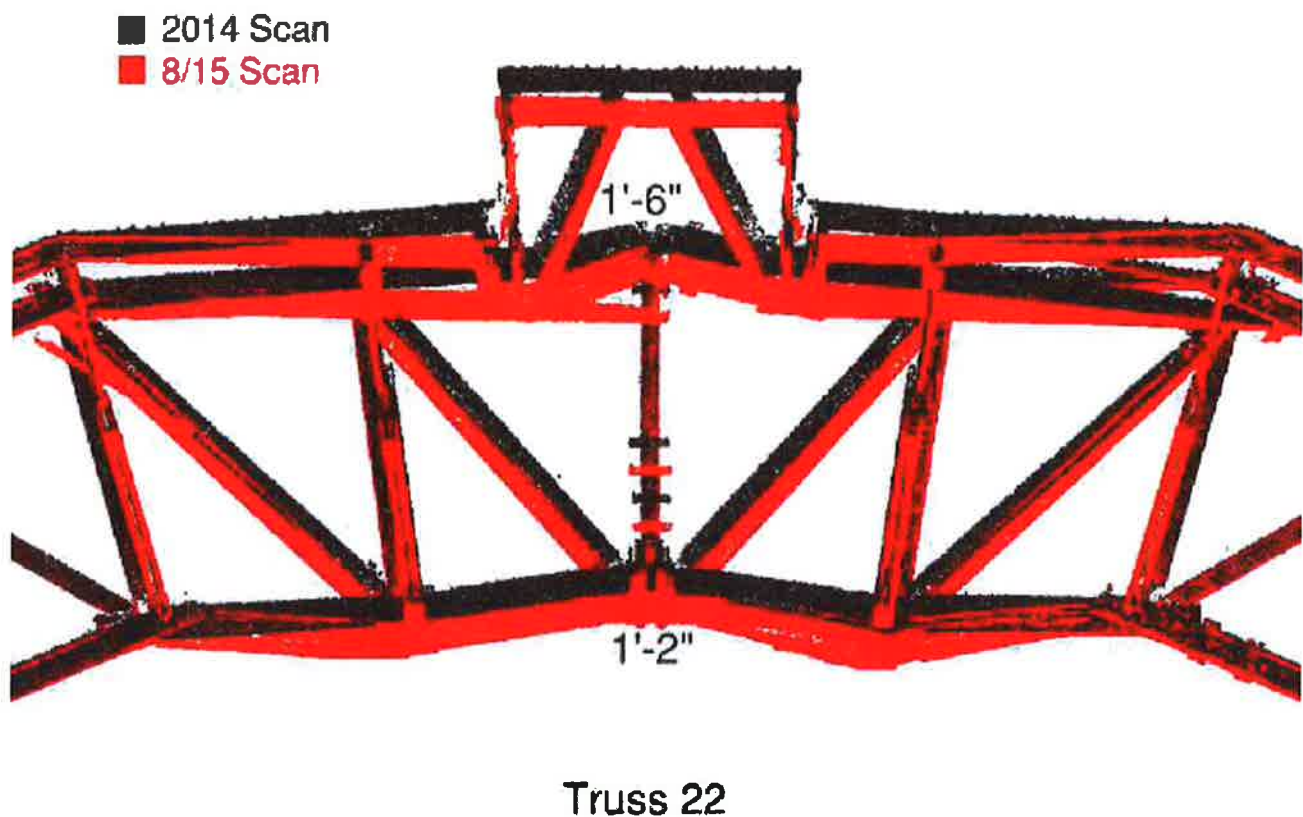
Quantitative measurements of the truss deflections were taken from successive point cloud surveying of the hangar interior. The damage progression is shown in an example processed image from the 3D point cloud scans taken in 2014 and 2015 (Figure 7). In that figure, the black portion represents the actual position of Truss 22 between Panel Points Q-West and Q-East in 2014, while the red portion shows the position in August 2015. The measurements on the image show the increase in downward deflection between the surveys. A summary of deflections at Panel Point S indicate zones of damage concentration (Figure 8).

Figure 7. Approximately 18" of additional deflection observed between 2014 and 2015 point cloud surveying scan at top of truss.

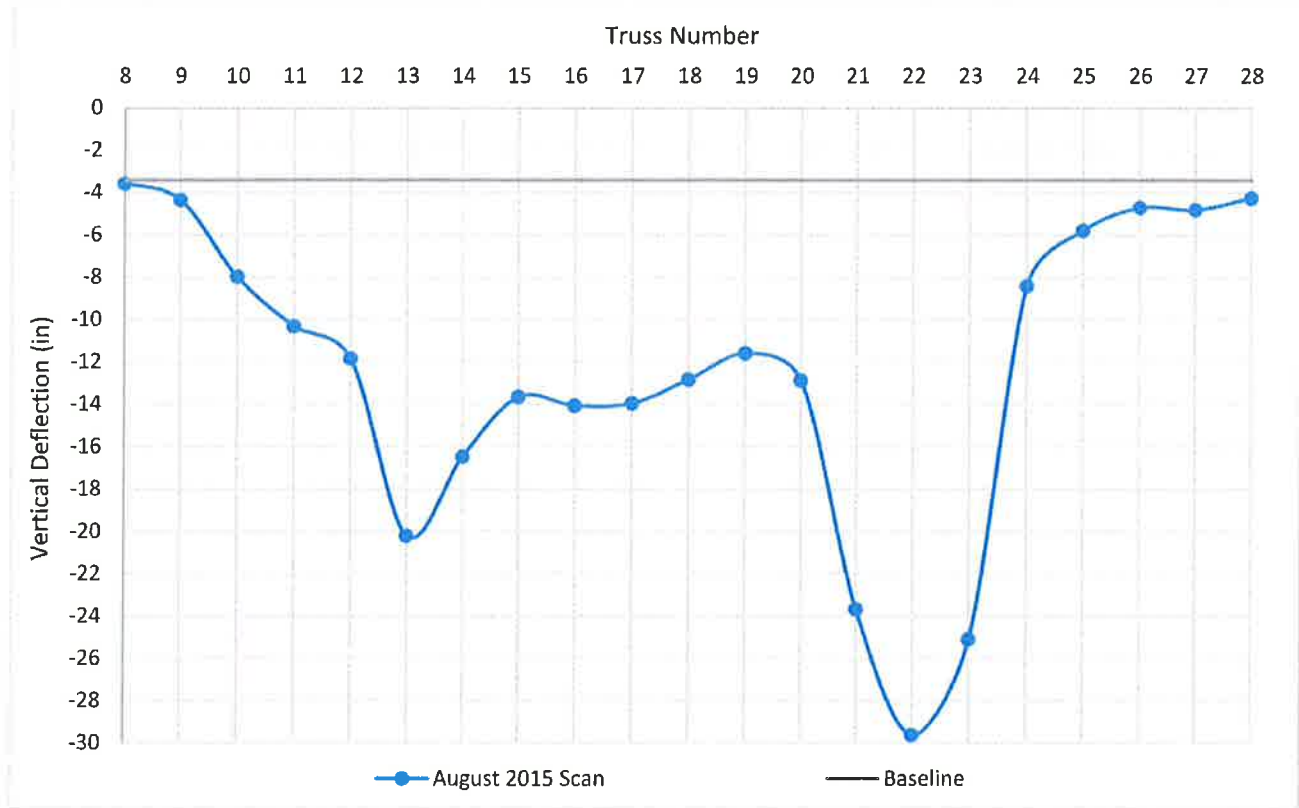
Figure 8. Deflections relative to baseline at Panel Point S.

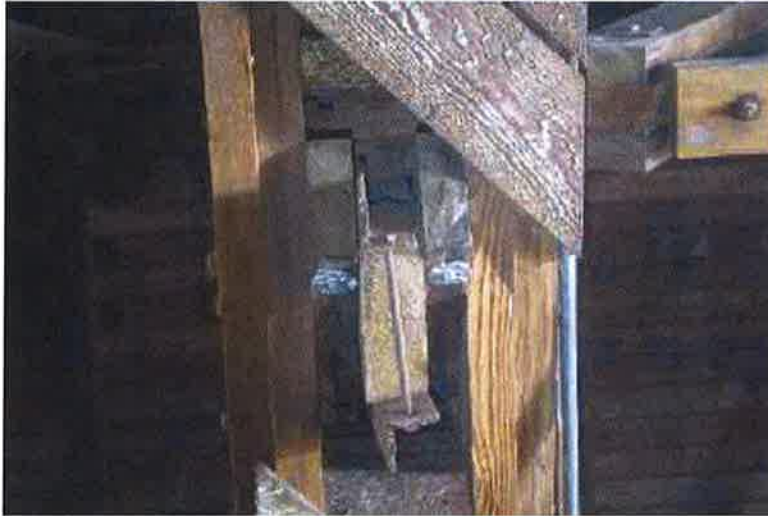
Figure 17. Example of new minor connection strengthening stitch bolts adjacent to existing angle clamp.

Permanent minor connection strengthening consists of stitch bolts at wood arch truss connection ends, and clamps at splits along the lengths of members (Figure 17). These have been installed in areas which require strengthening as part of the jacking sequence and emergency truss repair installation.

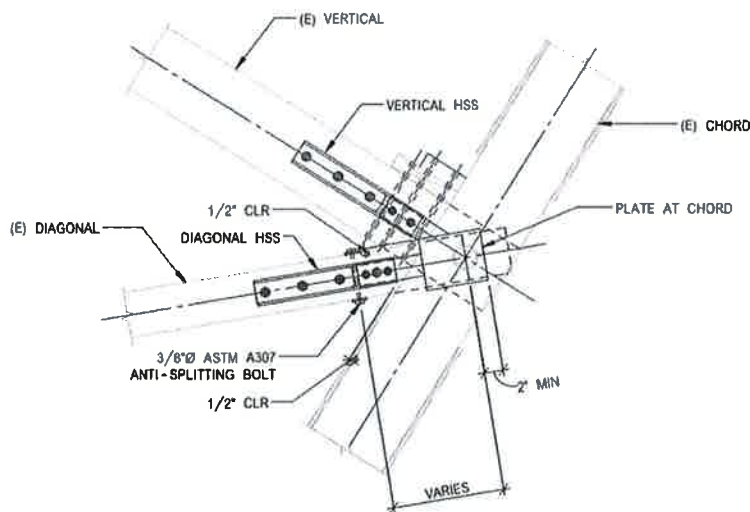
Figure 18. Permanent major connection strengthening.

Permanent major connection strengthening consists of galvanized and painted cut HSS steel tubes, steel plates, and bolts (Figure 18). These items are currently being fabricated and coated and are pending installation. This type of repair will be installed in locations of severe damage within truss panel point connections, where the connection is damaged, but the timber is in fair condition outside the connection zone.

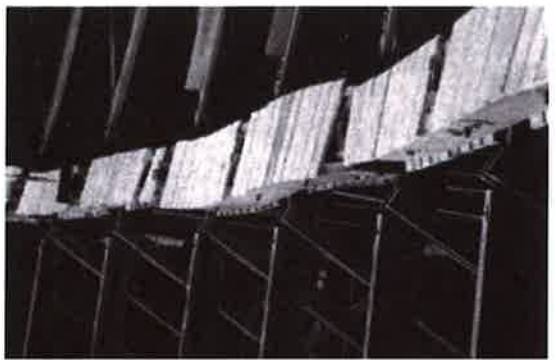
- Major glulam repairs were made in 1981 to correct buckling observed in truss chords
- Glulam strongback members were installed to re-align chords, but load path remained in the original members
- Major repairs made to **49** members
- Struts added at each arch at node 18 to brace top of truss, with rod cross-bracing added at the north and south ends of the hangar
- Minor repairs were also made with clamps and stitch bolts. Many 1x6 purlin ties were replaced with steel rod ties

Buckled chords (left) and glulam strongback repairs (right)
-“Restoration of Navy LTA (Lighter than air) Hangars”, Donal Neal, 1996

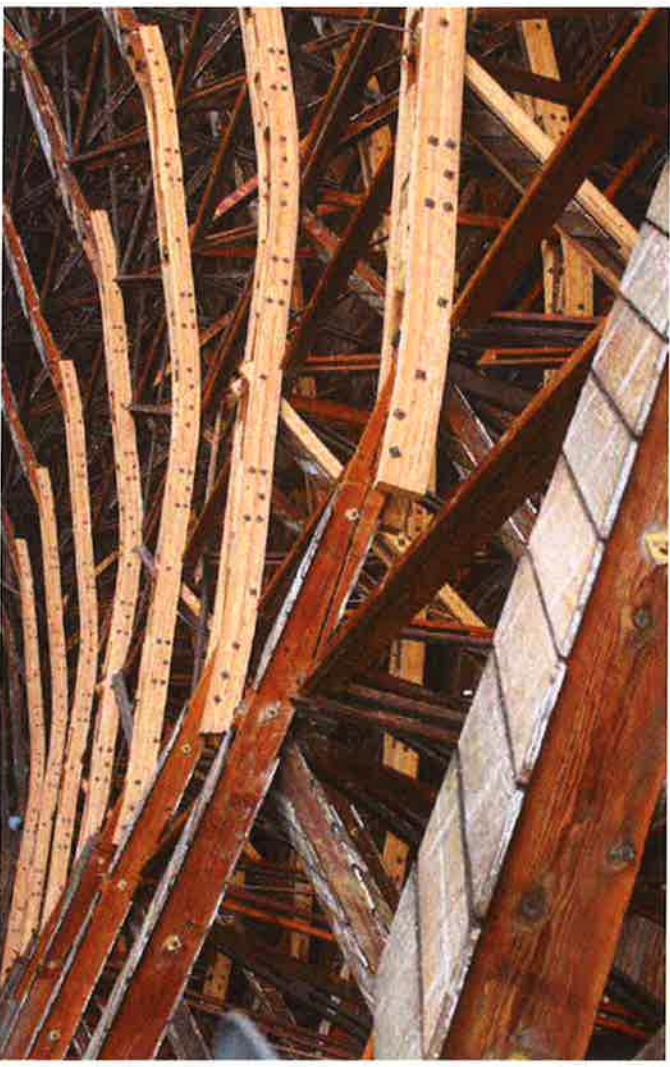
- Continued deterioration of Hangar 3 necessitated further glulam repairs in 1993
- Repairs consisted of glulam strongbacks for buckling, and multi-chord glulam sistered members
- Many of these repairs were made in the critical zone where the most severe deflections and damage were later found
- Major repairs made to **75** members
- Sistering repairs also made to roof support purlins and minor clamp repairs were again performed on arch trusses

1993 glulam sister repairs to chord members in critical zone

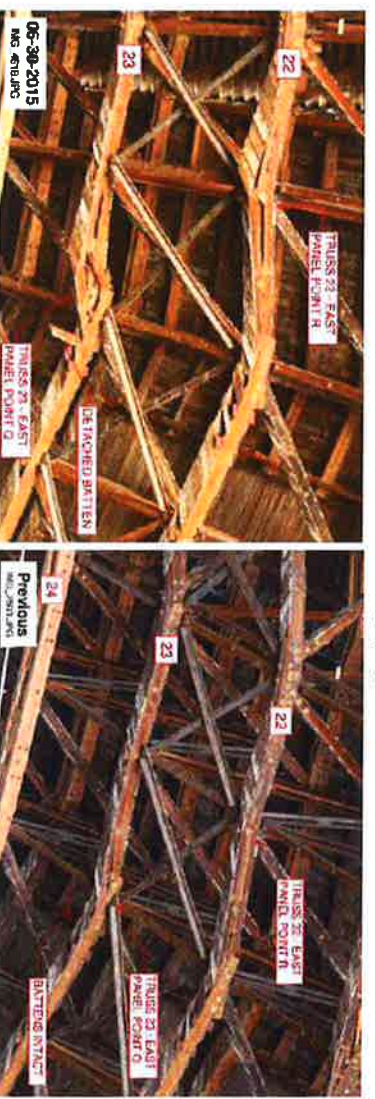
Photos of damage progression

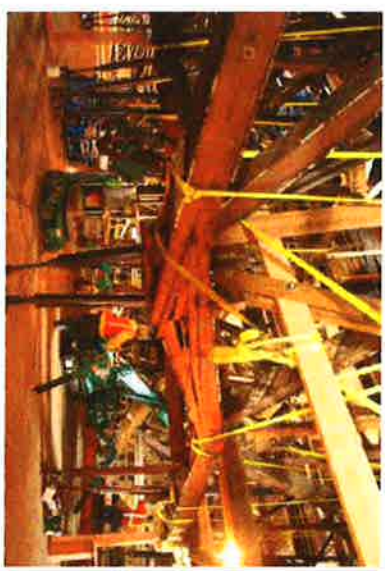
Temporary strapping on chord marked for removal and replacement

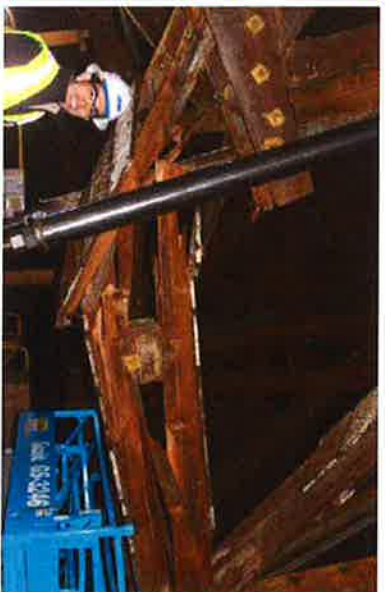
Damaged chord member viewed from access tower

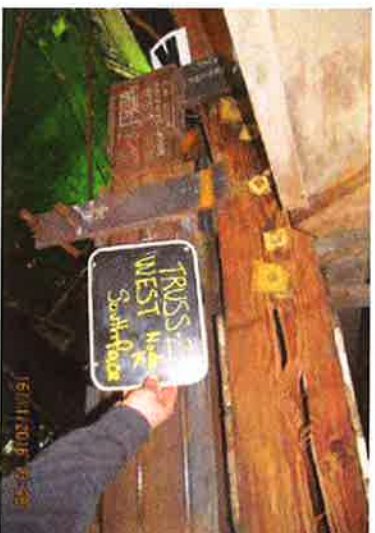
Chord damage at node K after exoskeleton install

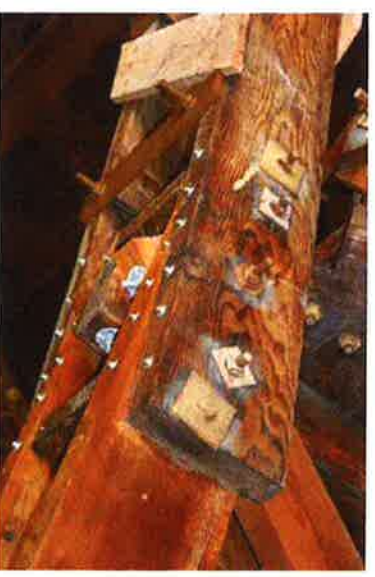
Preemptive screw and clamp strengthening on undamaged chord at node K
