Causal Analysis Report

Chevron Richmond Refinery  
Reportable Flaring Events

January 8, 2019 – January 9, 2019  
Shutdown and Start-up of Hydrogen Plant Train 2 (S-4450)

Refinery Flare Event – Cause Investigation Report

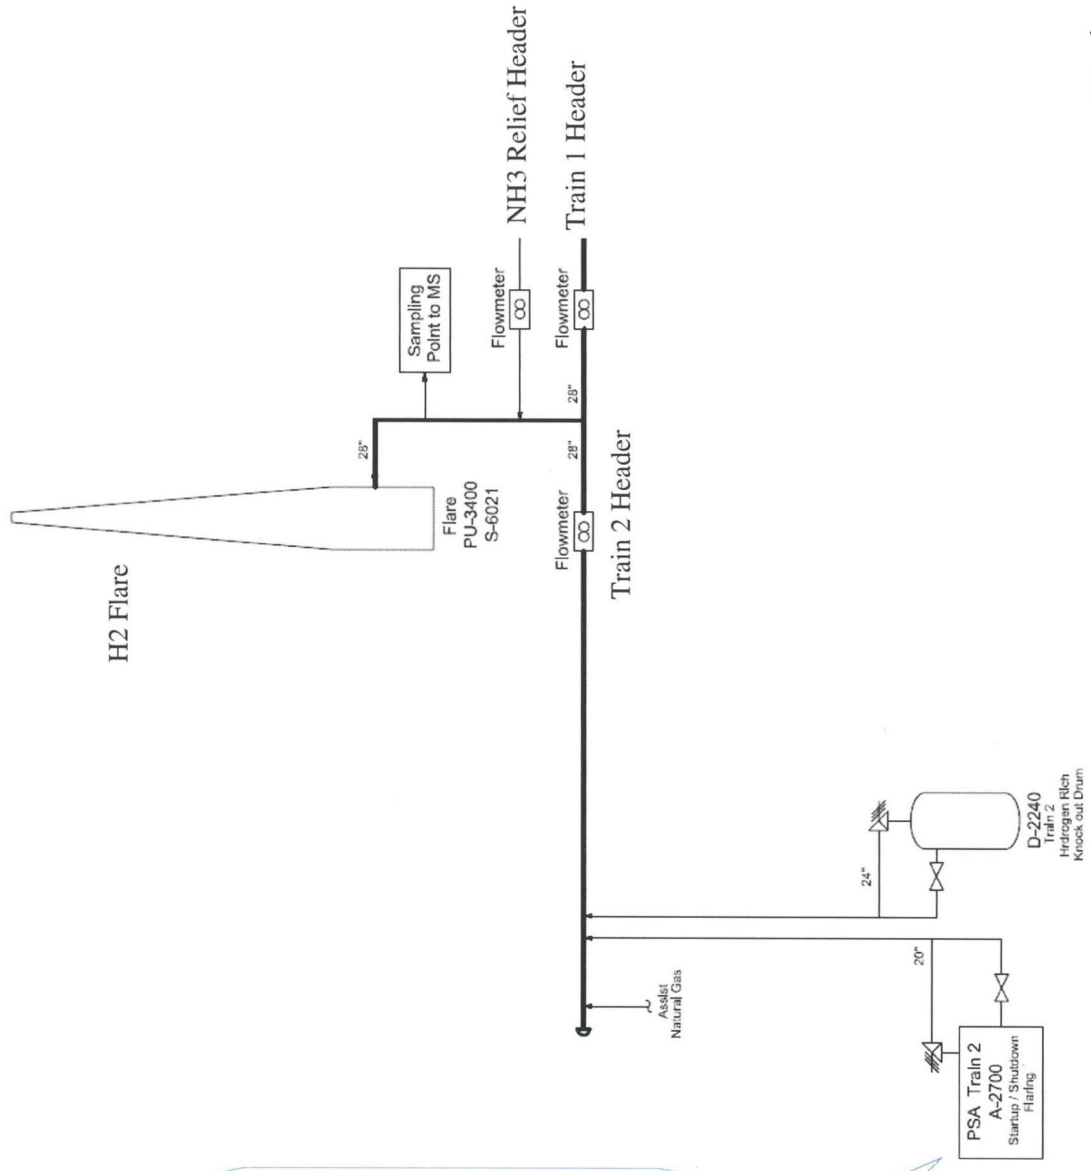
# Hydrogen Plant Train 2 Planned Start-up

During commissioning, Train 2 shutdown on January 7, 2019 and subsequently started up on January 8, 2019. Both the start-up and shutdown procedures include routing flows to relief and the Hydrogen Plant flare does not have a water seal or flare gas recovery.
