BEFORE THE HEARING BOARD
OF THE
BAY AREA AIR QUALITY MANAGEMENT DISTRICT
STATE OF CALIFORNIA

APPLICATION FOR VARIANCE

DOCKET NO. **3750**
(Assigned by Clerk)

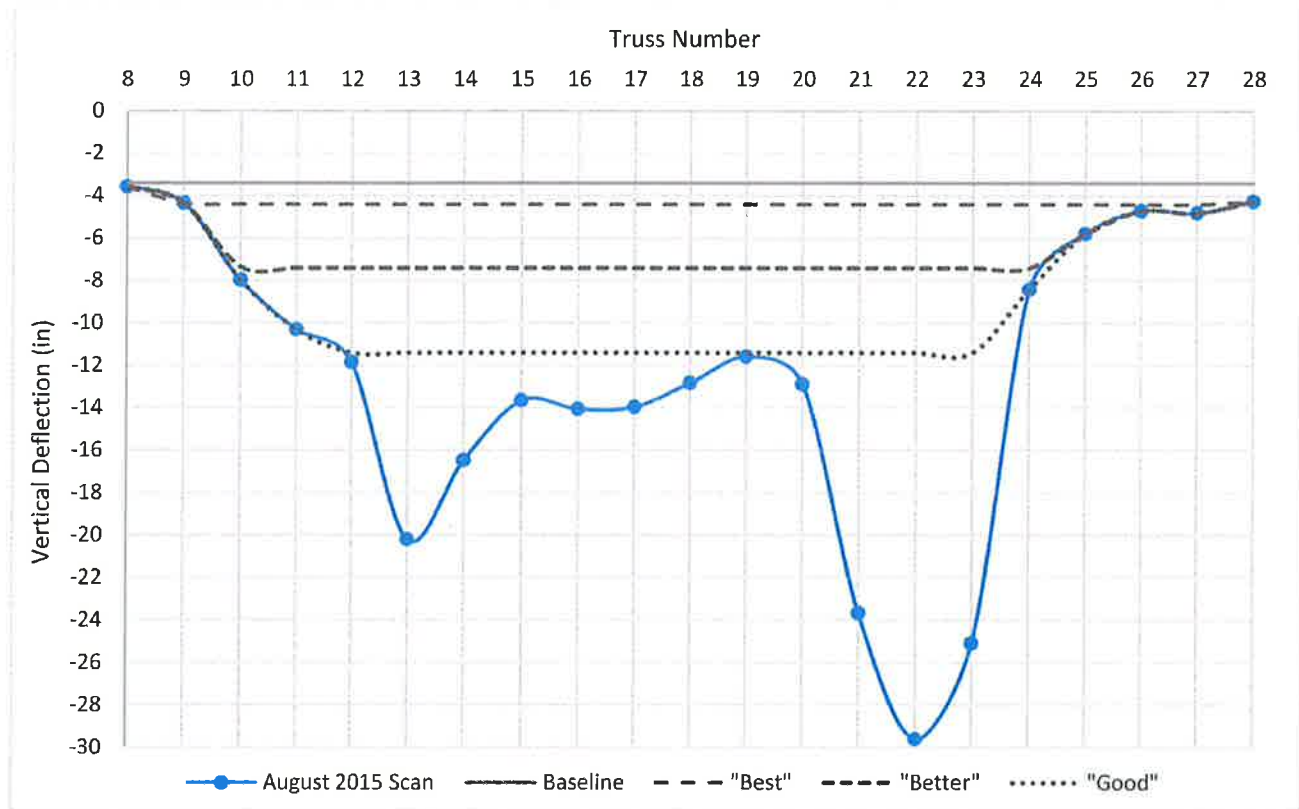
Figure 9. Hangar 3 Panel Point 18 Deflection with Deflection Criteria Options

Figure 9 was generated to illustrate the roof deflections (in blue) relative to a baseline that represents the average roof deflection at the trusses in the hangar that do not exhibit severe damage. The figure was used to compare the different deflection criteria options.

In addition to selecting a method of installation, the project team also selected a target criteria for roof deflections. The number of exoskeletons and the number of jacks required depends on the amount of deflection to be reversed during the Emergency Repair process. However, full restoration back to the previous undamaged roof geometry may prove to be physically infeasible due to the complexity, risk, and timing involved in these operations due to existing field conditions. KPFF established the target deflection criteria shown in Table 1 and Figure 9 based on “Good”, “Better”, and “Best” scenarios.

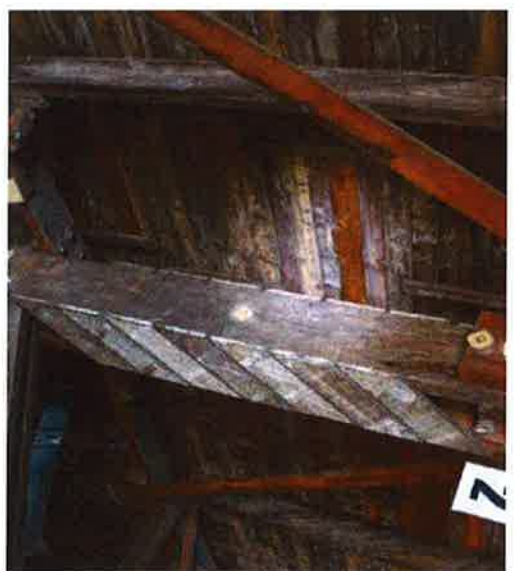
- Battens were added to bottom chords, and some top chords and diagonals to increase stability and help prevent buckling
- Upgrade was intended to increase the longevity of the temporary structure
- Battens added to **2244** members per hangar
- Batten wood was treated with a mixture of borax, white lead, and linseed oil paint.
- "These battens, with a few additional bolts and blocking at the chord splices, are the principle measures taken in strengthening and making permanent these wood buildings." "Strengthening of LTA Hangars, Naval Air Station, Moffett Field, California", J.S. Marsh, 1946

Typical chord member with battens

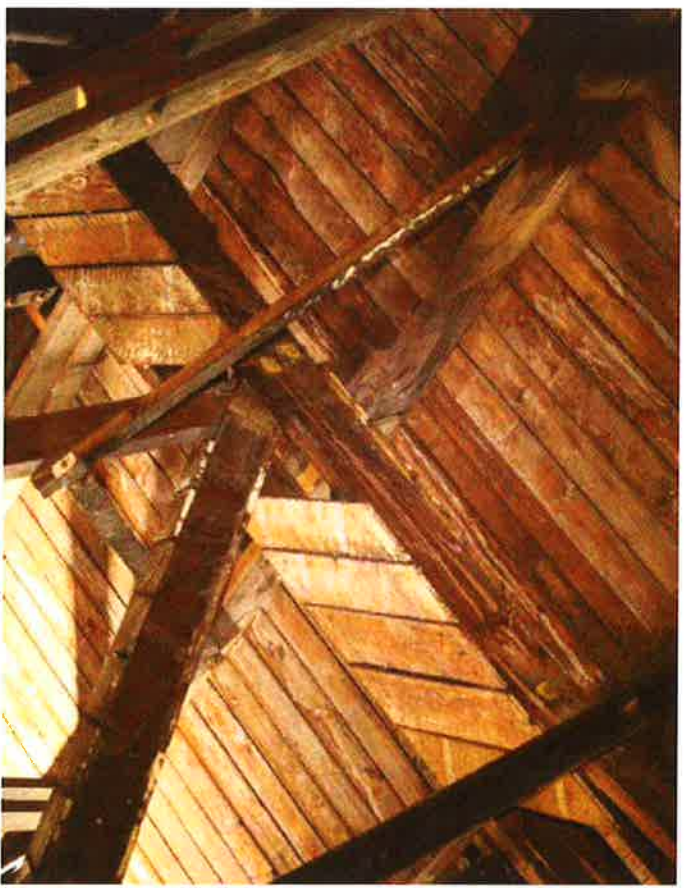
Typical vertical web member with added knee-braces

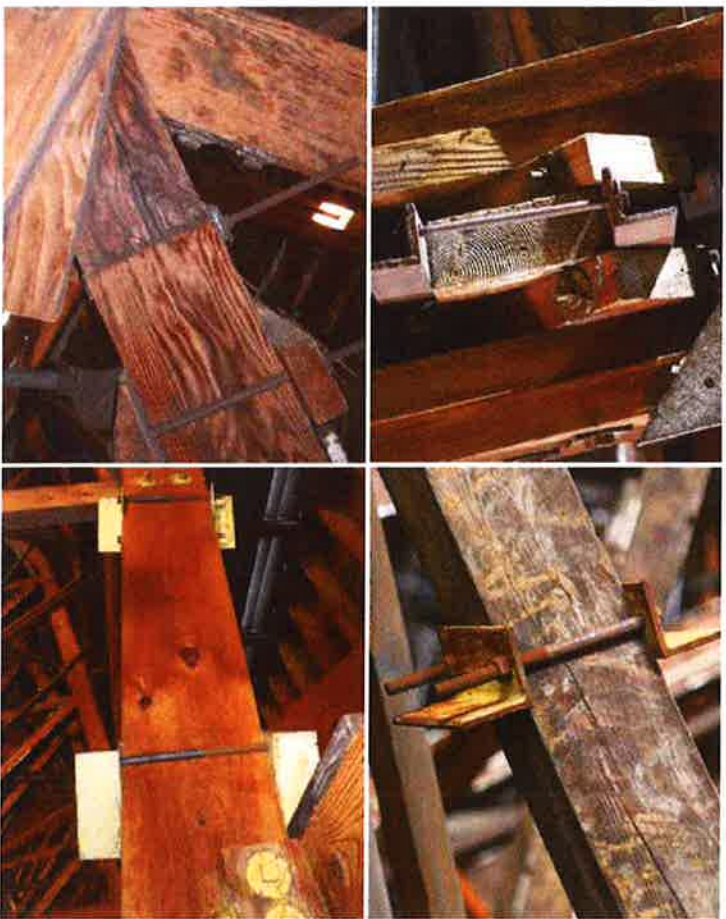
- Standard repairs for Navy maintenance included steel clamps and stitch bolts to fix minor splits
- "Maintenance Procedure for Timber Trussed Structures" Department of Navy Bureau of Yards and Docks, 1944
- Repairs occurred periodically throughout the service life of the hangars
- Navy records indicate that Timber Structures performed an inspection of the hangars in 1954
- The extent of these repairs is not fully documented
- Minor repairs have been documented at **541** members in H3 (many still undocumented)

Minor repairs made during Hangar 3 service life

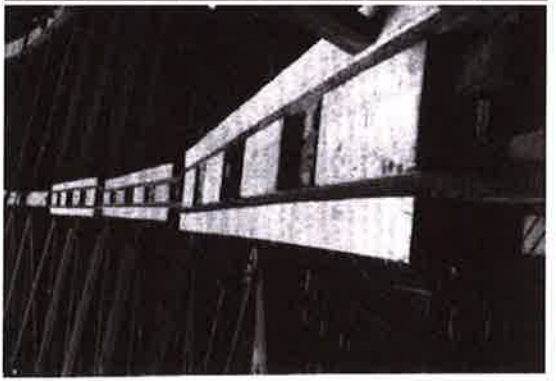
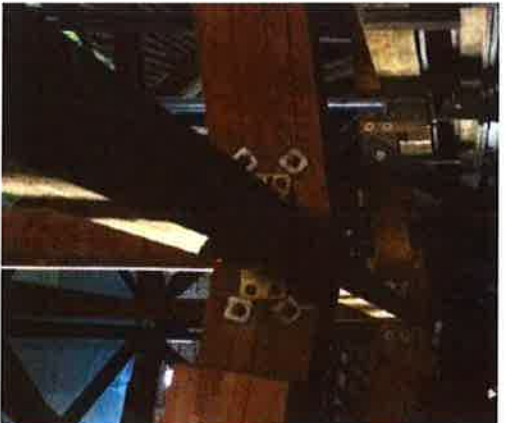
Node 18 struts

- Major glulam repairs were made in 1981 to correct buckling observed in truss chords
- Glulam strongback members were installed to re-align chords, but load path remained in the original members
- Major repairs made to **49** members
- Struts added at each arch at node 18 to brace top of truss, with rod cross-bracing added at the north and south ends of the hangar
- Minor repairs were also made with clamps and stitch bolts. Many 1x6 purlin ties were replaced with steel rod ties

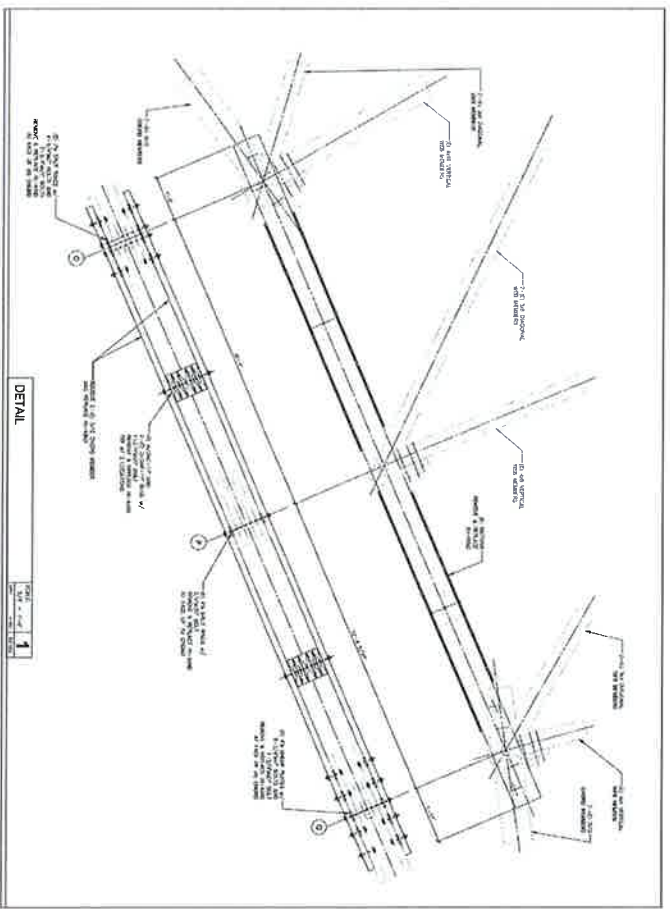
- TPAS® data was reviewed and damaged members were identified for repair
- **68** members were found to be damaged and in need of major repairs

Example detail for removal and replacement of damaged chords found in TPAS®

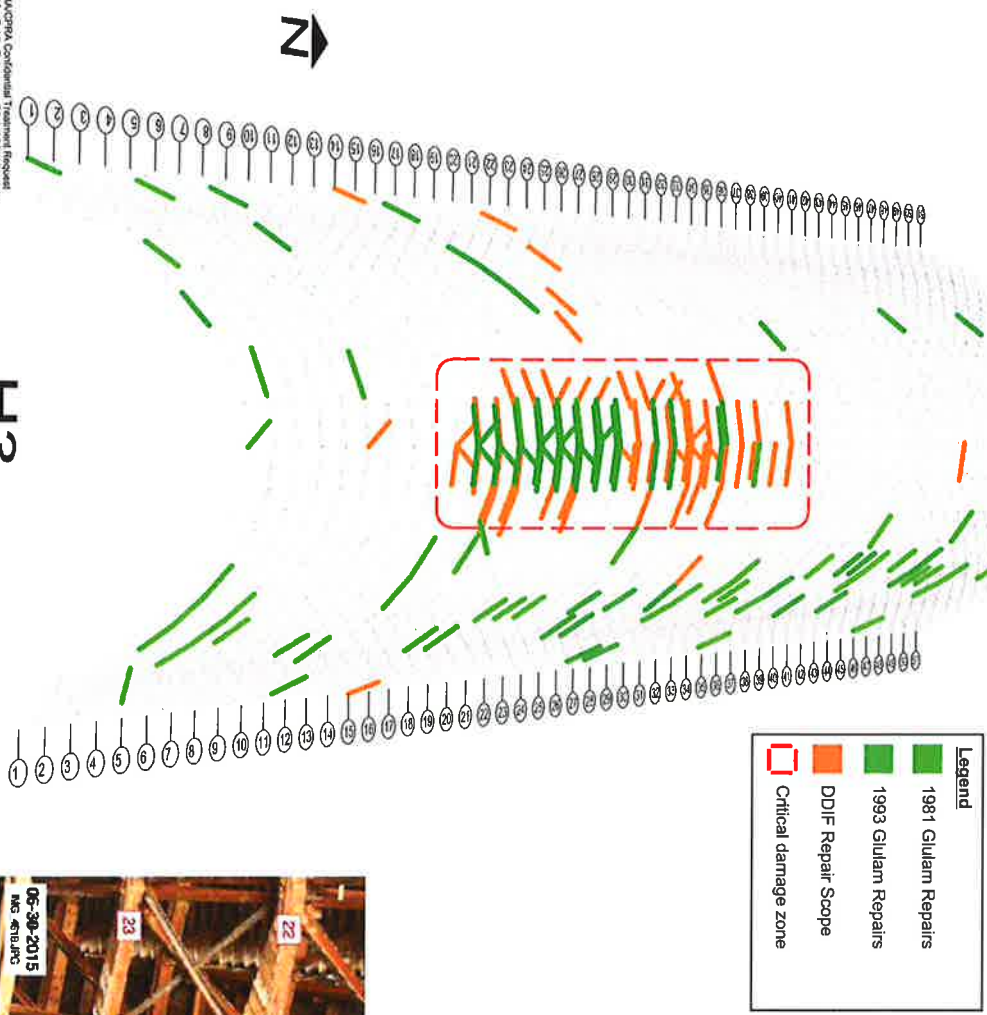
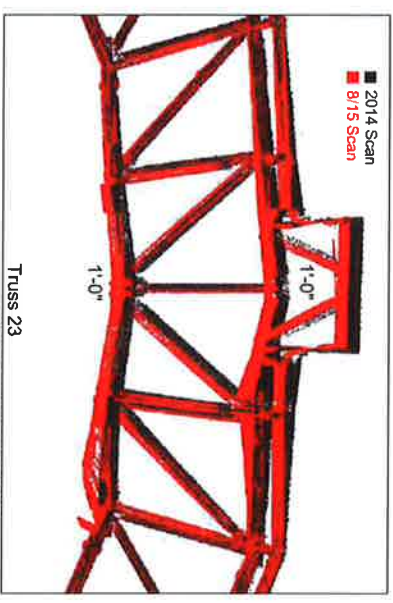
Point cloud visualization of damage progression

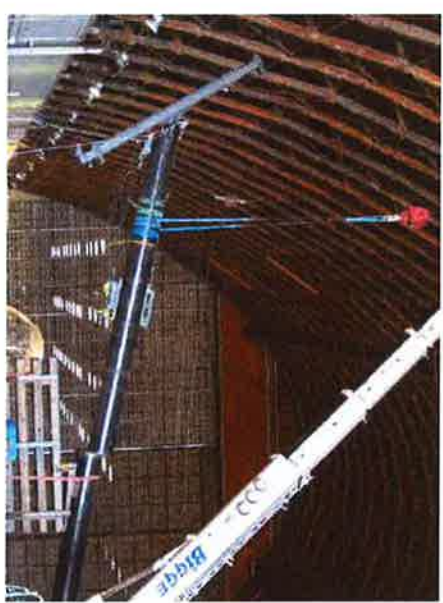
- Evidence of severe damage and progressive collapse of Hangar 3 necessitated a shoring and emergency repair program
- As part of the contractor's means and methods of performing repairs, 36" ø steel pipe shores were placed between trusses 9-26
- Pipe shores were designed to provide secondary stability in the event of progressive roof collapse during repair procedures
- Steel exoskeletons with jacks would then be placed at top to jack the roof and rebuild the critical zone

Hoisting of temporary shore segment

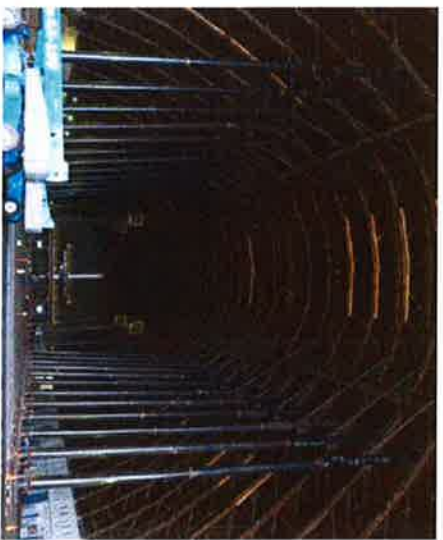
Temporary shores after installation

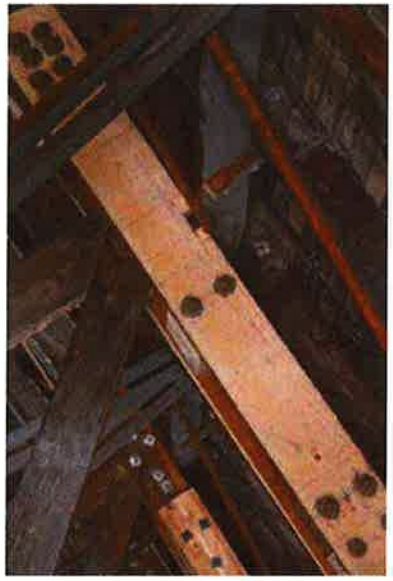
- The KPF survey discovered chord damage which was either not observed or not present during the due diligence investigations
- The survey uncovered extensive deficiencies within the web member connections, including many plug pullout failures
- **10** additional arch members received glulam sistering repairs
- **39** chord connections received connection strengthening brackets

Chord sister repair installed prior to exoskeletons

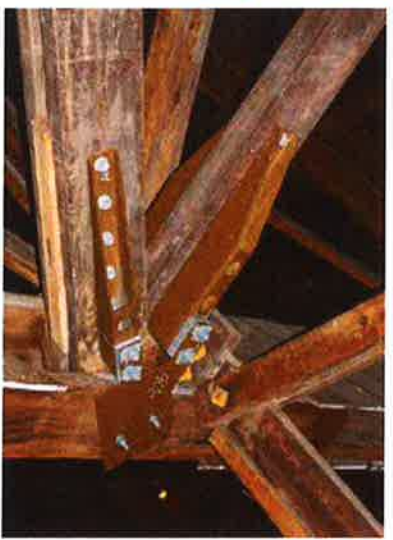
Typical connection strengthening bracket

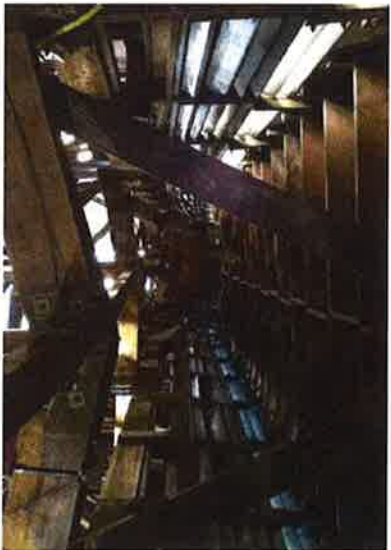
- 50 additional members were identified as severely damaged and scheduled to be removed and replaced after roof jacking
- Before jacking and repairs were made, decision was made to defer further construction activities

Roof monitor deflection in critical zone

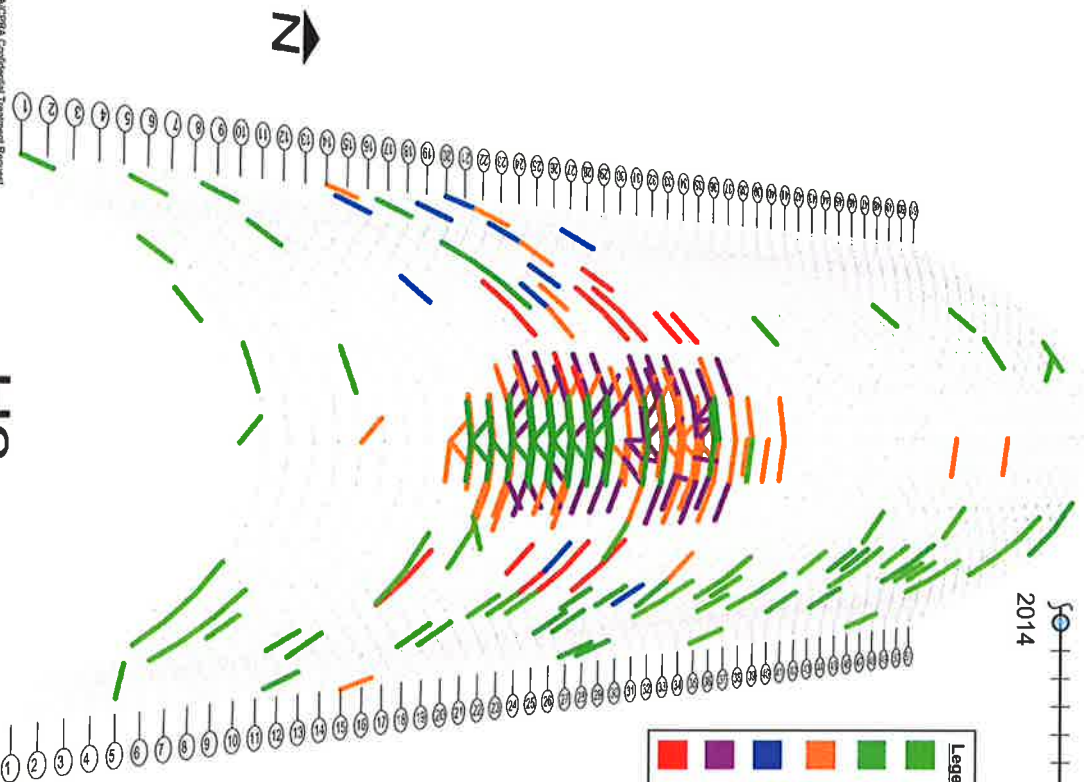
- Months after installation of exoskeletons, major splits were observed in chord members which had previously been observed and cleared.
- Major damage was observed on **19** chords, most between panel points I to M.
- Sistering repairs installed on most severe cases
- Due to the concentration of new damage at the lower chord members at panel points I to M, preemptive measures were taken to help reduce the progression of damage.
- Preemptive measures included fully-threaded screws at connections, and steel clamps.

Chord damage at node K after exoskeleton install
