Shell Martinez Refinery

FLARE MINIMIZATION PLAN

Updated October 1, 2015

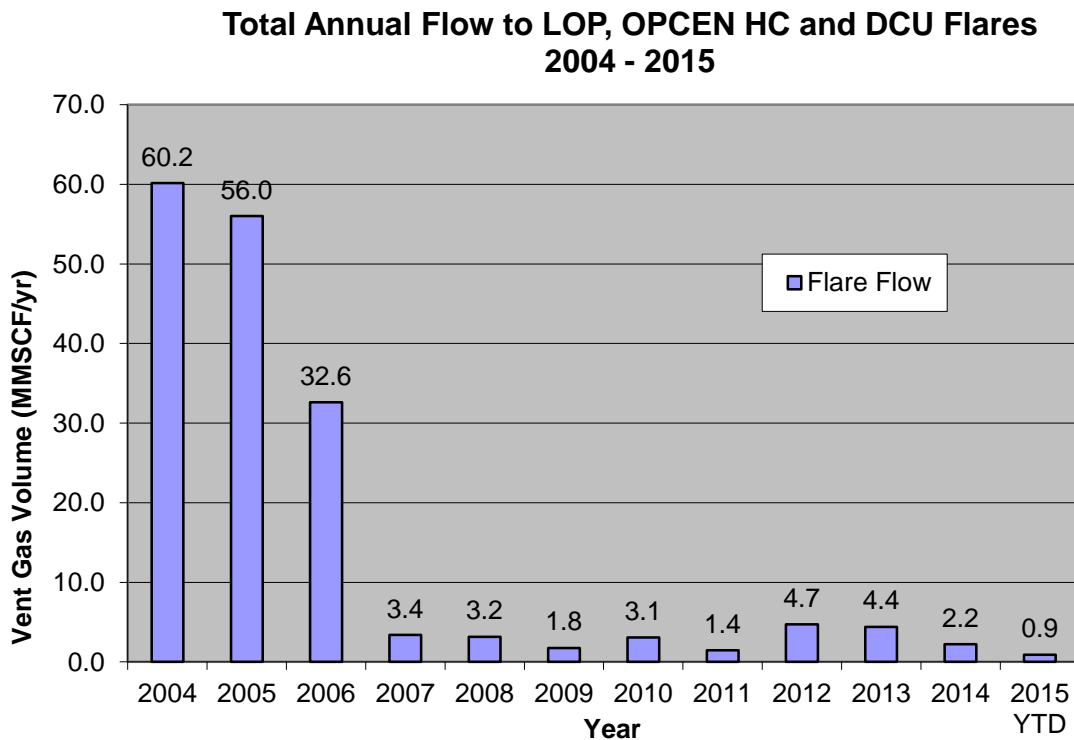
FIGURE ES-1

Figure ES -1 presents the total annual vent gas flow to the LOP, OPCEN Hydrocarbon and Delayed Coking (Clean Fuels) Flares at the refinery from 2004 through June 30, 2015. Total flare flow decreased from the previous two years and 2015 is on track to be one of the best years for flare minimization at the refinery.

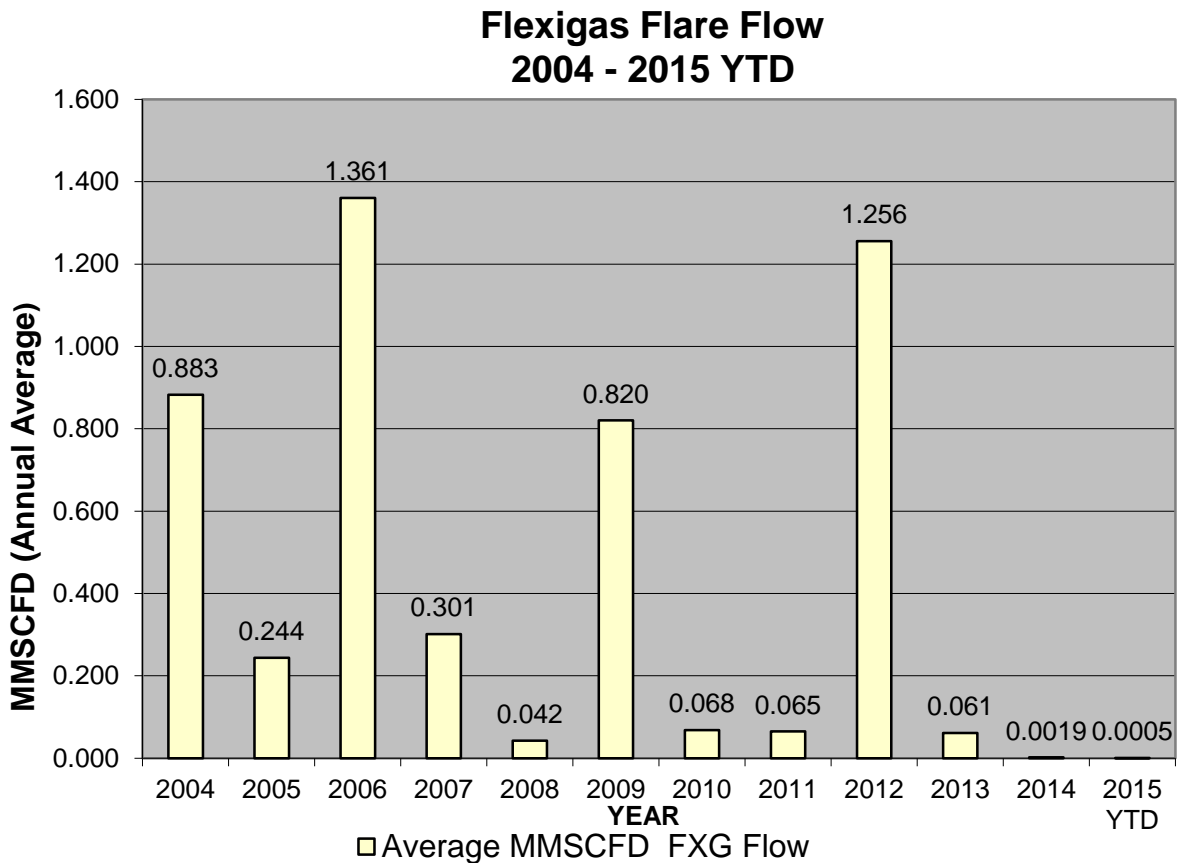
FIGURE ES-2

Figure ES-2 shows the annualized vent gas flow from the Flexigas flare. This figure shows an increase in Flexigas flaring during years with startup and shutdown of the Flexicoker due to the nature of the Flexicoking and Flexsorb processes. The flaring of treated flexigas during startups and shutdowns of the Flexicoker is specifically allowed up to certain limits in Shell's Title V permit.

Other than startup and shutdown flaring, flexigas flaring can occur due to refinery fuel gas imbalance. Shell continues to fine-tune the Flexigas pressure control scheme to minimize flexigas flaring due to small imbalances in fuel gas. Improvements in this system, most notably addition of COGEN to the pressure control scheme, contribute to the very low flexigas flare rate experienced in 2013, 2014 and 2015.

The Flexigas Flare flow volume is displayed separately in ES-2. Flexigas is used as a supplemental refinery fuel gas in refinery process heaters. Flexigas is treated for sulfur removal in the Flexsorb Unit before being combusted either in the refinery process heaters or if necessary, in the flare. When FXG is flared, the volume of gas is typically large compared to the volume flared in the other refinery process flares, but emissions are significantly less because Flexigas contains very low concentrations of non-methane hydrocarbon and sulfur.

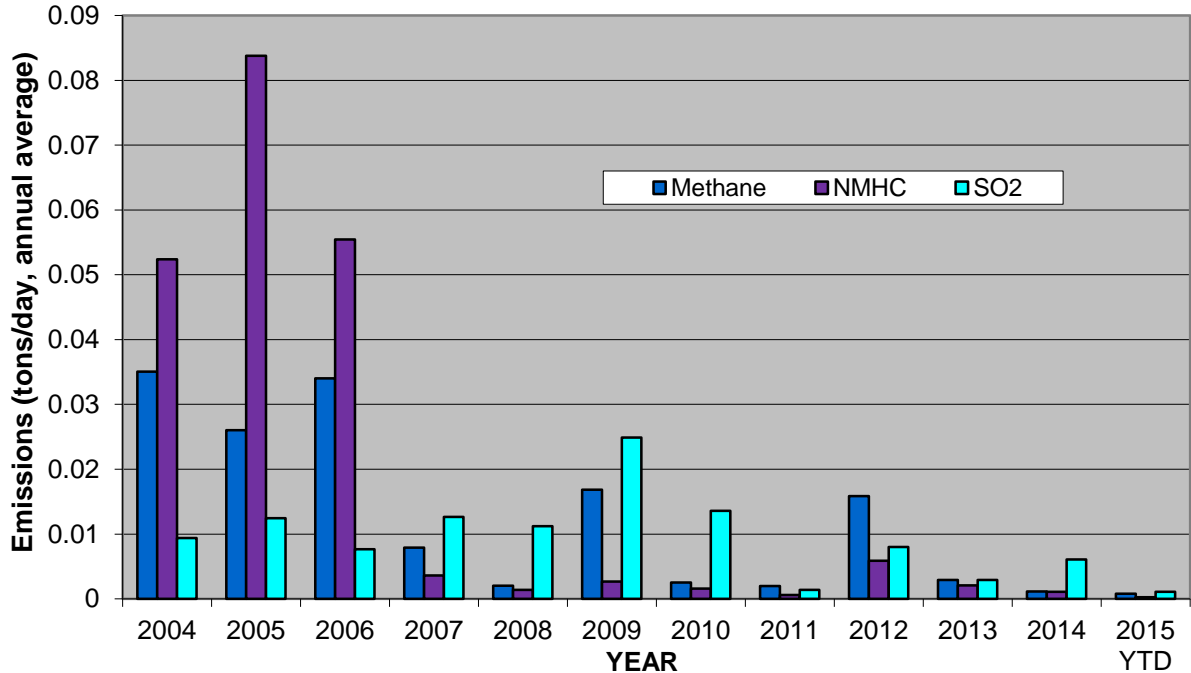
FIGURE ES-3

Figure ES-3 displays the methane, non-methane hydrocarbon and sulfur dioxide emissions from all four refinery process flares from 2004 through June 30 of this year.

**Shell Flare Emissions - All Flares
2004 - 2015**

Figure ES-3 shows the significant reduction in emissions that has occurred since the implementation of the Flare Minimization Plan in 2006.

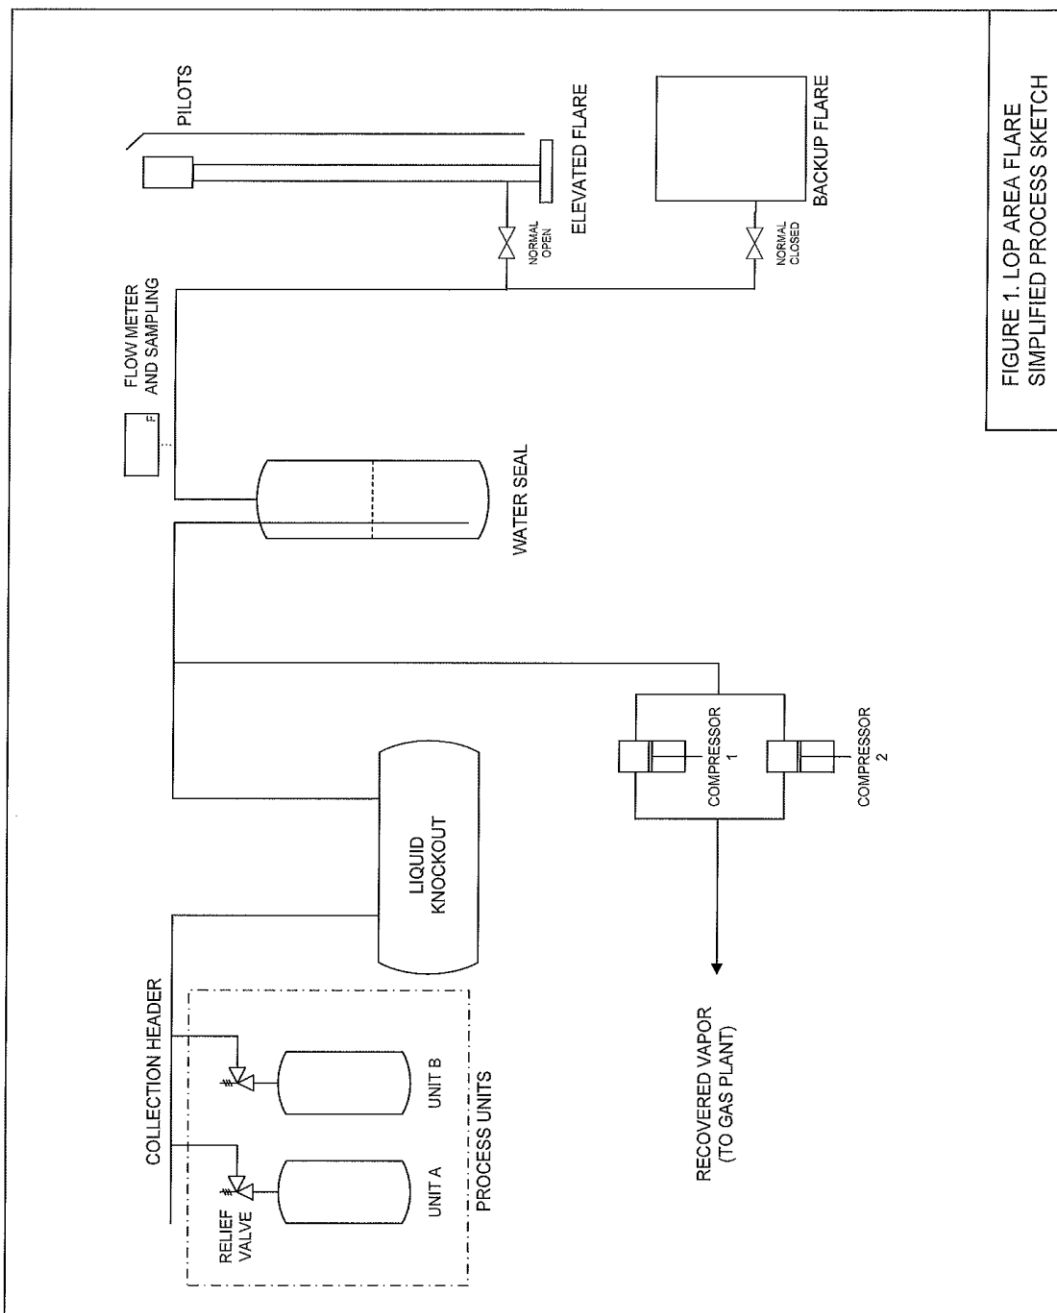
FIGURE 1. LOP AREA FLARE SIMPLIFIED PROCESS SKETCH

Recovered flare gas is treated to remove hydrogen sulfide and condensable liquids. Treated gas is routed to the fuel gas system. The fuel gas treaters typically used for LOP recovered flare gas are located in the Catalytic Cracker Gas Plant (CGP). When this unit is unavailable for any reason, recovered gas may be routed to the Saturates Gas Plant (SGP). Sufficient capacity can be made available in both sets of treaters for the incremental flow up to the total capacity of both compressors of about 6.4 MMSCFD.

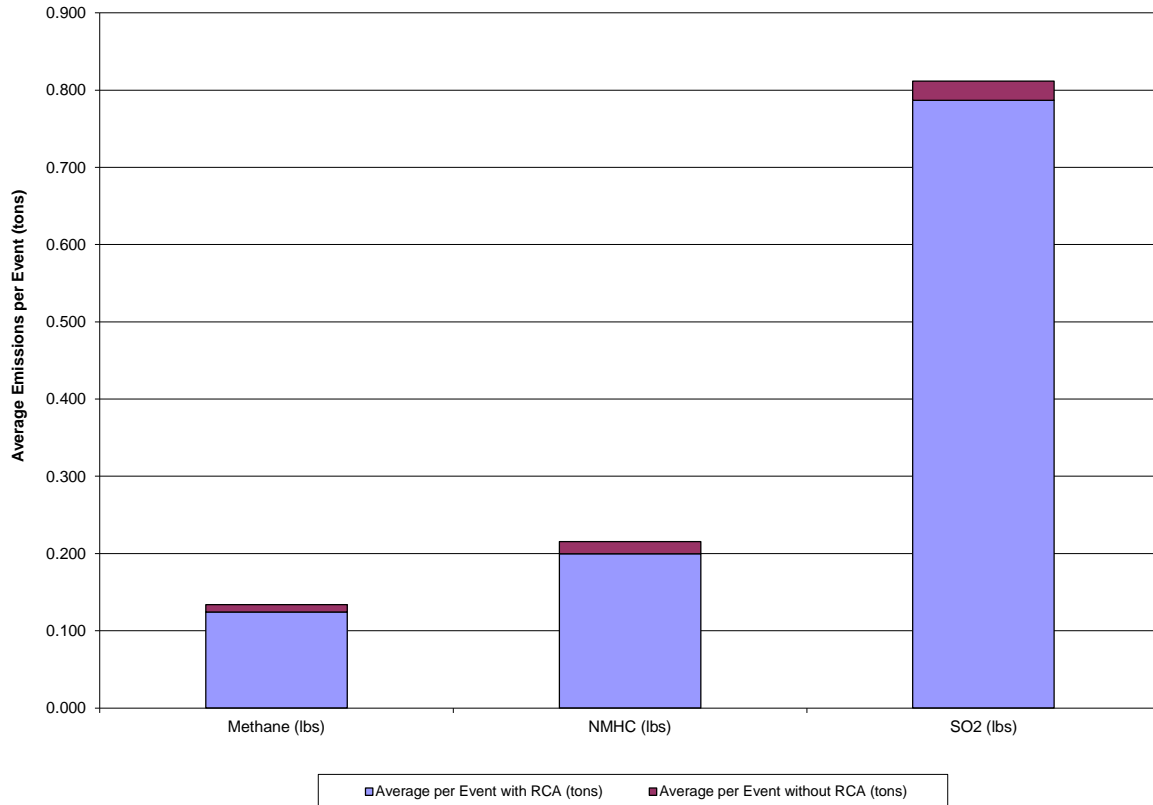
FIGURE 2008 –1

Beginning in November 2006 with the adoption of the Flare Procedures described in the Common Measures Section, pertinent information, when available, was captured immediately after a flaring event to determine the cause of any flaring and what could be done to prevent it from happening again. Total emissions from all flaring during the period from 12/1/06 through 6/1/08 were: 0.6 tons of methane, 0.99 tons of non-methane hydrocarbon and 2.5 tons of SO₂. Figure 2008-1 presents a comparison of the average emissions per large reportable events over this time period vs. the average emissions per small event. This figure shows that small events contributed on average < 10% of the emissions of a large event. Figure 2008-1 reinforces the appropriateness of the causal analysis trigger of 0.5 MMSCF/ 500 lbs SO₂ to ensure the resources to conduct a Causal Analysis are most effectively applied to address high emission events.

LOP Flare Events w/ Causal Analysis vs. Small Events
1/1/06 - 6/1/08

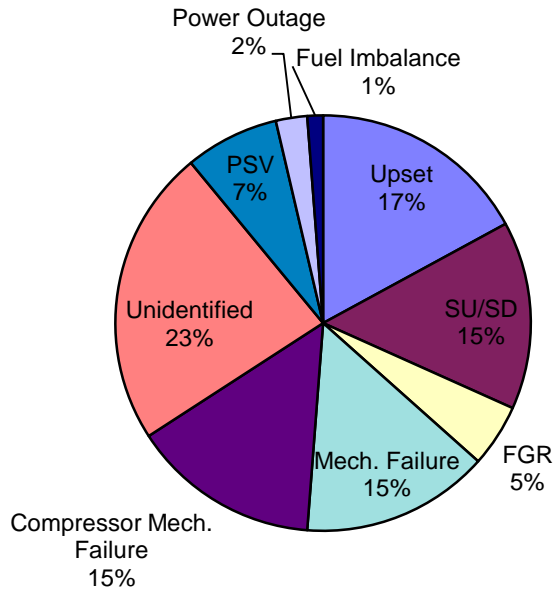
**Figure 2. LOP Area Flare Events
(2000-2005)**

Based on these data, about 65% of the flare events occurring from 2000 - 2005 are essentially evenly divided among the following categories: process upsets, process startup and shutdowns, mechanical failures of compressors and other equipment. Almost one quarter of the time the occurrences where the water seal was broken indicating that flaring occurred were so small, and of such brief duration, no cause could be reliably determined.

Flaring prior to January 2004. Review of flare events prior to January 2004 provided little usable information. Without flow meters, neither durations nor volumes could be accurately determined. In many cases, even the proximate cause of flaring could not be reliably determined due to the limited documentation and time elapsed since the event. With these qualifications, a breakdown of the general cause of LOP flare events for the previous five years is depicted in Figure 2. A description of the various categories listed is provided below:

There has been a significant decrease in the number of flare events caused by fuel system imbalance and startup/shutdown in recent years. This is a direct reflection of the increased emphasis on reducing flaring. Regardless of historical performance, major turnarounds in the recent past on units served by this flare have been performed without planned flaring. That this work was performed without planned flaring is evidence of careful review and planning. We commit to continue this careful review and planning prior to planned major maintenance and expect to perform turnarounds with little or no planned flaring. Therefore there is no predicted flaring resulting from planned major maintenance for which to evaluate prevention measures against. If during the maintenance planning and review process we find that planned flaring is required, all appropriate prevention measures will be considered and feasible measures will be implemented to reduce or eliminate the planned flaring.

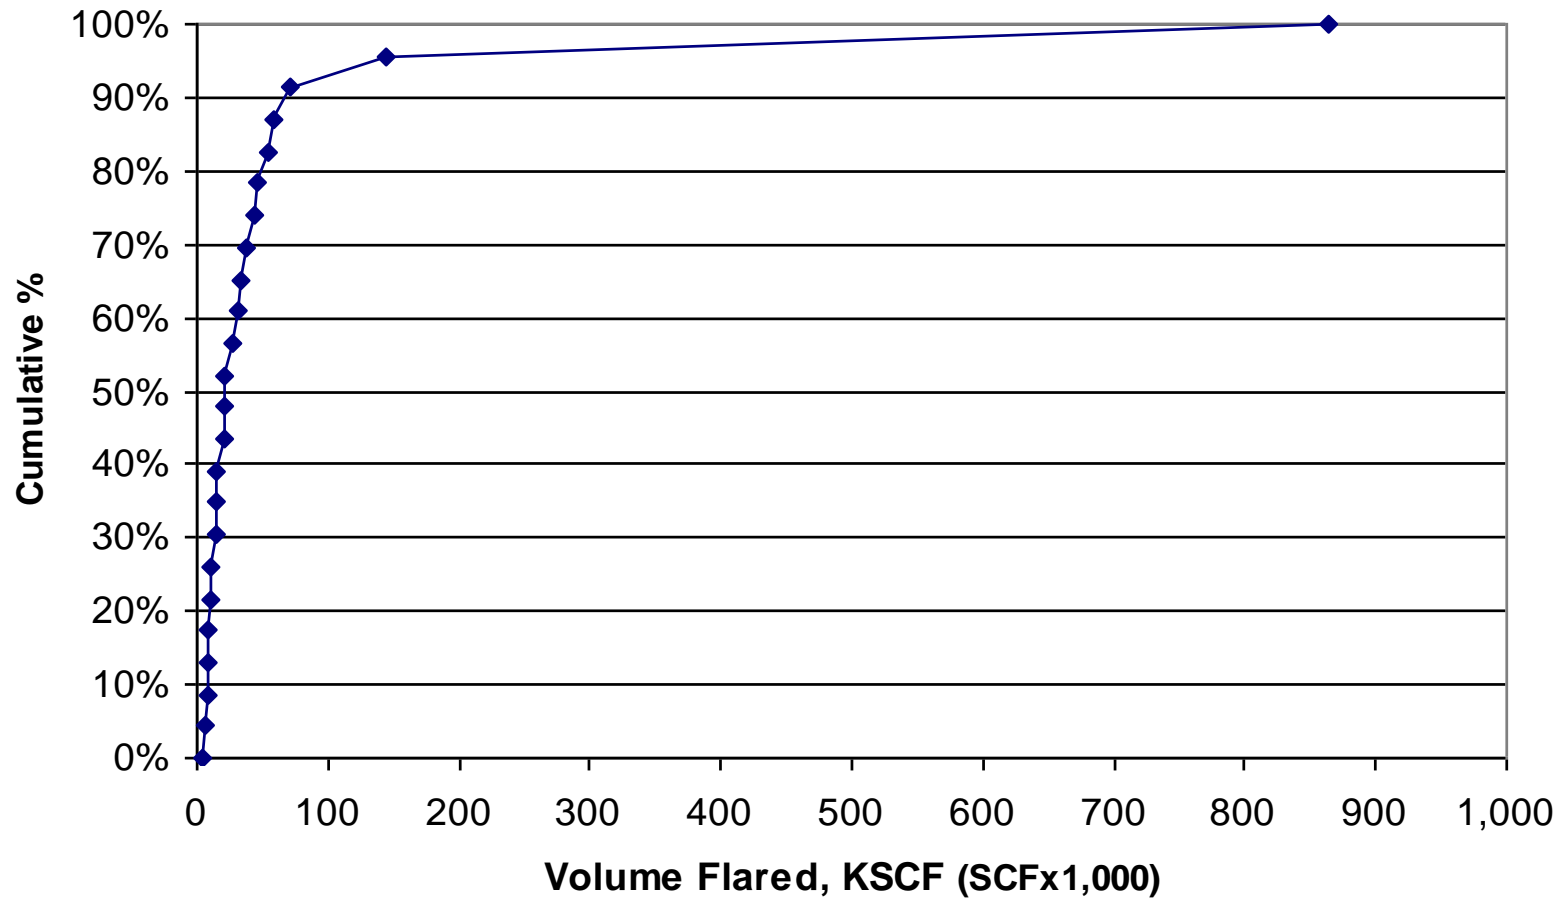
Figure 3. LOP Flare Gas Volumes
(2005)

Volumes flared: Figure 3 depicts the amount of material flared during the 25 events occurring in 2005. Each point on this plot represents the total flare volume of gas during that event. The

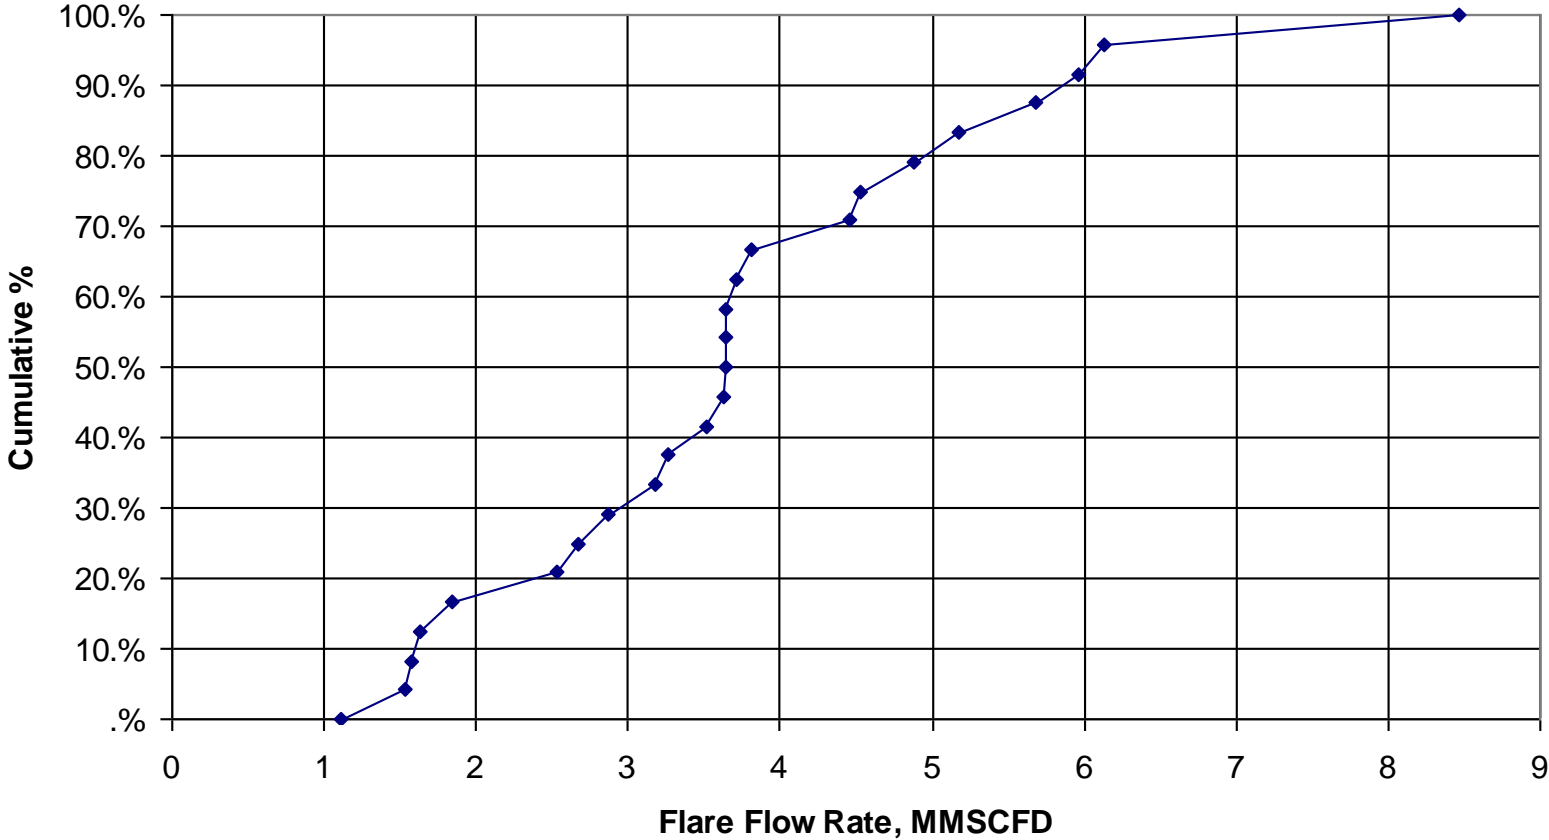
**Figure 4. LOP Flare Gas Flow Rates
(2005)**

Figure 4 depicts the average rates of flow to the flare for events occurring in 2005. These data indicate that approximately 30% of the flare events had event-average flow rates of less than 3 million standard cubic feet per day. Actual instantaneous rates are generally higher – often significantly – than these average rates. This difference between the average rate for an event and instantaneous flare gas rate during an event is important because once the instantaneous rate exceeds the available compressor capacity the water seal is typically broken and flaring occurs. Once flaring begins, backpressure in the flare header provided by the water seal is significantly reduced. Due to the lower header pressure, flare gas recovery rates are typically significantly reduced from their rated capacity.

Data from Figure 4 were used to evaluate the leverage provided by additional flare gas recovery in LOP. As each increment of compressor capacity was added, the corresponding events with average flows within the newly revised total capacity were considered to be recovered rather than flared. Similarly, the reported emissions for these events were presumed not to occur. This provided the basis for emissions reductions as a function of compressor capacity.

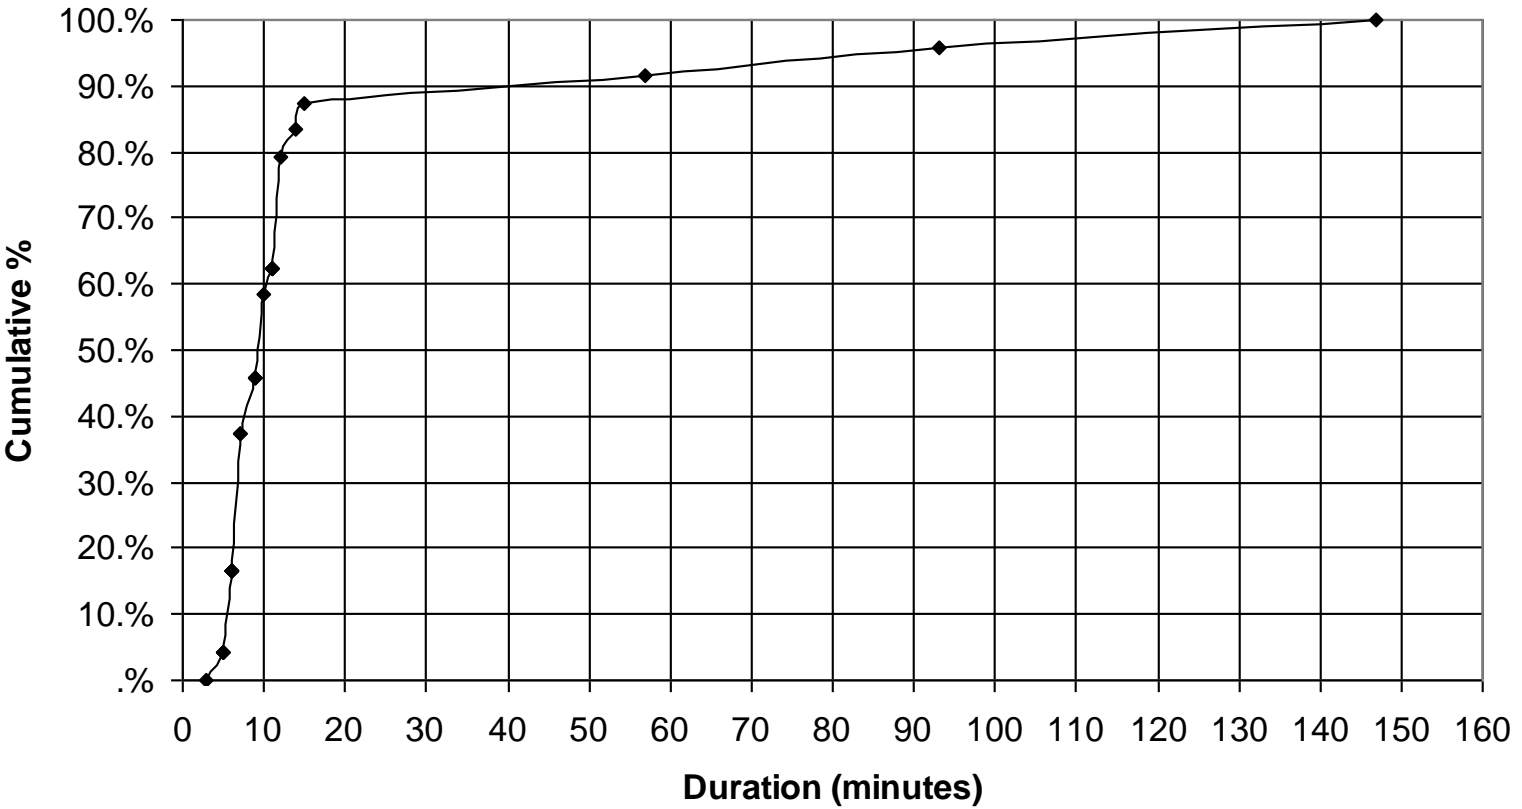
Figure 5. LOP Flare Durations
(2005 - 25 Events)

Figure 5 depicts the distribution of flare event durations for 2005, the year for which these data are available. Most flare events have very short durations with small volumes of gas flared. From Figure 5 it can be seen that half of the flare events had durations of less than 10 minutes. By combining event durations with additional data on the volume flared during each event, it can be shown that the 50% of events with durations less than 10 minutes contributed less than 10% to the total volume of gas flared. The 85% of events which lasted 15 minutes or less contributed less

⁹ The requirement for continuous compressor operation derives from actual data showing that most events in the LOP flare last less than 10 minutes. It is impractical to expect a compressor of this size to go from shutdown to full operation rapidly enough to capture such events.

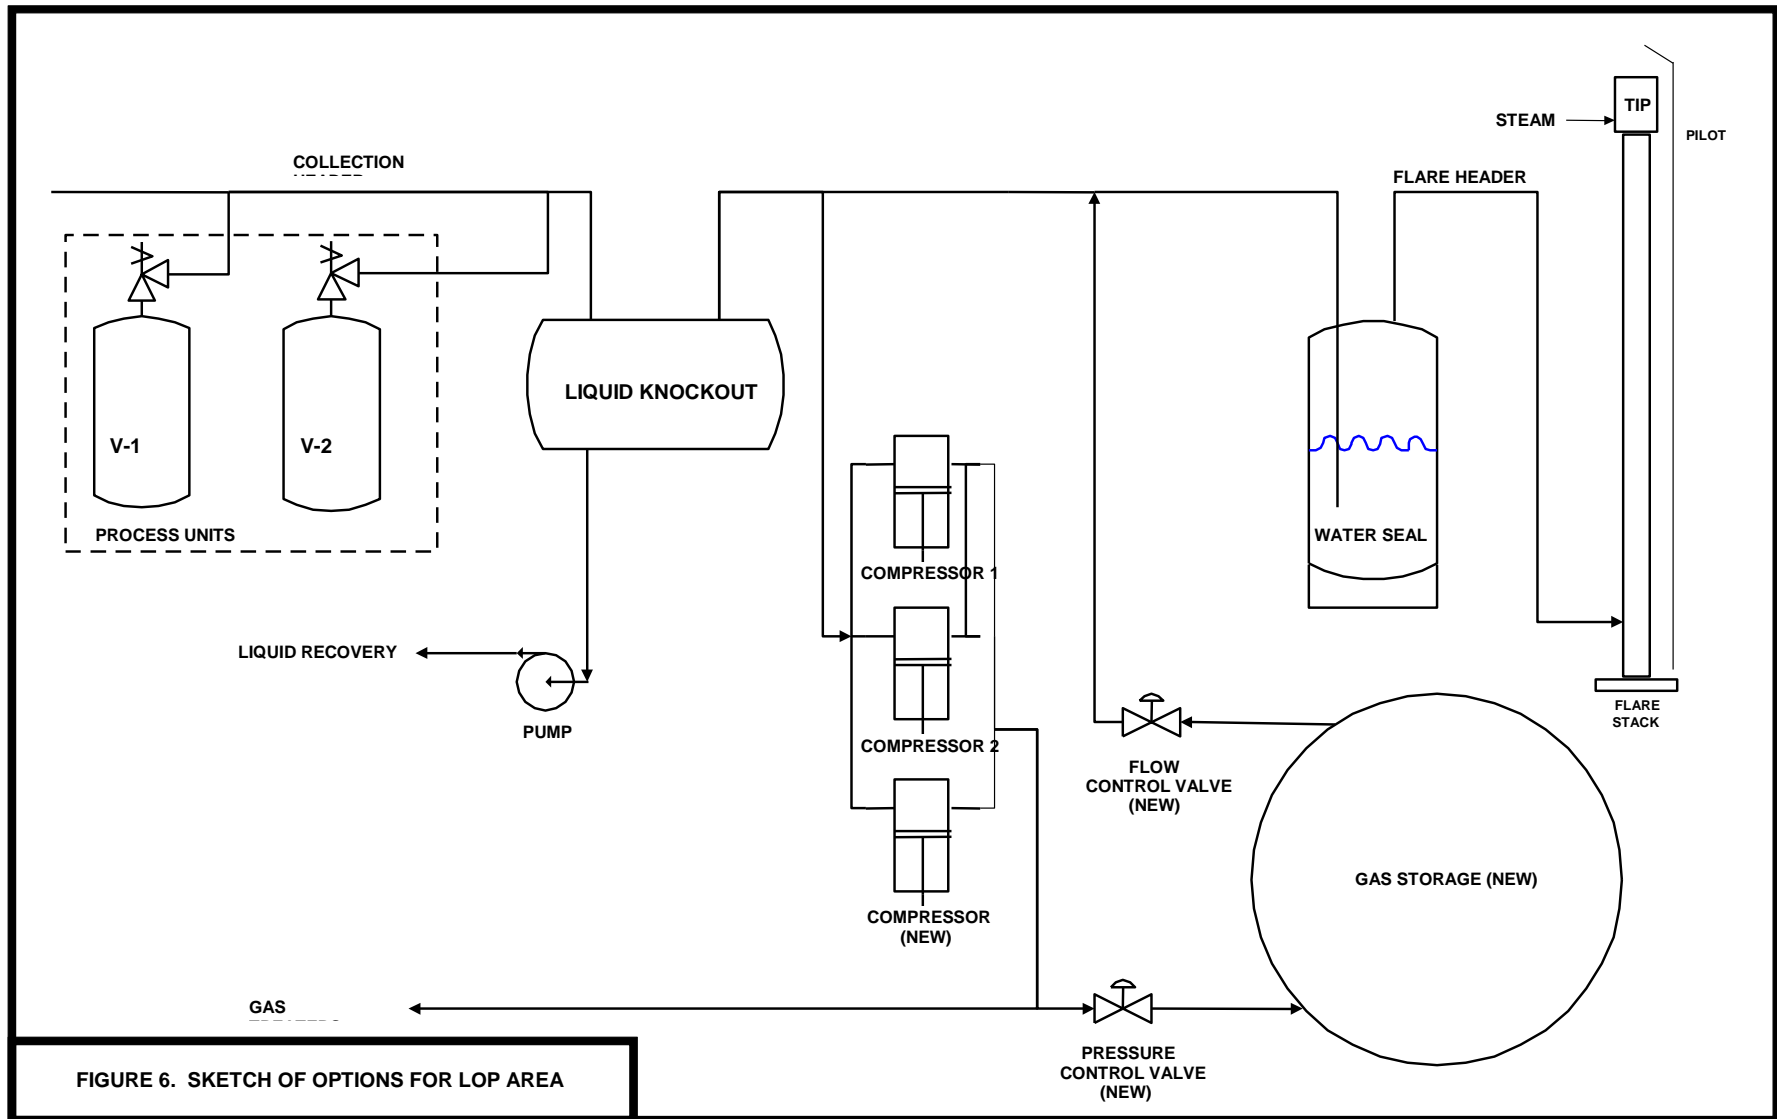
FIGURE 6. SKETCH OF OPTIONS FOR LOP AREA

Prevention Measure Options Considered for Recovery, Storage and Treatment: Costs and potential benefits of improving gas recovery and reducing flare emissions from the current 99.7% recovery efficiency are addressed by considering the addition of flare gas recovery compression and flare gas storage. Gas treating capacity is expected to be adequate for all options evaluated. A sketch of the potential options is provided in Figure 6.

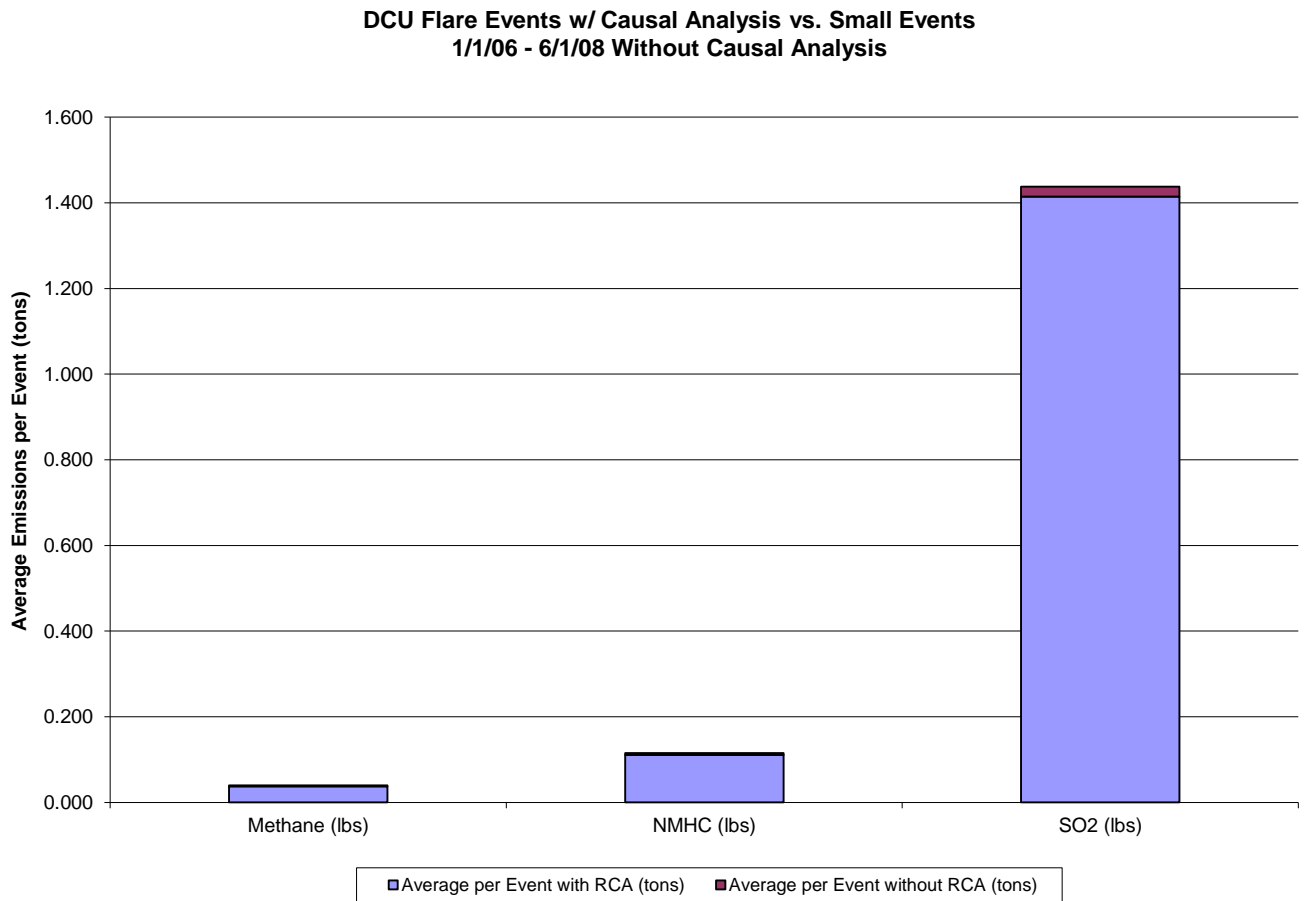
FIGURE 2008-2

Beginning in November 2006 with the adoption of the Flare Procedures described in the Common Measures Section, pertinent information, when available, was captured immediately after a flaring event to determine the cause of any flaring and what could be done to prevent it from happening again. Total emissions from all flaring during this 30-month period were: 0.17 tons of methane, 0.45 tons of non-methane hydrocarbon and 4.19 tons of SO₂. Figure 2008-2 presents a comparison of the average emissions per large reportable events over this time period vs. the average emissions per small event for the DCU Flare. This figure shows that small events contributed < 6% of the emissions of a large event. Figure 2008-2 reinforces the appropriateness of the causal analysis trigger of 0.5 MMSCF/ 500 lbs SO₂ to ensure the resources to conduct a Causal Analysis are most effectively applied to address high emission events.

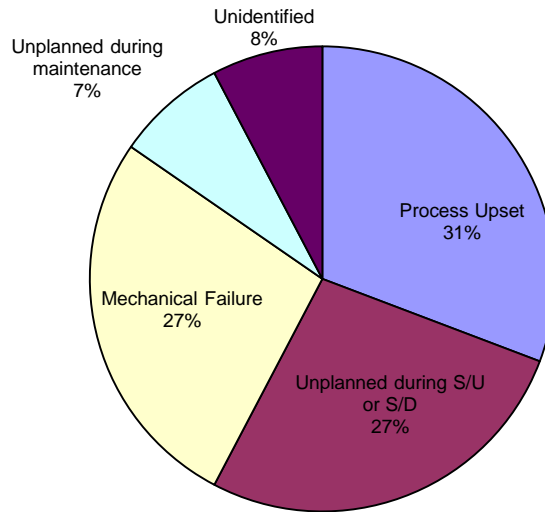
FIGURE 2008 - 3

The DCU flare events that occurred from 1/1/06 – 6/1/08 were categorized by probable cause in Figure 2008-3. None of the flaring was planned. Most of the events were < 10 minutes long. The majority of the events were caused by process upset, mechanical failure or were unplanned during startup and shutdowns.

**Probable Cause of Flaring on DCU Flare 1/1/06-6/1/08
26 Events**

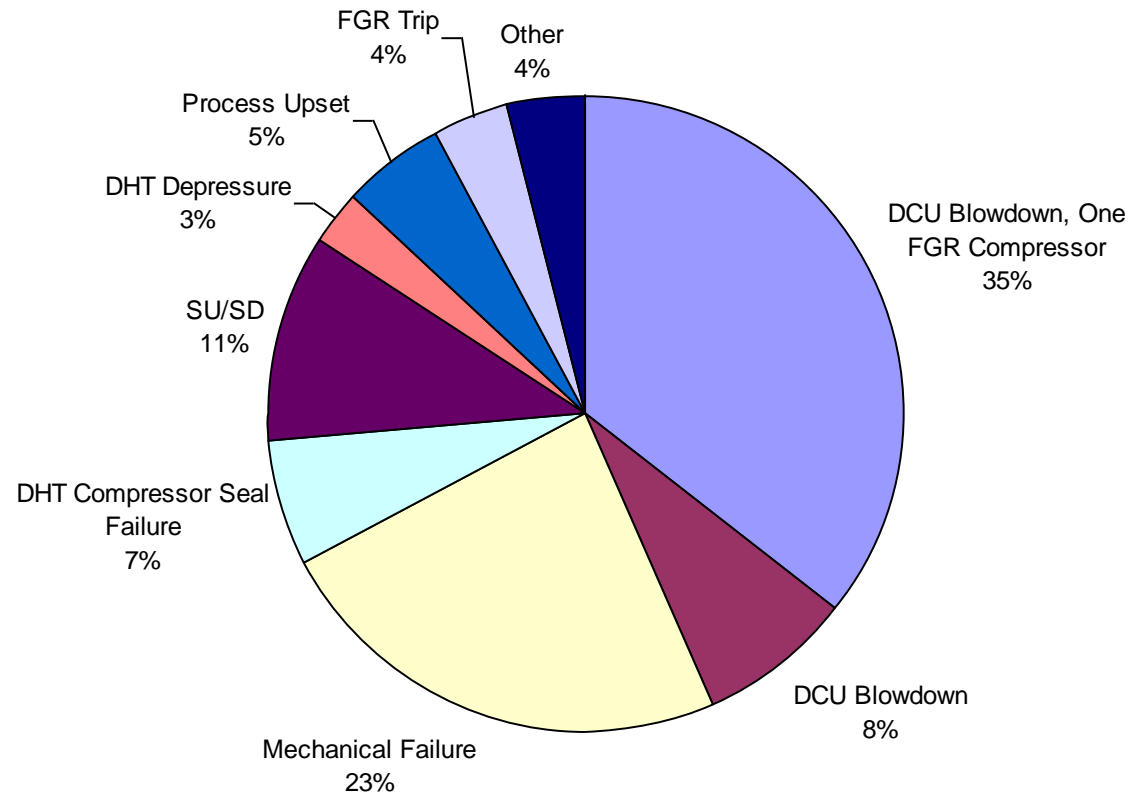
**Figure 8. Delayed Coking Area Flare Events
(2000 - 2005) 76 Events**

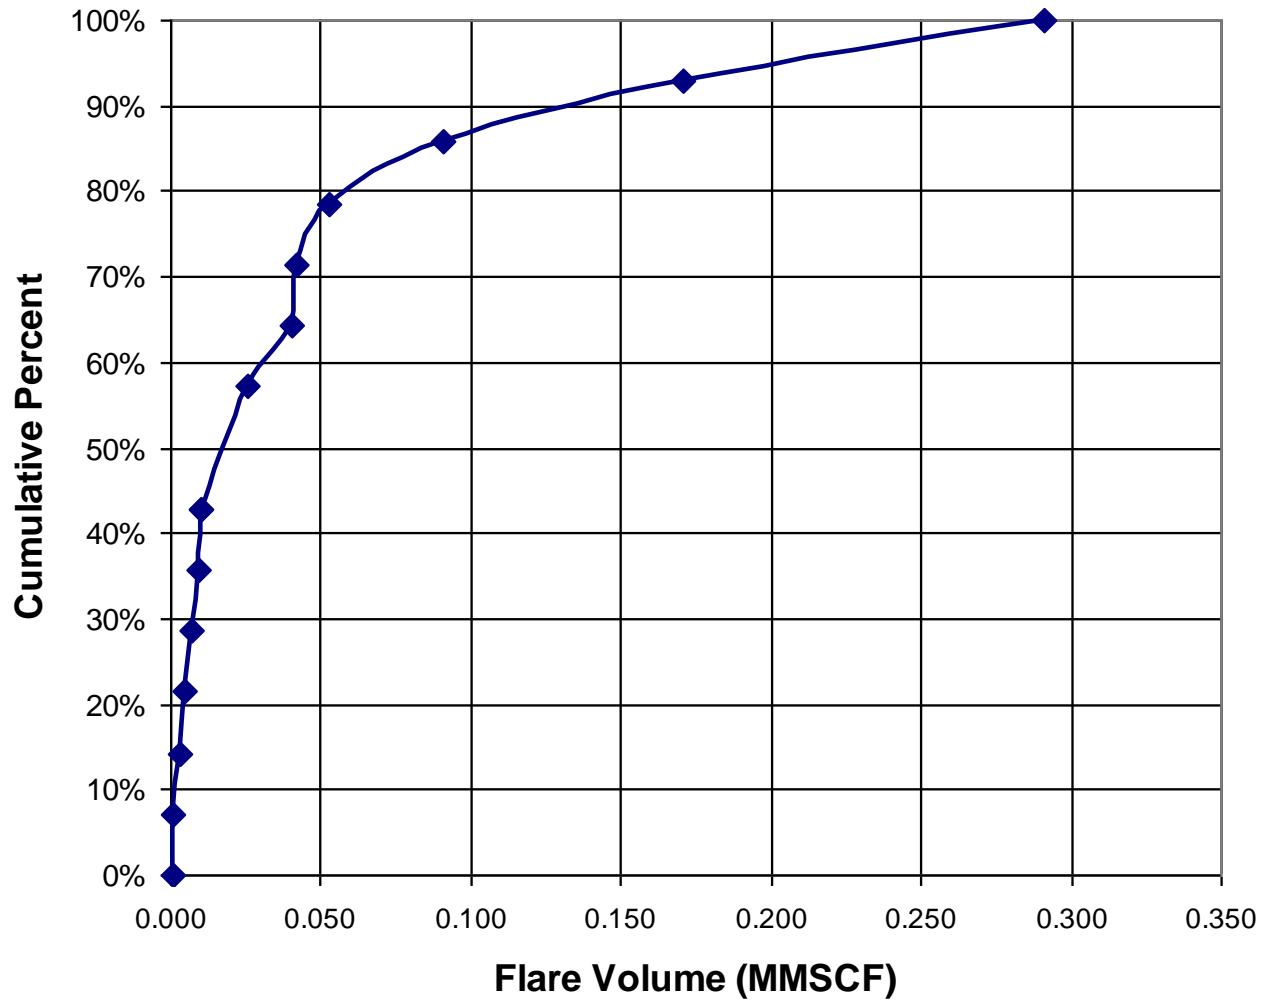
**Figure 9. Delayed Coking Area Flare Gas Volumes
(2005)**

Flaring due to gas quantity: Non-emergency flaring from the Delayed Coking Area flare during 2004 and 2005 amounted to less than 0.04% of permitted emissions of non-methane hydrocarbon. Efficiency of the existing flare gas recovery system is > 99.9%. Actual data for this flare is provided in figures 9 through 11. These data, together with knowledge of the various process units and hardware served by the flare, provide no new alternative mitigations beyond those already presented for the LOP Area flare.¹⁴

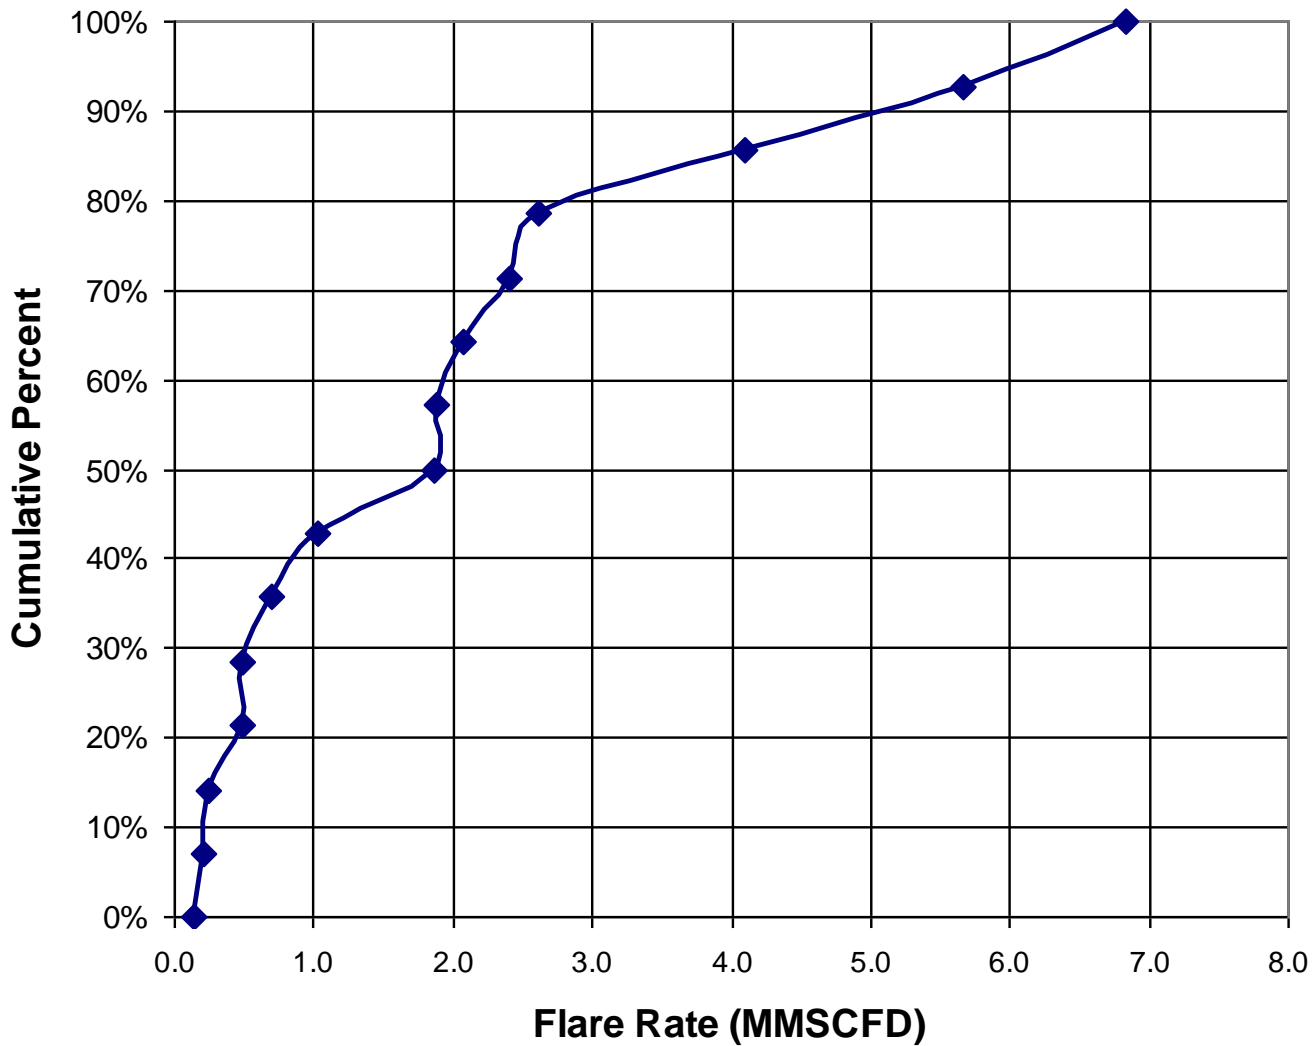
**Figure 10. Delayed Coking Area Flare Gas Flow Rates
(2005)**

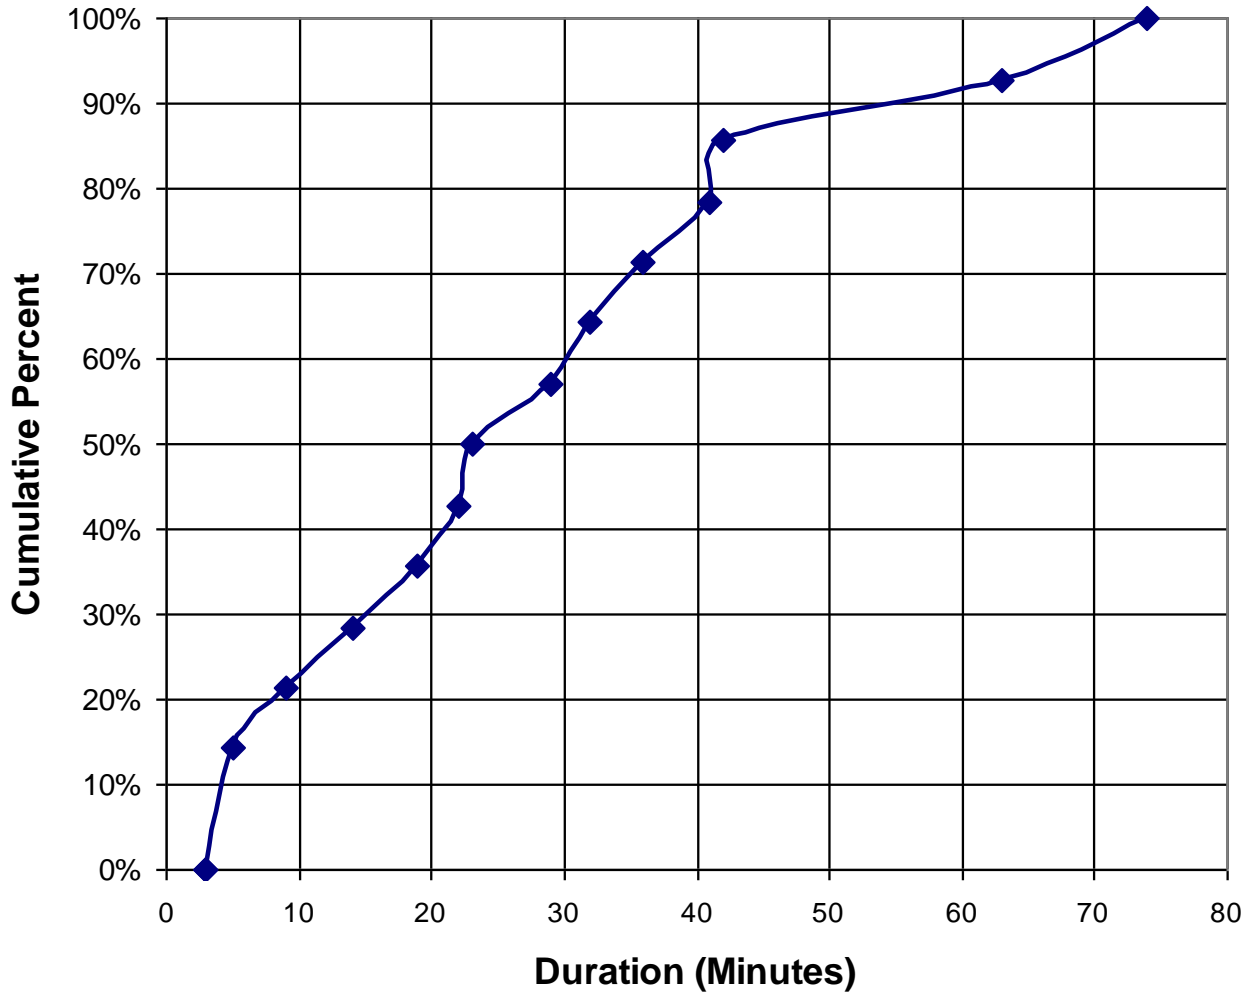
Figure 11 depicts the distribution of flare event durations for 2005 where these data are available. 50% of the events lasted less than 30 minutes. This is consistent with other data characterizing the bulk of flare events being very brief.

**Figure 11. Delayed Coking Area Flare Event Durations
(2005)**

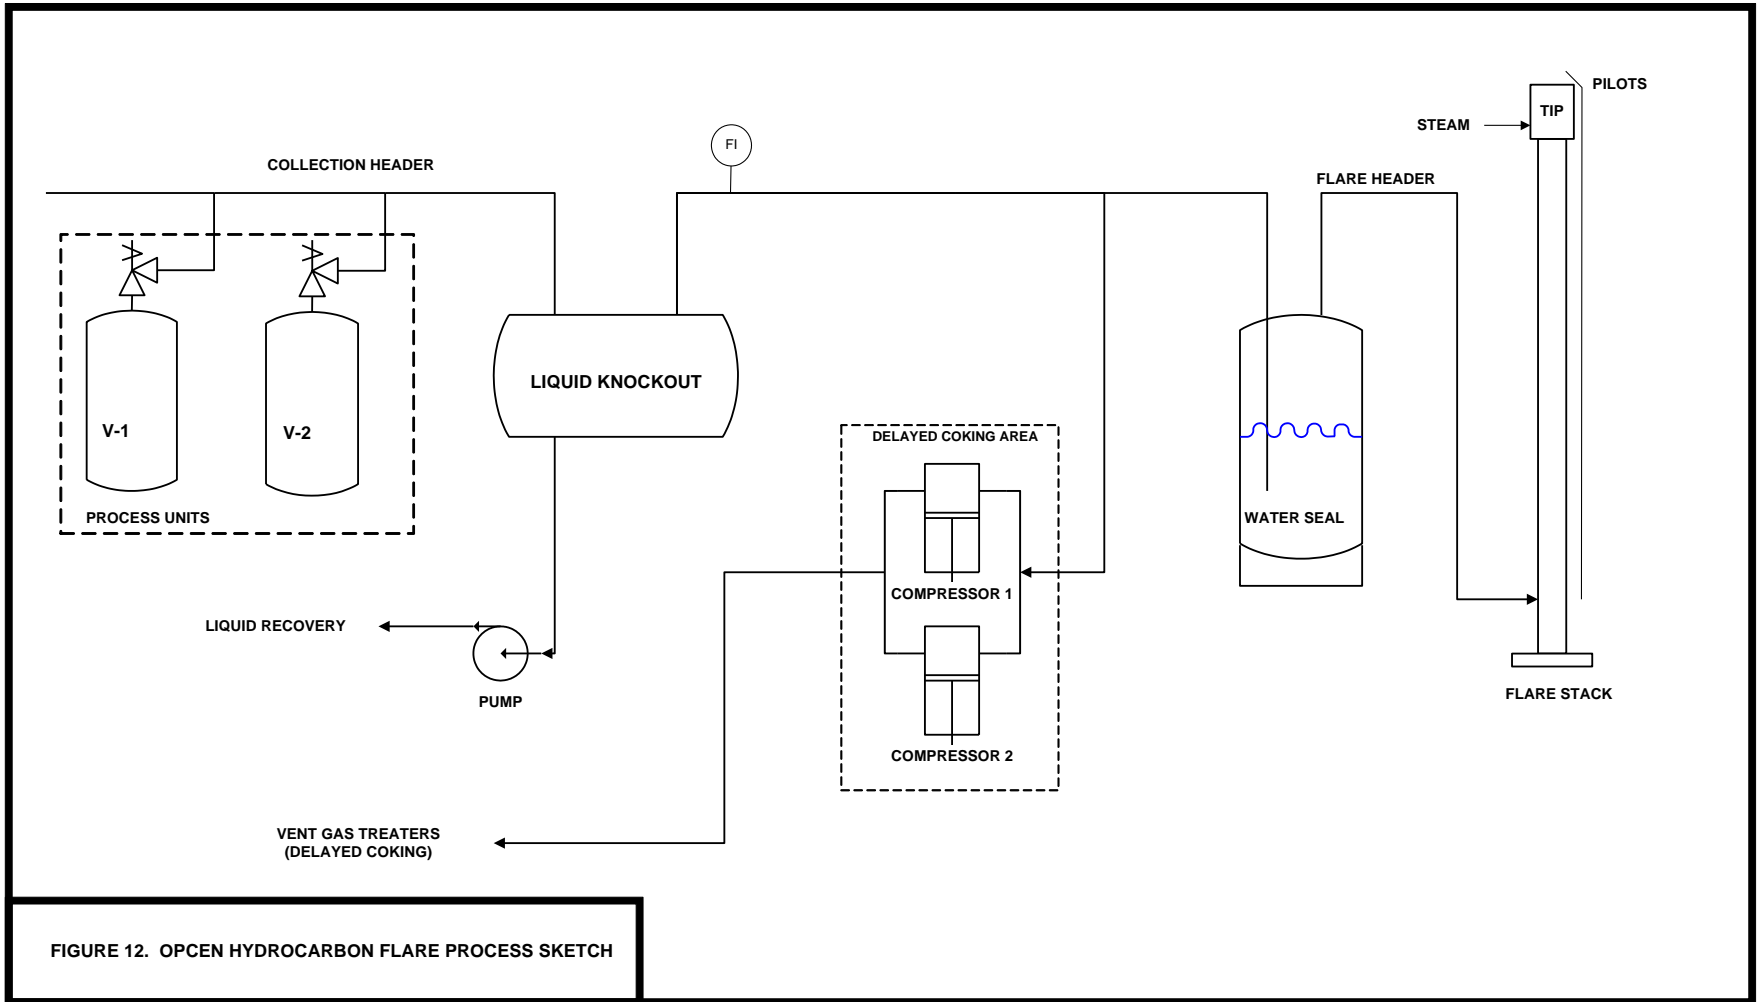
FIGURE 12. OPCEN HYDROCARBON FLARE PROCESS SKETCH

Process units in the OPCEN area are served by a dedicated flare system. This flare was modified by a project to provide flare vapor recovery. The vapor recovery project was operational in November 2006. A sketch of the flare system is provided in Figure 12. The OPCEN HC flare system is comprised of collection headers, a liquid knockout vessel, a water seal vessel, piping to flare gas recovery compressors and gas treating, the flare header proper, and the flare¹⁶. Additional details of the flare are provided in Appendix C.

Recovered gas from OPCEN is treated to remove H₂S and routed to fuel and hydrogen plant feed along with the recovered gas from Delayed Coking. The normal routing for Delayed Coker Area recovered flare gas is the Vent Gas Treater. Sufficient capacity is available for the incremental flow (up to the total recovery compressor capacity of about 8 MMSCFD).

¹⁶ This figure includes the flare gas recovery system with the modification. Due to the need for a general shutdown of process units in the OPCEN area, the system was not operable in time for the August 1, 2006 original submittal of this plan. Post-project facilities are used as the basis for system description. However, the historical performance of this flare obviously provides little basis for evaluating mitigation options beyond the implemented flare gas recovery.
