Shell Martinez Refinery

FLARE MINIMIZATION PLAN

Updated October 1, 2015

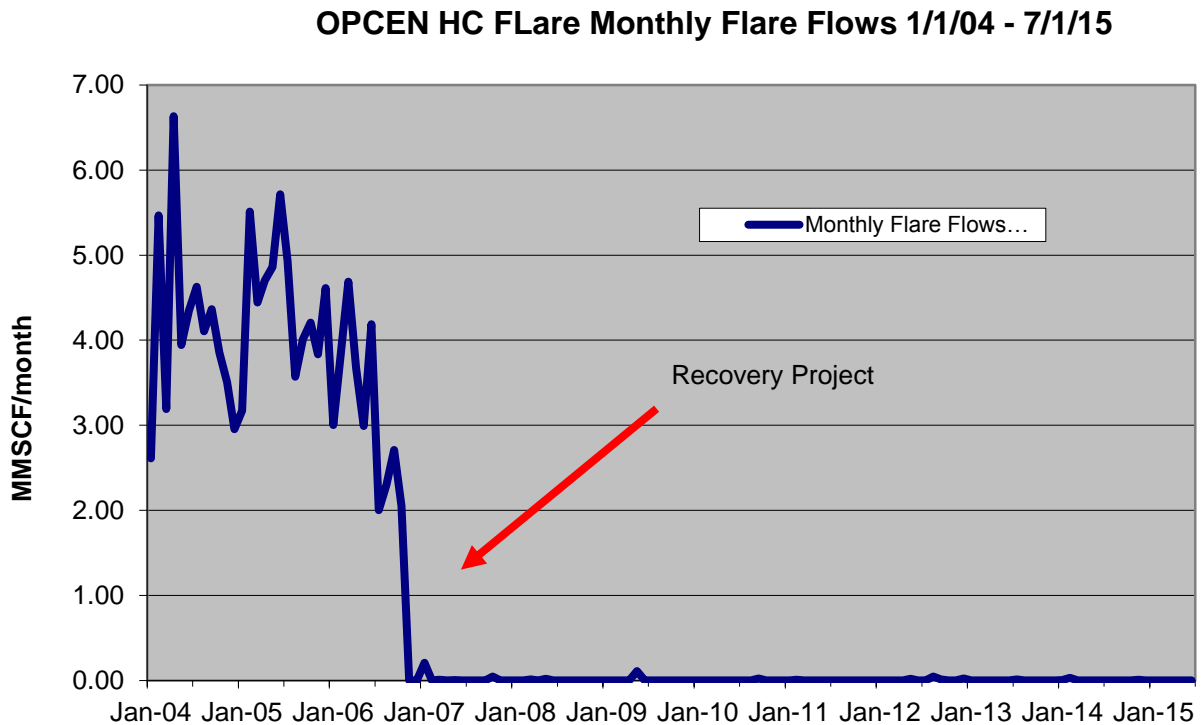
FIGURE 1

Figure 1 below has been updated through 7/1/15 and shows the continued success of the implementation of the flare recovery project that occurred in 2006 on this flare.

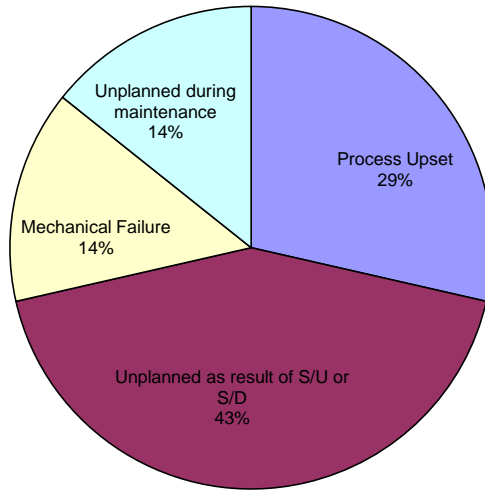
FIGURE 2008-4

OPCEN HC Flare- Cause of Flaring 11/1/06 - 6/1/08
7 Events

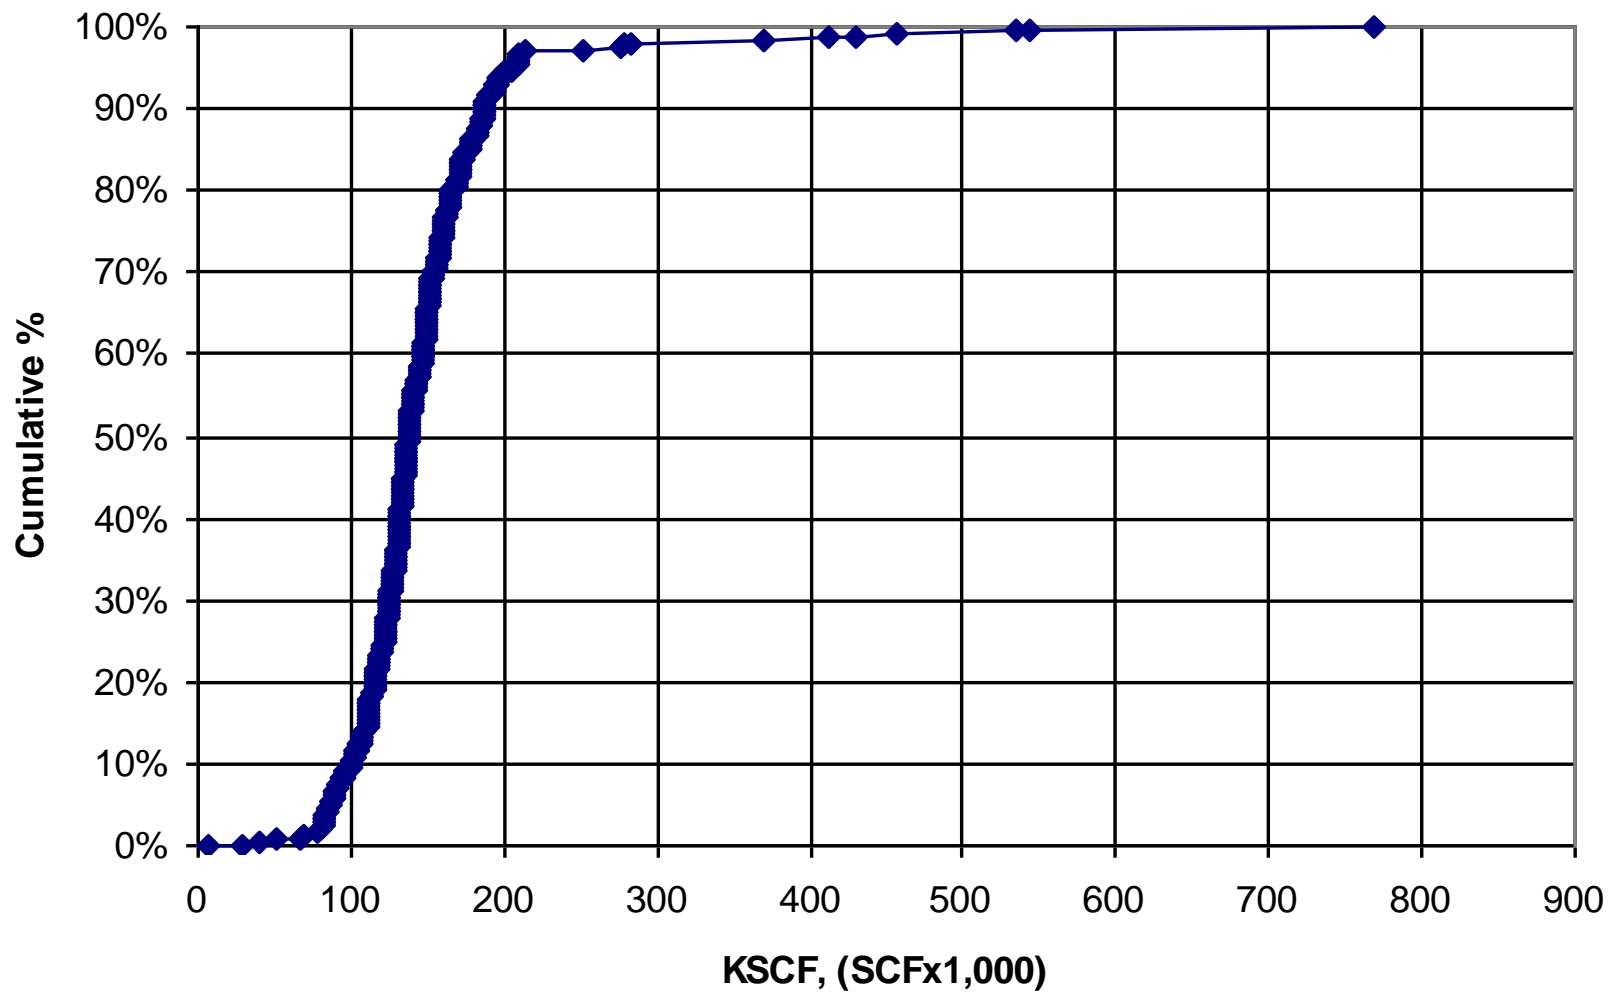
**Figure 13. OPCEN Hydrocarbon Flare Gas Volumes
(2005)**

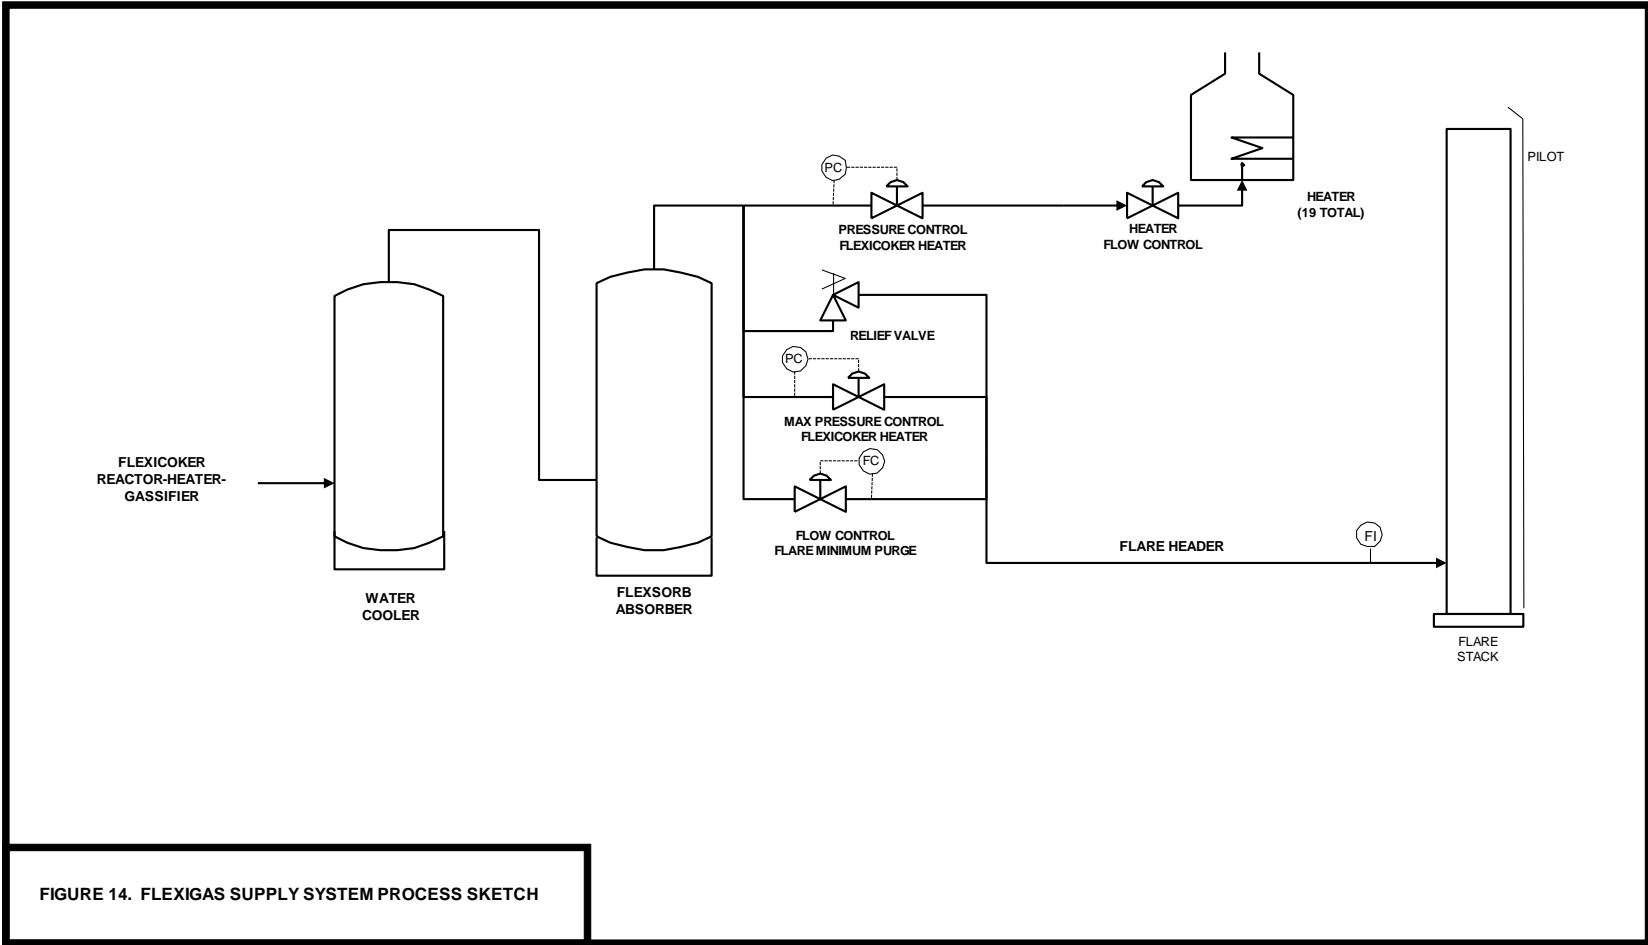
FIGURE 14. FLEXIGAS SUPPLY SYSTEM PROCESS SKETCH

The OPCEN Flexigas flare is a dedicated flare serving the Flexicoker Reactor/Heater/Gasifier. The Flexigas flare only combusts flexigas (FXG). This flare differs significantly from all other process flares serving Bay Area refineries for reasons described below. A simplified process sketch is provided in Figure 14. Details of the system are provided in Appendix D.

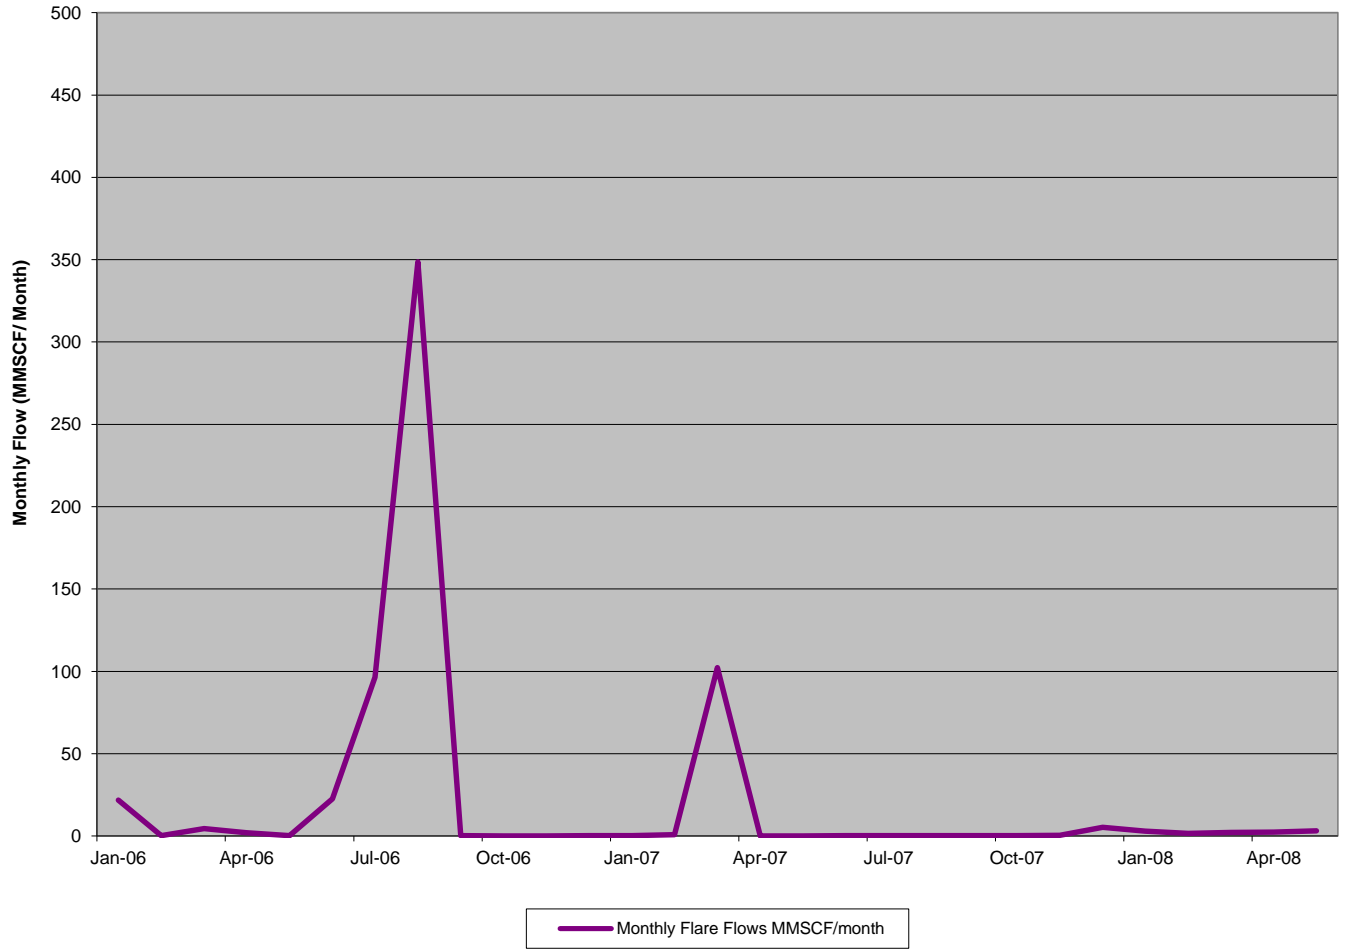
FIGURE 2008-5

FYG Flare Flows 1/1/06 - 6/1/08

Flexigas flare activity since 1/1/06 was reviewed for potential reduction opportunities. Figure 2008-5 shows the FXG flare flows over this time period. There were 11 events that required Causal Analysis. All of these flaring events were investigated and prevention measures identified and implemented (see Part 3 of this Section – Reductions Previously Realized). The results of the investigations into these events were reported to the District in Causal Analysis reports.

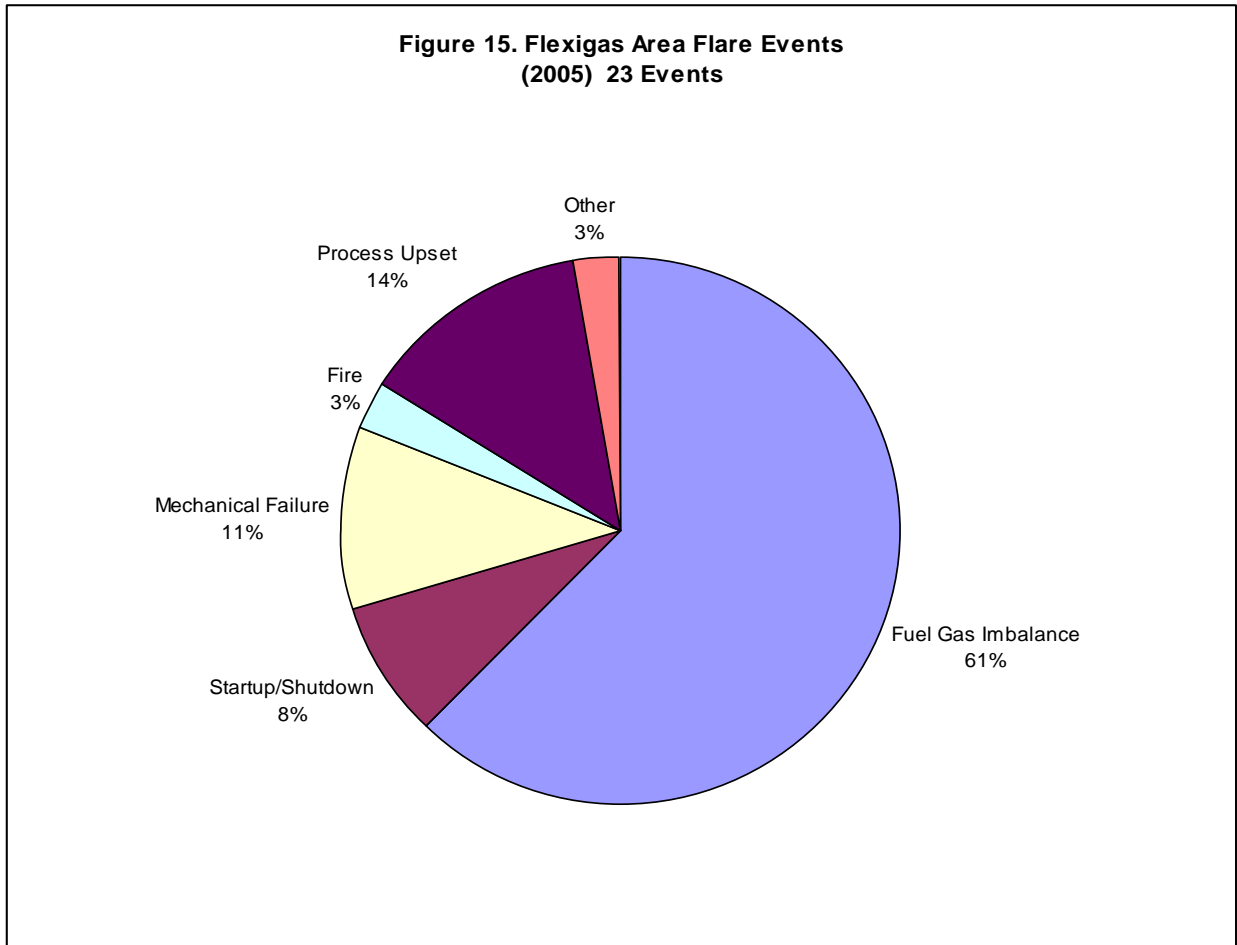
Historical flaring at the OPCEN Flexigas flare was reviewed to identify opportunities for potential mitigation. The highest quality data are available for the period from December 2003, to January 2006. This coincides with installation of the flare flow meter and BAAQMD flare reporting. Data for 2005 are plotted in Figure 15 and Figure 16.

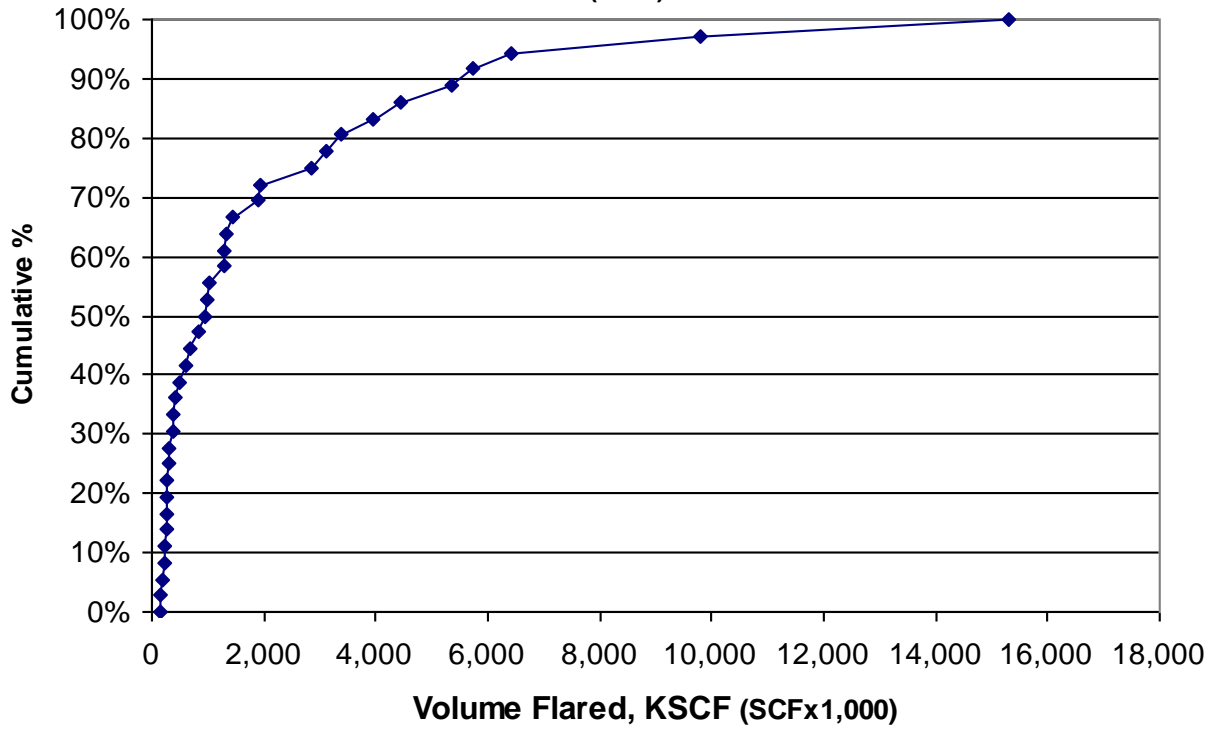
**Figure 16. Flexigas Flare Gas Volumes
(2005)**

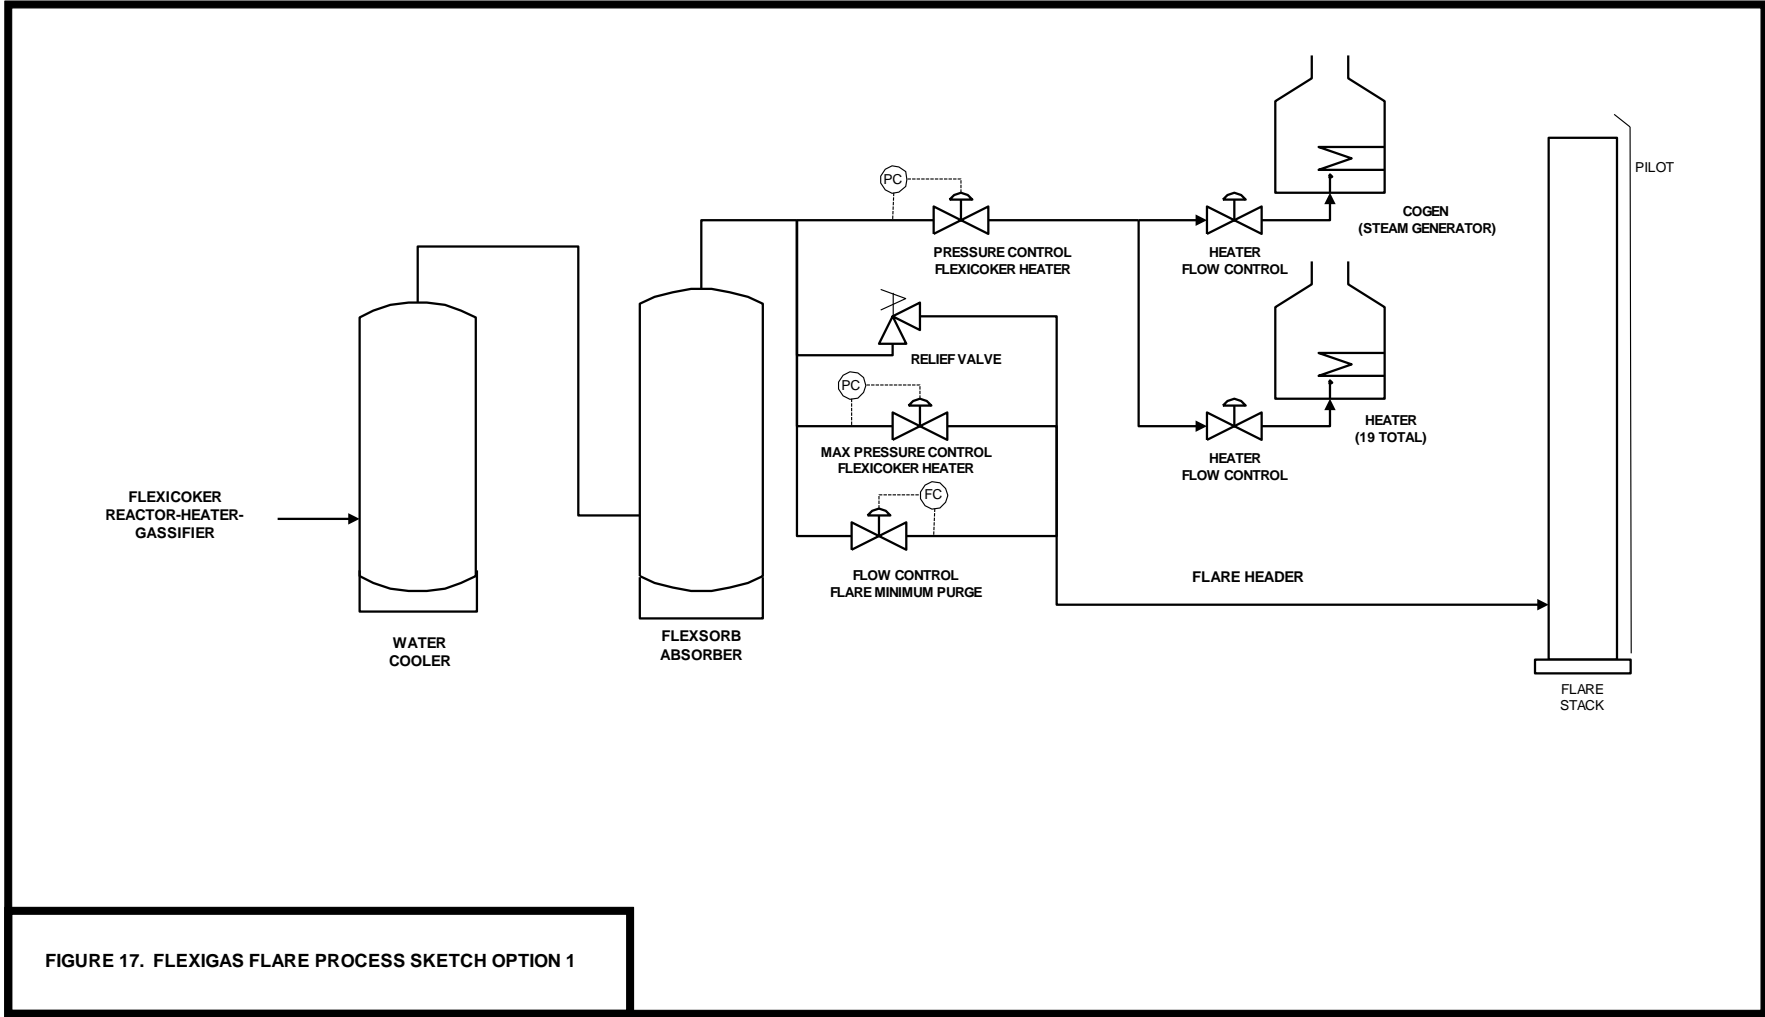
FIGURE 17. FLEXIGAS FLARE PROCESS SKETCH OPTION 1

OPTION 1: PROVIDE ADDITIONAL FLEXIGAS CONSUMERS (see Figure 17).

The objective of this project would be to provide an additional consumer that can rapidly pick up the Flexigas volumes made available by loss of another consumer (e.g., process heater) for any reason. Because excess Flexigas is available less than 10% of the time (based on the percent of days on which flaring occurred from Figure 16), and the current fuel system is roughly in balance, this consumer must essentially remain in hot standby until needed. This means it must be waiting to burn between 1 MMSCFD and 40 MMSCFD Flexigas when an existing consumer unexpectedly comes off line.

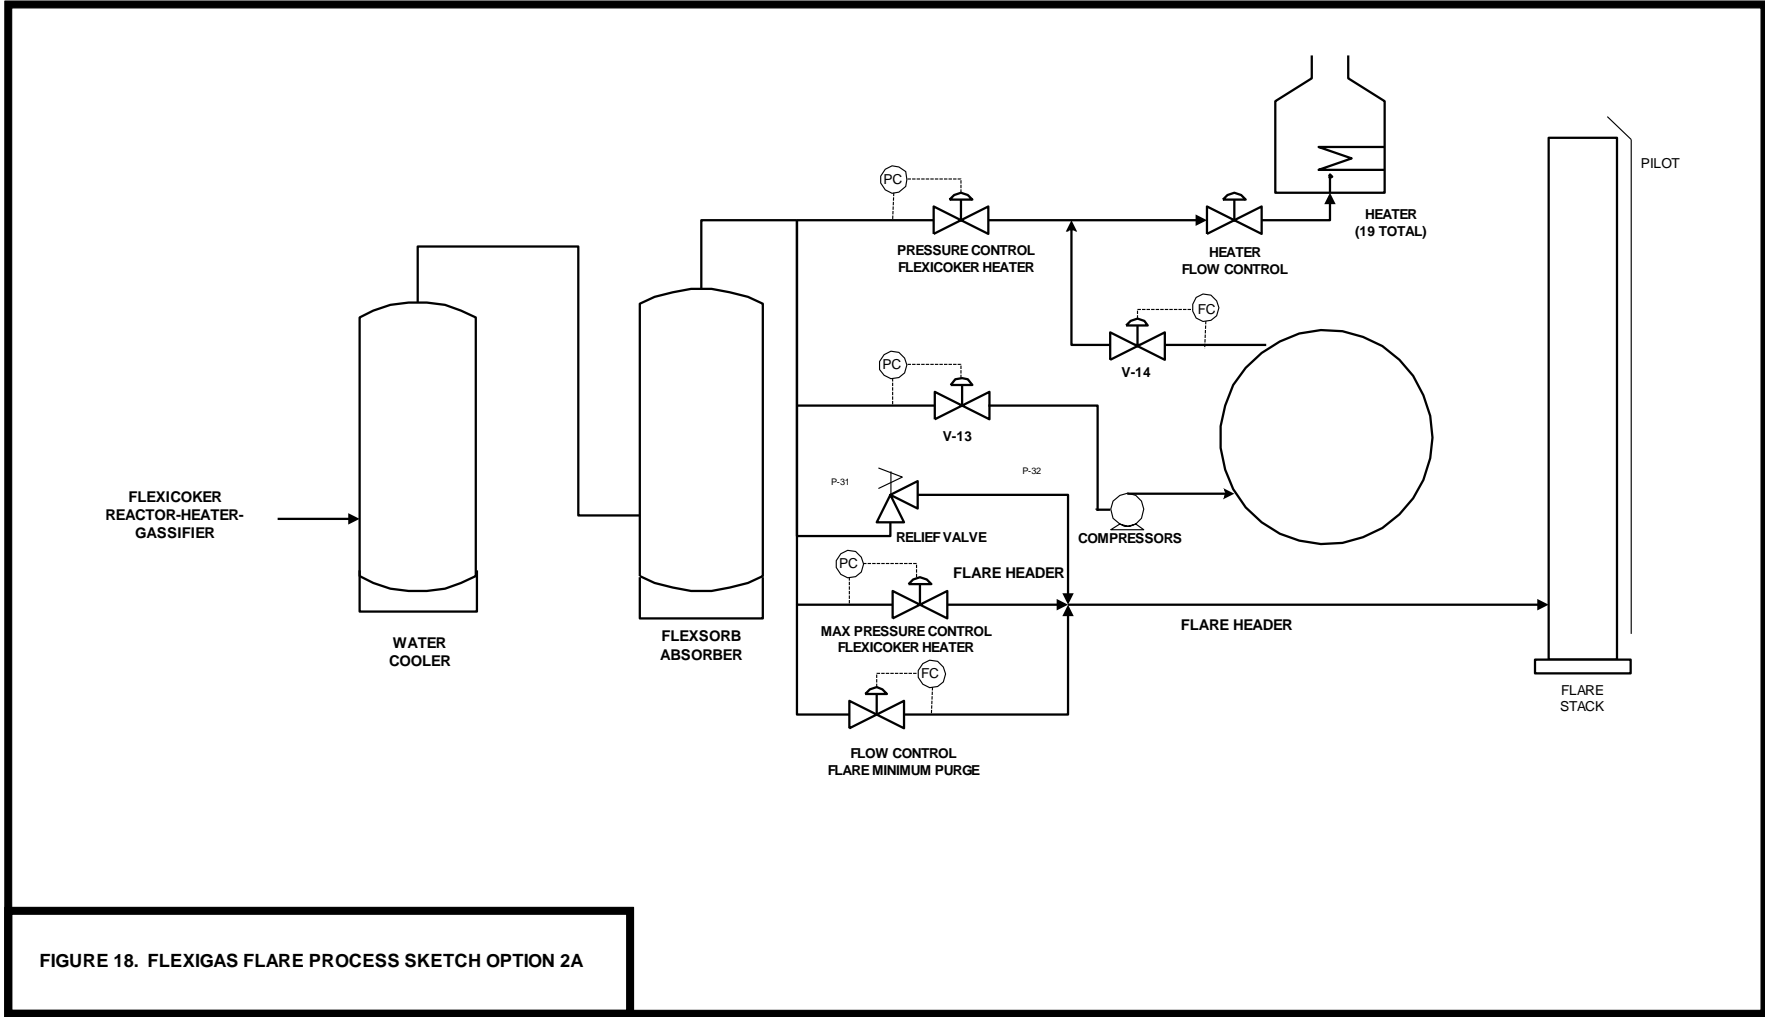
FIGURE 18. FLEXIGAS FLARE PROCESS SKETCH OPTION 2A

Option 2A consists of a pressurized vessel that would require a compressor with capacity ranging between 1 MMSCFD and 10 MMSCFD. This option is depicted in Figure 18. Flexigas in excess of consumer demand is routed to storage via compressor(s). A controlled flow is returned to the distribution system when enough consumers are available to avoid flaring. Due to the limited capacity of this storage, it has no real capability to accommodate prolonged fuel system imbalances. As a result, the expected best-case emission reductions are about the same as those available in 2005. A rough capital cost for the storage and large compressors is about \$27,000,000²². Annual electrical costs for the required compressors add another \$600,000. The annualized capital plus electrical costs to eliminate a ton of non-methane hydrocarbon result in a cost-effectiveness of approximately \$190 Million dollars per ton. Therefore, Option 2A is even less cost-effective for reducing flaring than Option 1.

²² Based on a nominal 1 MMSCF sphere (60' diameter) at 120 psig, and two 4 MMSCFD compressors. This system would handle only minor imbalances while the Flexicoker cuts rate.

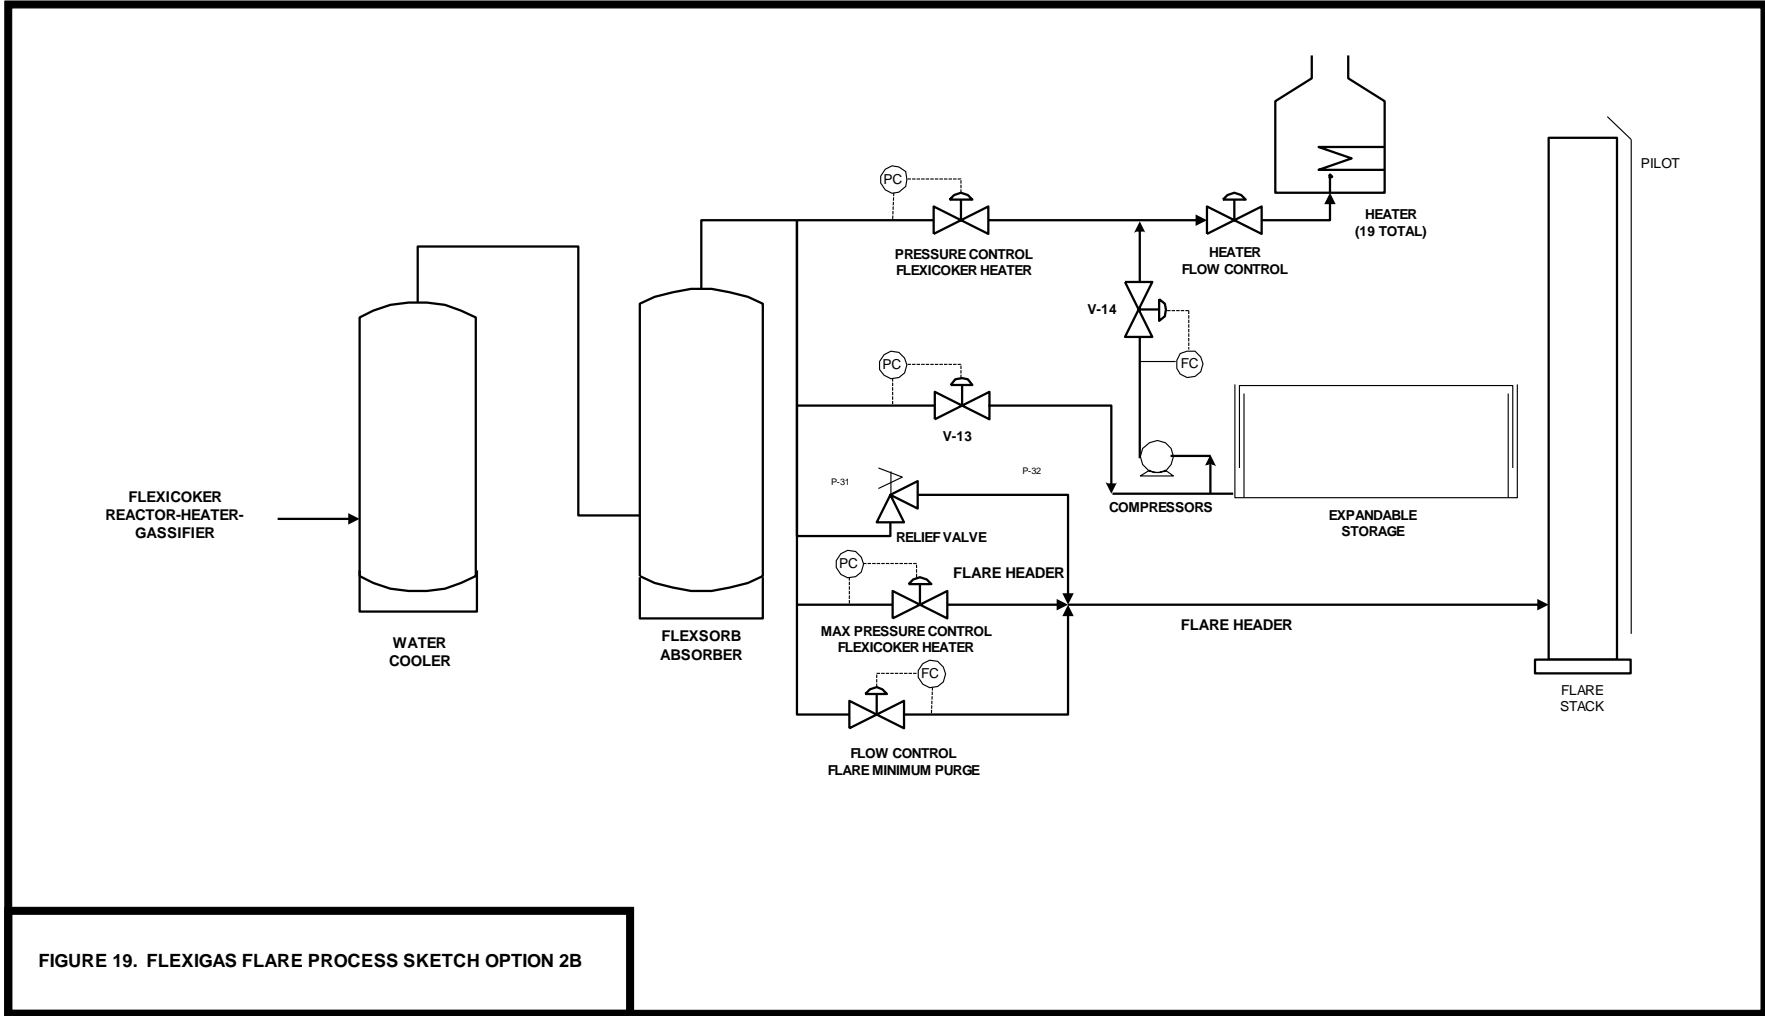
FIGURE 19. FLEXIGAS FLARE PROCESS SKETCH OPTION 2B

Option 2B uses low-pressure expandable gas storage. This option is depicted in Figure 19. This type of storage can be built significantly larger than the pressurized storage used in option 2A, and has the advantage of not requiring compressors in some cases. However, the concentration of carbon monoxide in the gas will likely require use of a water seal to limit leakage, restricting vessel height to a single lift. The requirement for a single lift, combined with low-pressure operation, significantly limits available storage volume²³. In any event, the installed cost is approximately \$21,000,000, providing cost-effectiveness of approximately \$276 Million dollars per ton of NMHC. As was the case for Option 2A, this option is even less cost-effective for reducing flaring than Option 1.

²³ The actual available storage volume is probably on the order of 1 MMSCFD, and will severely limit achievable emissions reductions. A 50% savings is premised for this analysis.
