Shell Martinez Refinery

FLARE MINIMIZATION PLAN

Updated October 1, 2016

Shell Oil Products US
Martinez Refinery
Martinez, California 94553
BAAQMD Plant No. A0011

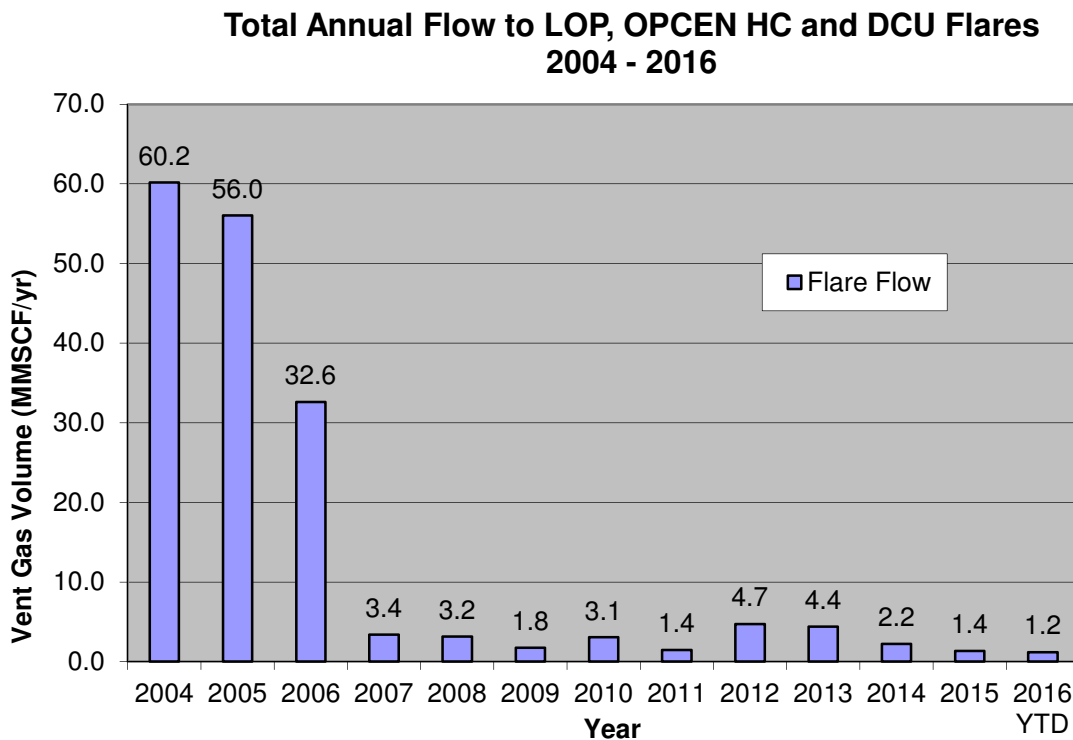
FIGURE ES-1

Figure ES-1 presents the total annual vent gas flow to the LOP, OPCEN Hydrocarbon and Delayed Coking (Clean Fuels) Flares at the refinery from 2004 through June 30, 2016. Flare flow continues to be very low and has been decreasing since 2012.

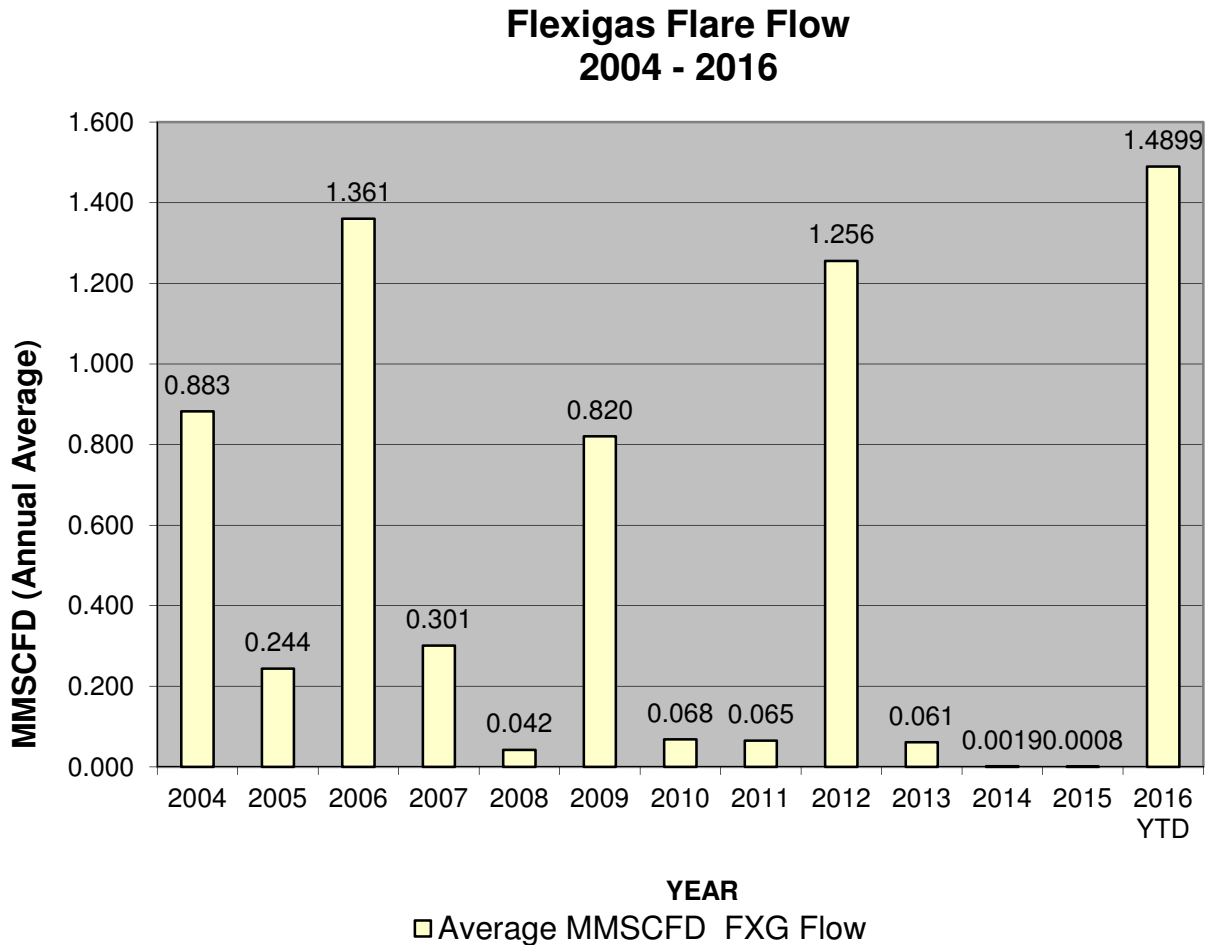
FIGURE ES-2

Figure ES-2 shows the annualized vent gas flow from the Flexigas flare. This figure shows a cyclic increase in Flexigas flaring which occurs during years with startup and shutdown of the Flexicoker due to the nature of the Flexicoking and Flexisorb processes. The flaring of treated flexigas during startups and shutdowns of the Flexicoker is specifically allowed up to certain limits in Shell's Title

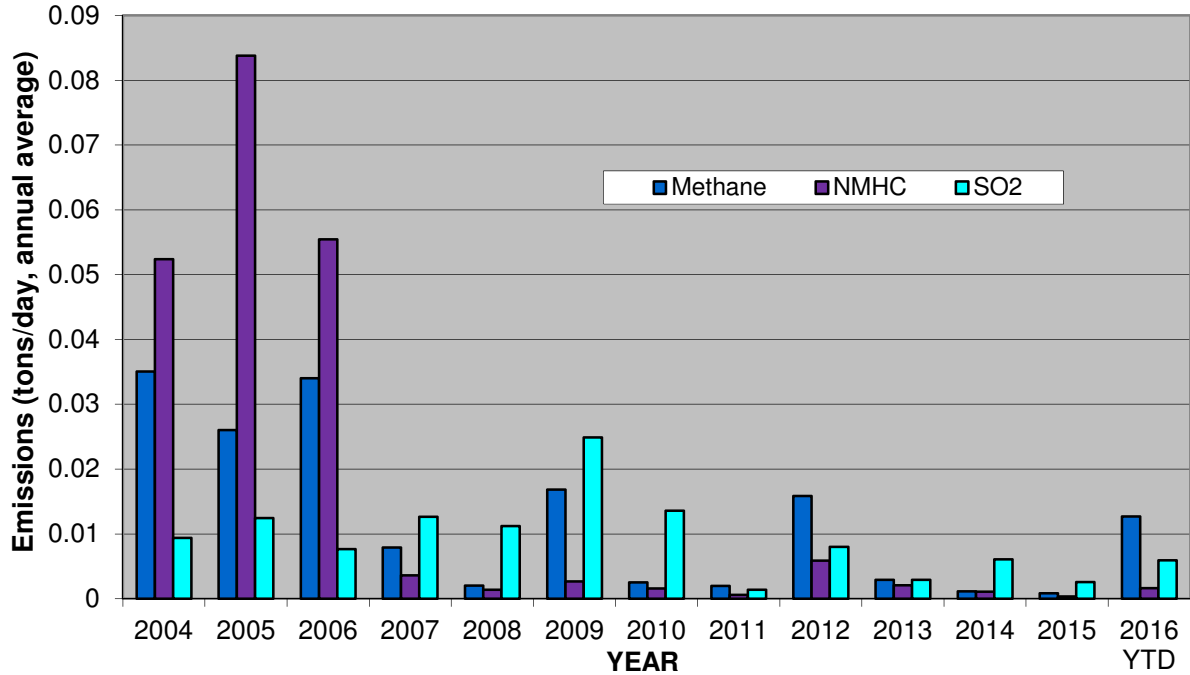
FIGURE ES-3

Figure ES-3 shows the methane, non-methane hydrocarbon and sulfur dioxide emissions from all four refinery process flares from 2004 through June 30 of this year.

**Shell Flare Emissions - All Flares
2004 - 2016**

Figure ES-3 shows the significant reduction in emissions that has occurred since the implementation of the Flare Minimization Plan in 2006 and highlights that even with large volumes of flexigas flaring in 2016, overall emissions from flaring are low.

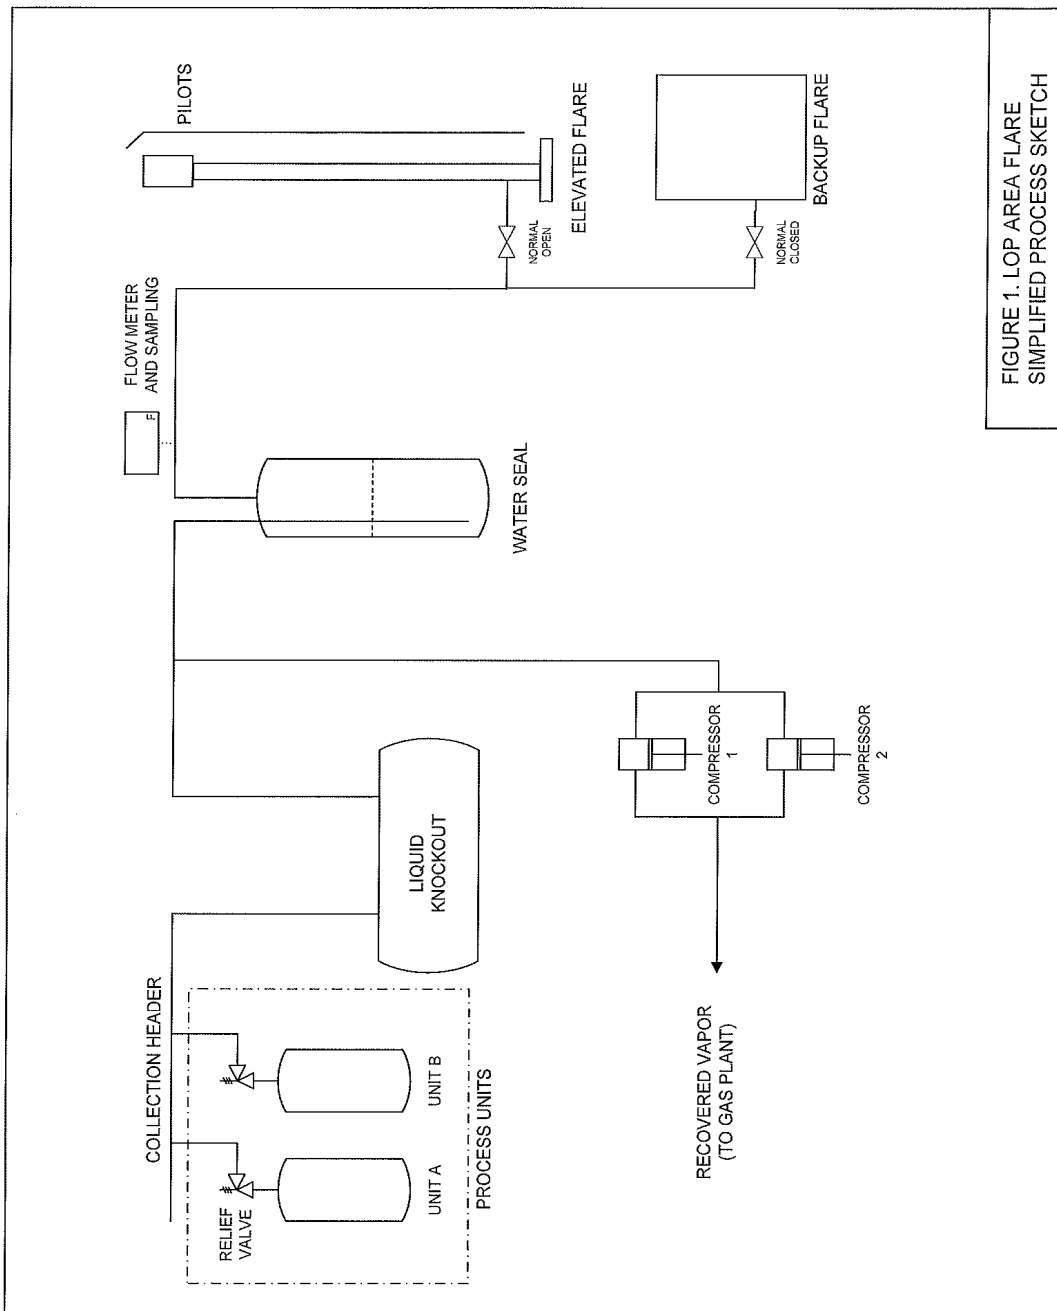
FIGURE 1. LOP AREA FLARE SIMPLIFIED PROCESS SKETCH

The LOP Flare system is comprised of collection headers, liquid knockout vessels, two flare vapor recovery compressors, piping to route recovered gas to fuel gas treaters, a water seal vessel, the flare header proper, and the flare stack. The LOP flare is an elevated, steam-assisted flare with nitrogen purge to prevent air intrusion. Piping and valves provide sufficient flexibility to operate in various configurations, allowing continuous and reliable operation during turnarounds, inspection and maintenance activities without flaring. Maintenance of the elevated flare (S#1471) is accomplished by putting an alternate flare in service. This alternate flare (Backup Flare, S#1472) is normally blinded and is only used when the elevated flare is out of service for inspection or repair. A sketch of the LOP Flare system is provided in Figure 1. Technical details of the system are provided in Appendix A².

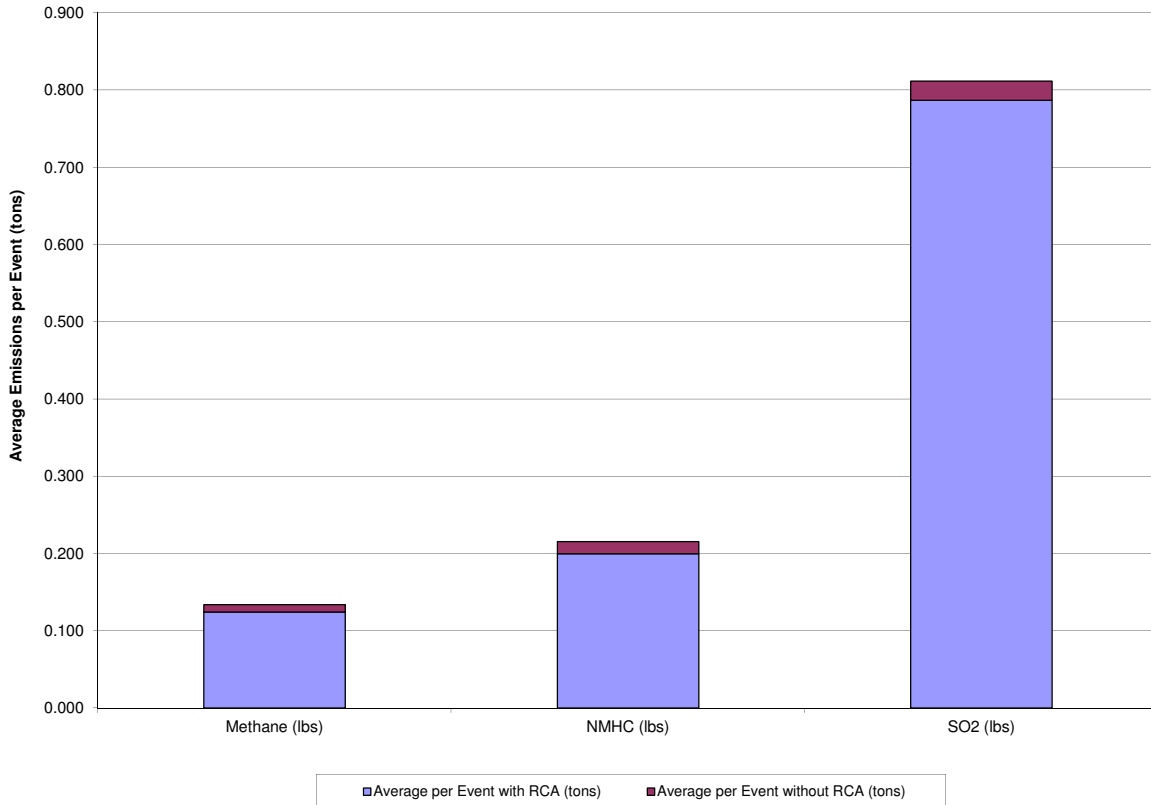
FIGURE 2008 –1

LOP Flare Events w/ Causal Analysis vs. Small Events
1/1/06 - 6/1/08

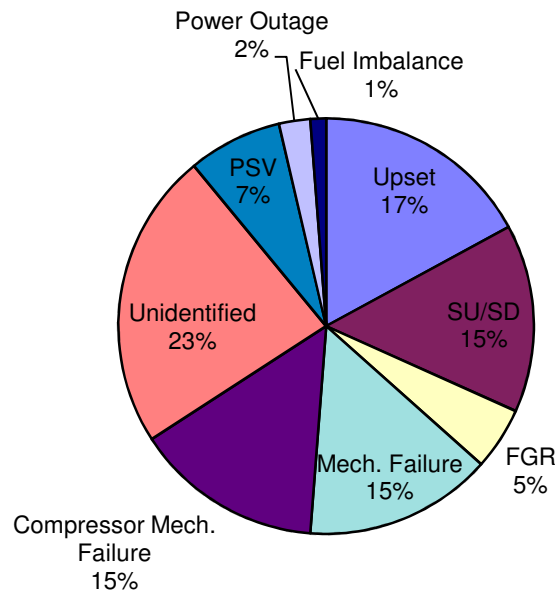
**Figure 2. LOP Area Flare Events
(2000-2005)**

Based on these data, about 65% of the flare events occurring from 2000 - 2005 are essentially evenly divided among the following categories: process upsets, process startup and shutdowns, mechanical failures of compressors and other equipment. Almost one quarter of the time the occurrences where the water seal was broken indicating that flaring occurred were so small, and of such brief duration, no cause could be reliably determined.

Figure 2 illustrates that there are a wide range of events that can cause flaring at LOP. The annual volume of gas flared could be reduced in two basic ways. One alternative is an increase in the capacity of the flare gas recovery system. The second is improved measures to limit the rate and volume of gas discharged to the flare gas header so that it does not exceed the capacity of the existing recovery system. These two alternative approaches are discussed below.

Figure 2 shows that activities that have occurred during startups and shutdowns have contributed to less than 15% of the flare events that occurred historically at the LOP flare. Analysis of the flaring back to 2005 indicate that flaring may have been prevented by changing operating practices, improved planning, or minor hardware revisions. The trend over the past years indicates that startup, shutdowns and maintenance-related flaring can be significantly reduced and largely eliminated with careful planning. Major turnarounds on units served by the LOP flare continue to be performed without planned flaring. That this work was performed without flaring is evidence of careful review and planning. We commit to continue this careful review and planning prior to planned major maintenance and expect to perform turnarounds with little or no planned flaring. If during the maintenance planning and review process we find that planned flaring is required, as was the case when preparing for the LOP flare pressure vessel inspections, then all appropriate prevention measures will be considered and feasible measures will be implemented to reduce or eliminate the planned flaring.

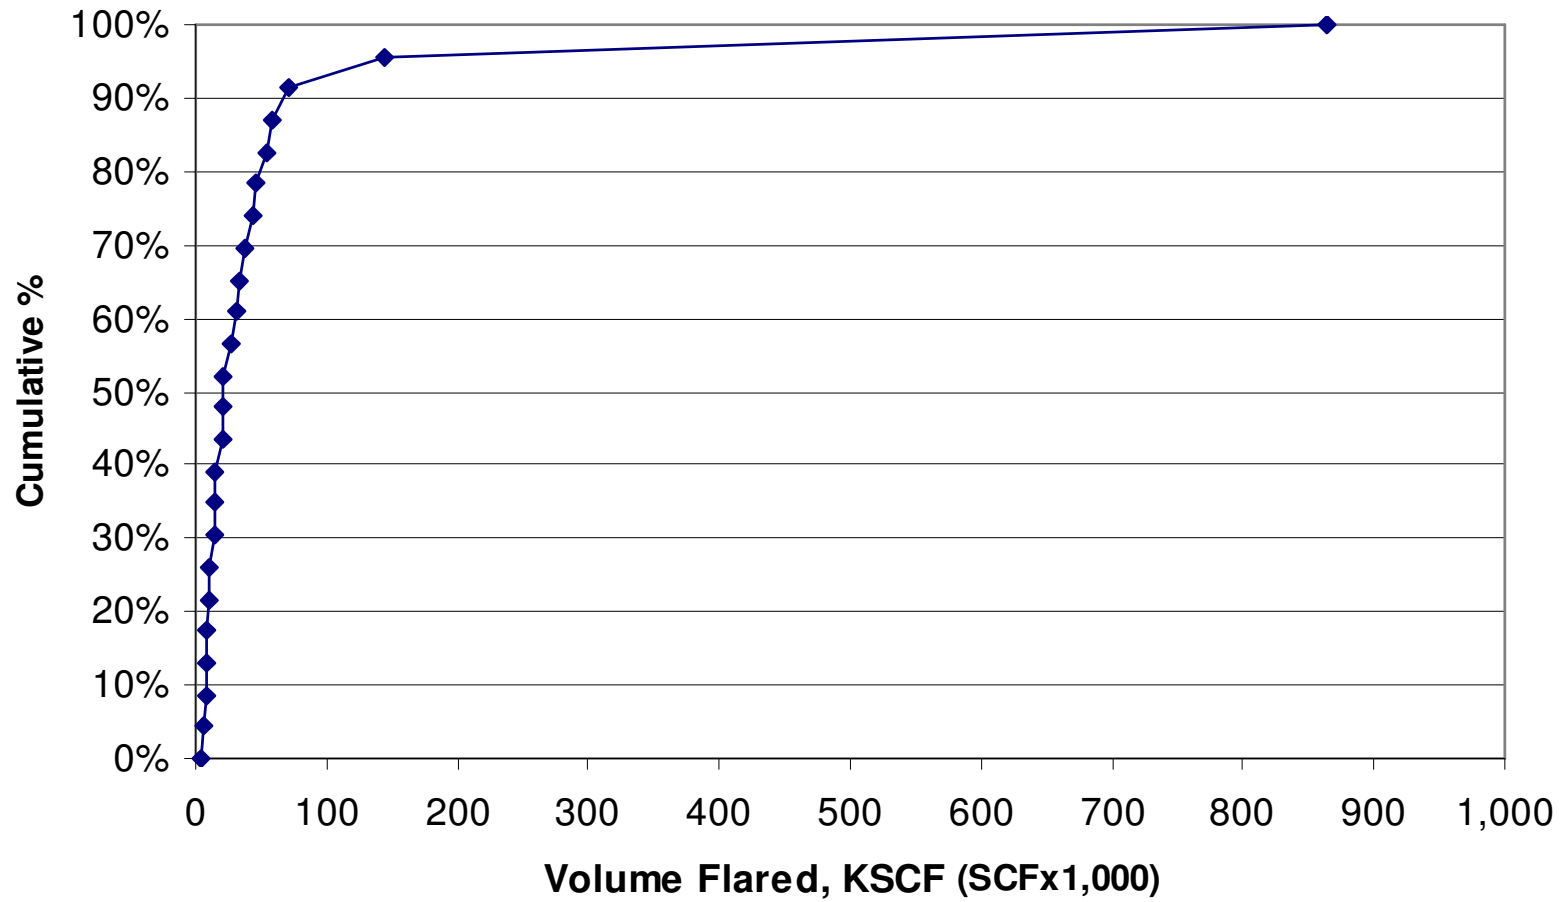
Figure 3. LOP Flare Gas Volumes
(2005)

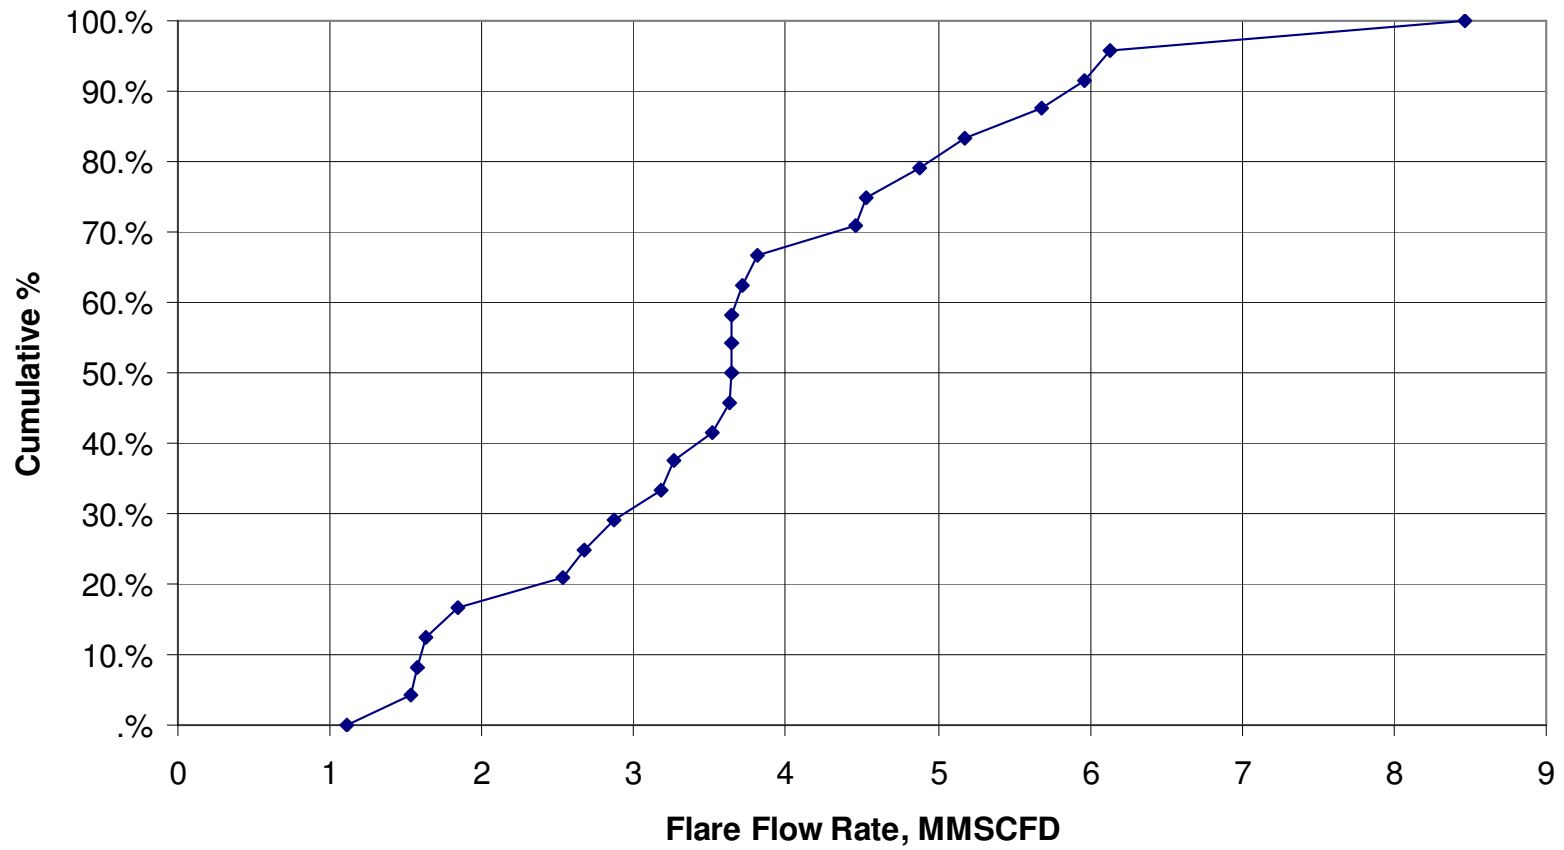
**Figure 4. LOP Flare Gas Flow Rates
(2005)**

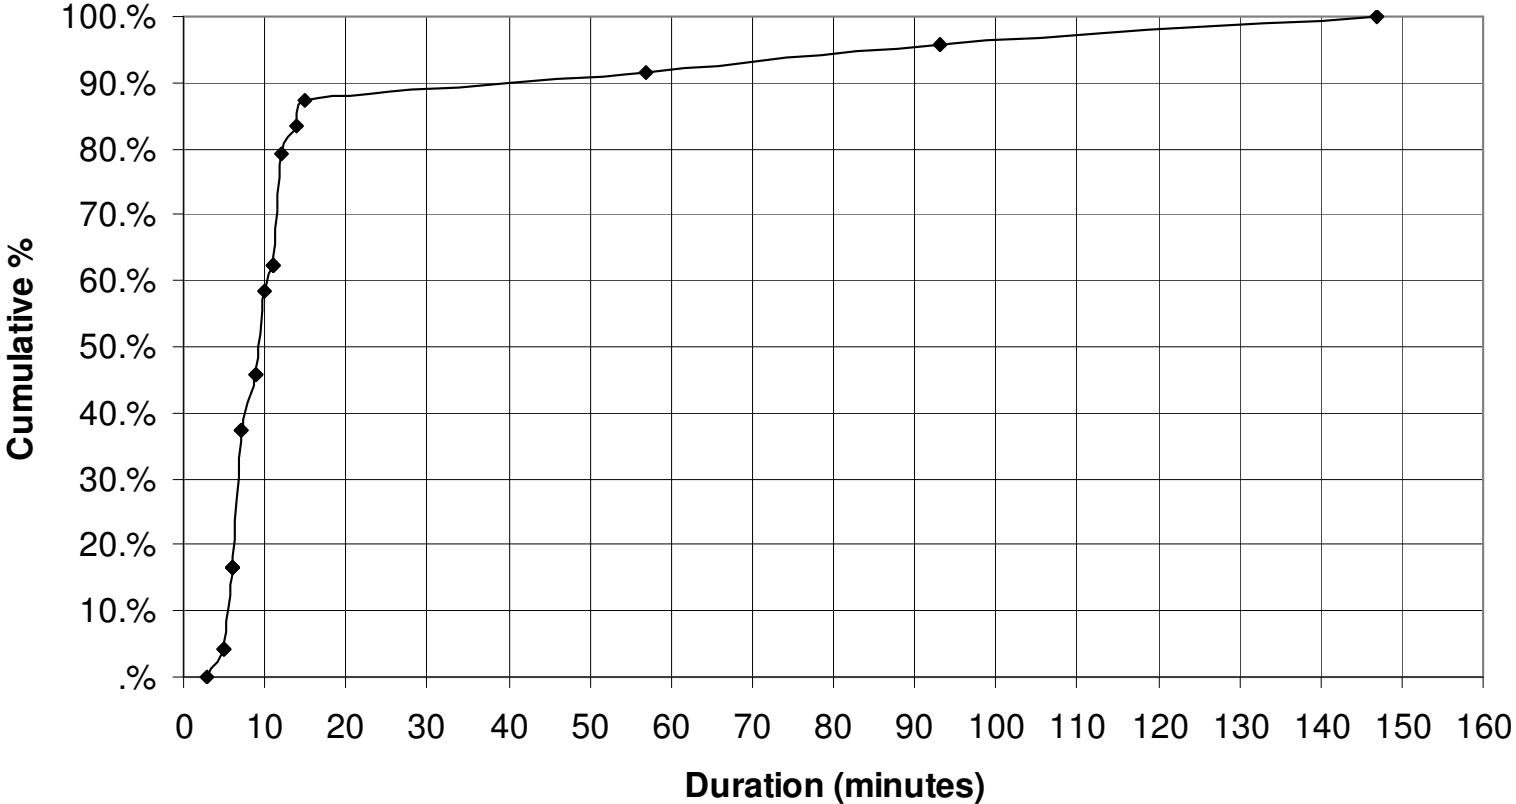
Figure 5. LOP Flare Durations
(2005 - 25 Events)

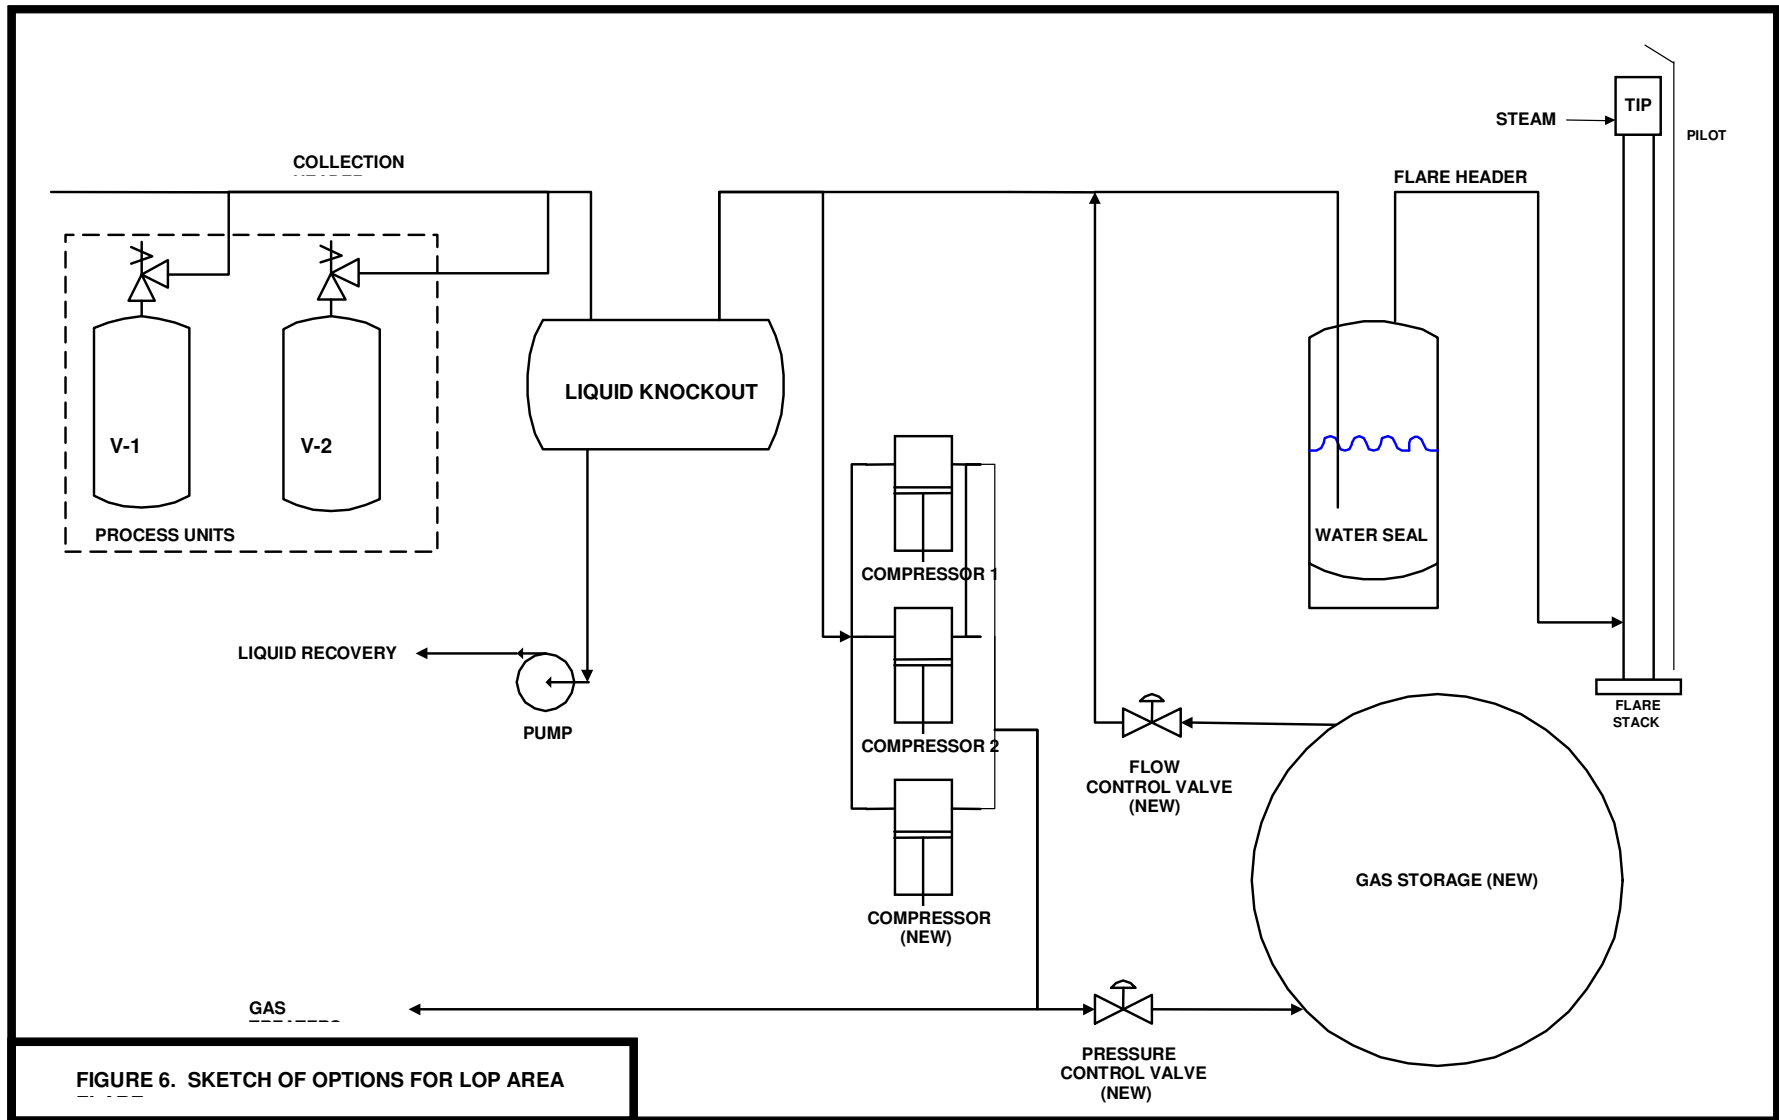
FIGURE 6. SKETCH OF OPTIONS FOR LOP AREA

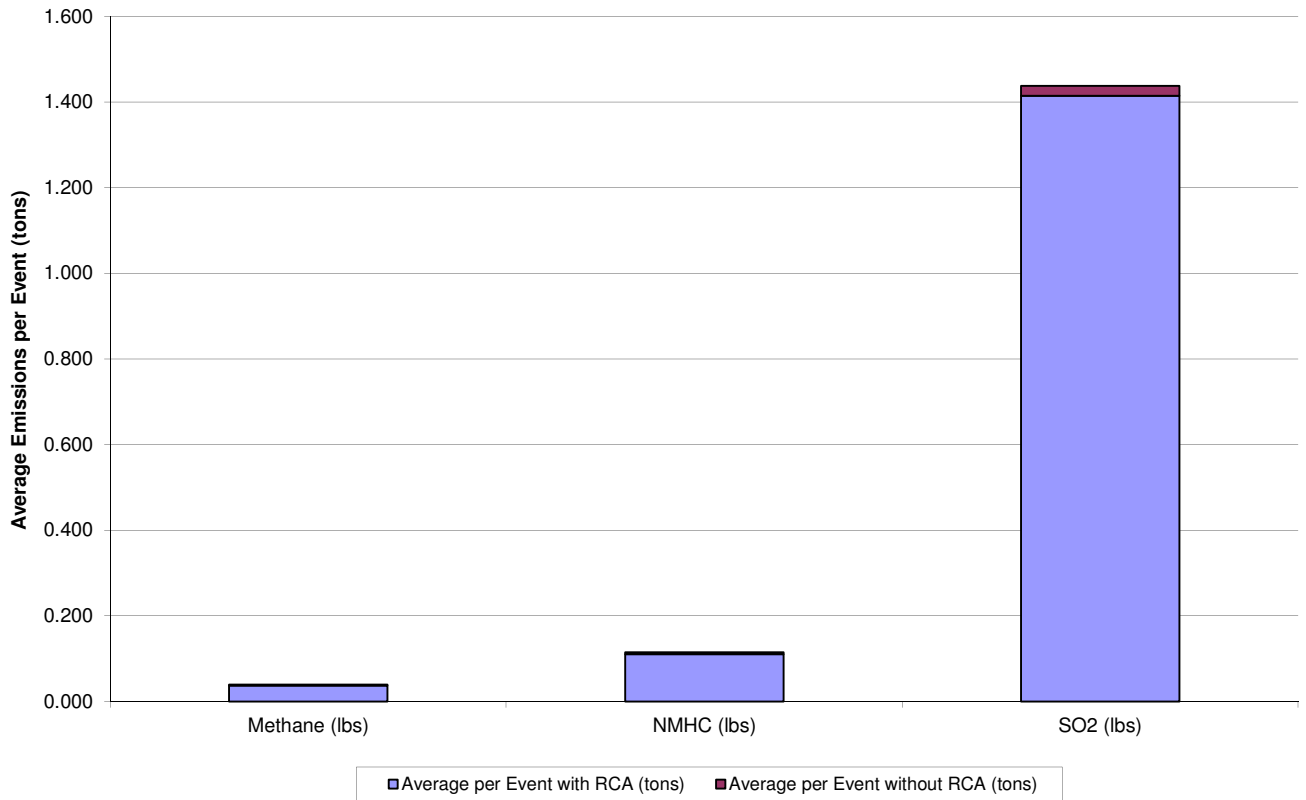
FIGURE 2008-2

**DCU Flare Events w/ Causal Analysis vs. Small Events
1/1/06 - 6/1/08 Without Causal Analysis**

Beginning in November 2006 with the adoption of the Flare Procedures described in the Common Measures Section, pertinent information, when available, was captured immediately after a flaring event to determine the cause of any flaring and what could be done to prevent it from happening again. Total emissions from all flaring during this 30-month period were: 0.17 tons of methane, 0.45 tons of non-methane hydrocarbon and 4.19 tons of SO₂. Figure 2008-2 presents a comparison of the average emissions per large reportable events over this time period vs. the average emissions per small event for the DCU Flare. This figure shows that small events contributed < 6% of the emissions of a large event. Figure 2008-2 reinforces the appropriateness of the causal analysis trigger of 0.5 MMSCF/ 500 lbs SO₂ to ensure the resources to conduct a Causal Analysis are most effectively applied to address high emission events.

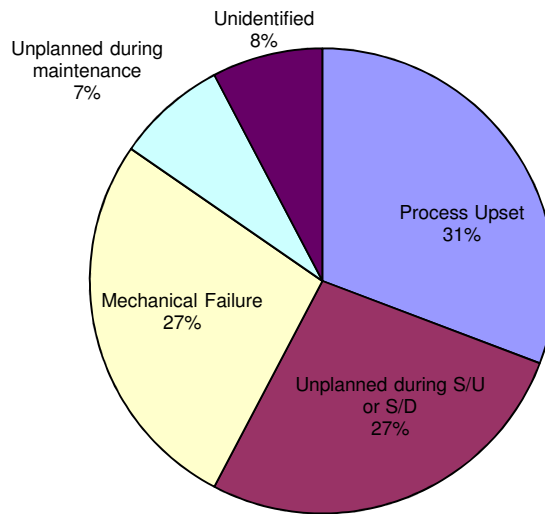
FIGURE 2008 - 3

**Probable Cause of Flaring on DCU Flare 1/1/06-6/1/08
26 Events**

The DCU flare events that occurred from 1/1/06 – 6/1/08 were categorized by probable cause in Figure 2008-3. None of the flaring was planned. Most of the events were < 10 minutes long. The majority of the events were caused by process upset, mechanical failure or were unplanned during startup and shutdowns.

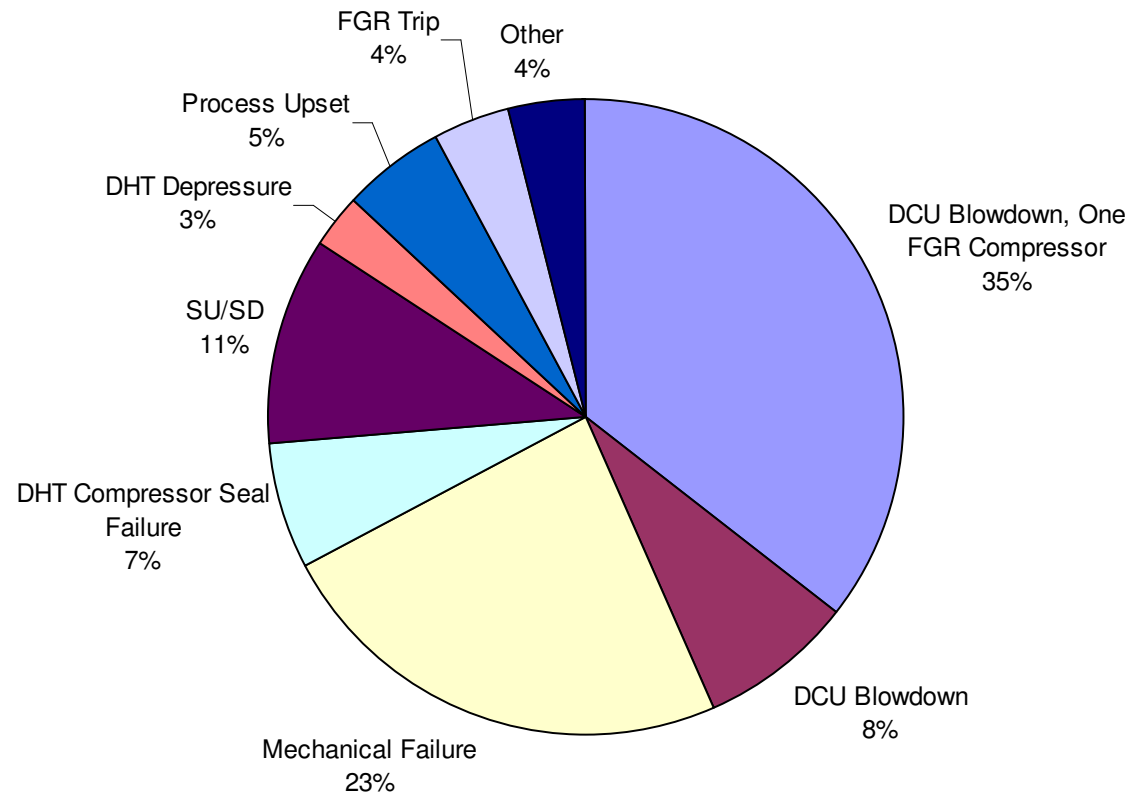
**Figure 8. Delayed Coking Area Flare Events
(2000 - 2005) 76 Events**

Flaring prior to January 2004. Review of flare events prior to January 2004 provided little usable information. Without flow meters, neither durations nor volumes may be determined with accuracy approaching that with flowmeters installed. In many cases, even the proximate cause of flaring could not be reliably determined due to the limited documentation and time elapsed since the event. With these qualifications, a breakdown for general cause of Delayed Coking flare events for the previous five years is depicted in Figure 8. A description of the various categories listed is provided below:

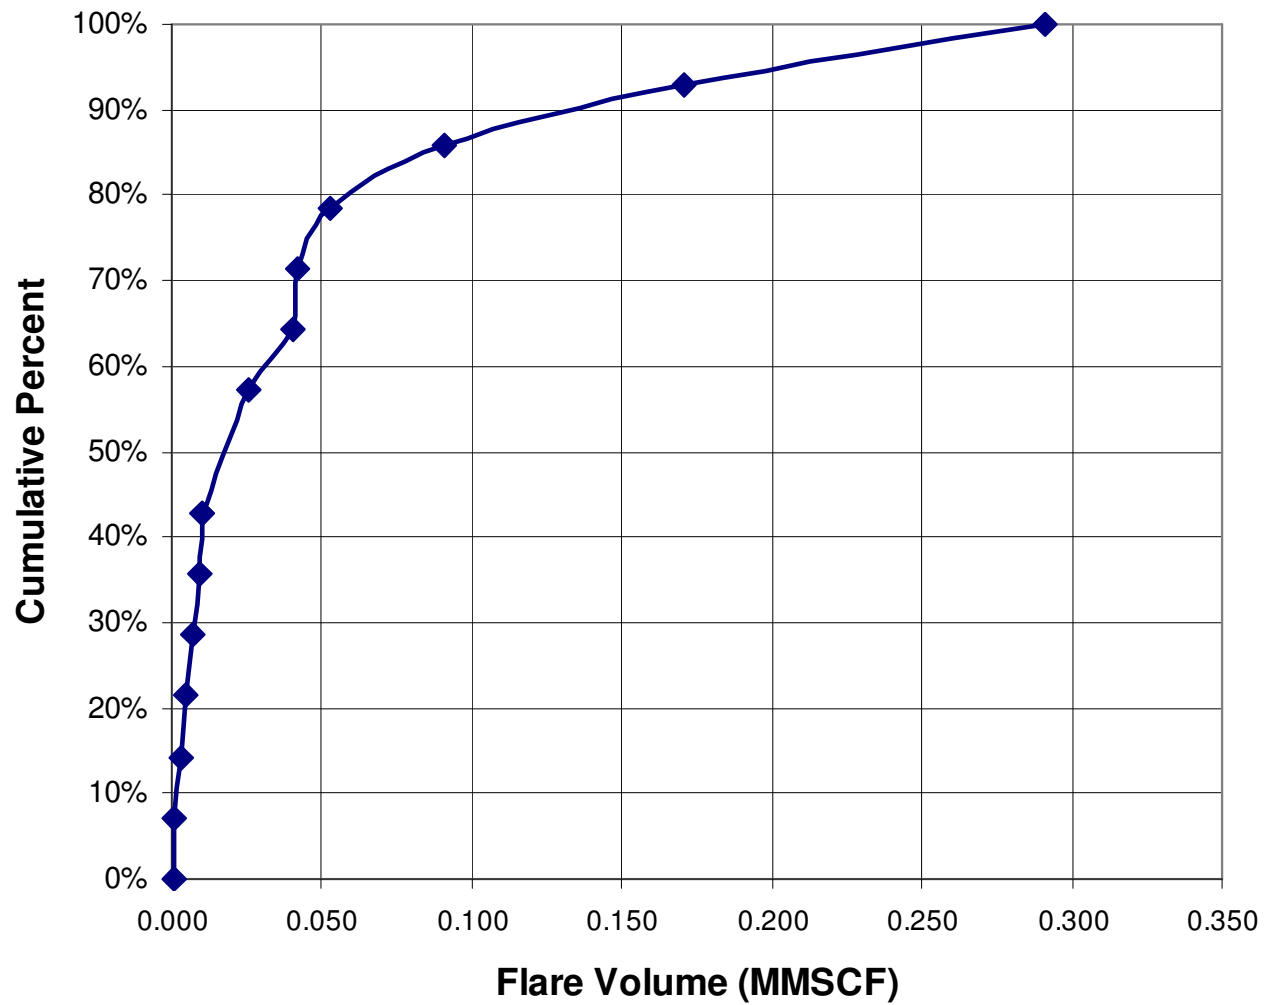
**Figure 9. Delayed Coking Area Flare Gas Volumes
(2005)**

Figure 9 depicts the amount of material flared during the reported incidents of flare activity in 2005. All flaring was below 500,000 scf. Approximately 70% of the incidents of reported flaring involved volumes of gas of 50,000 SCF or less. All were below 300,000 standard cubic feet.

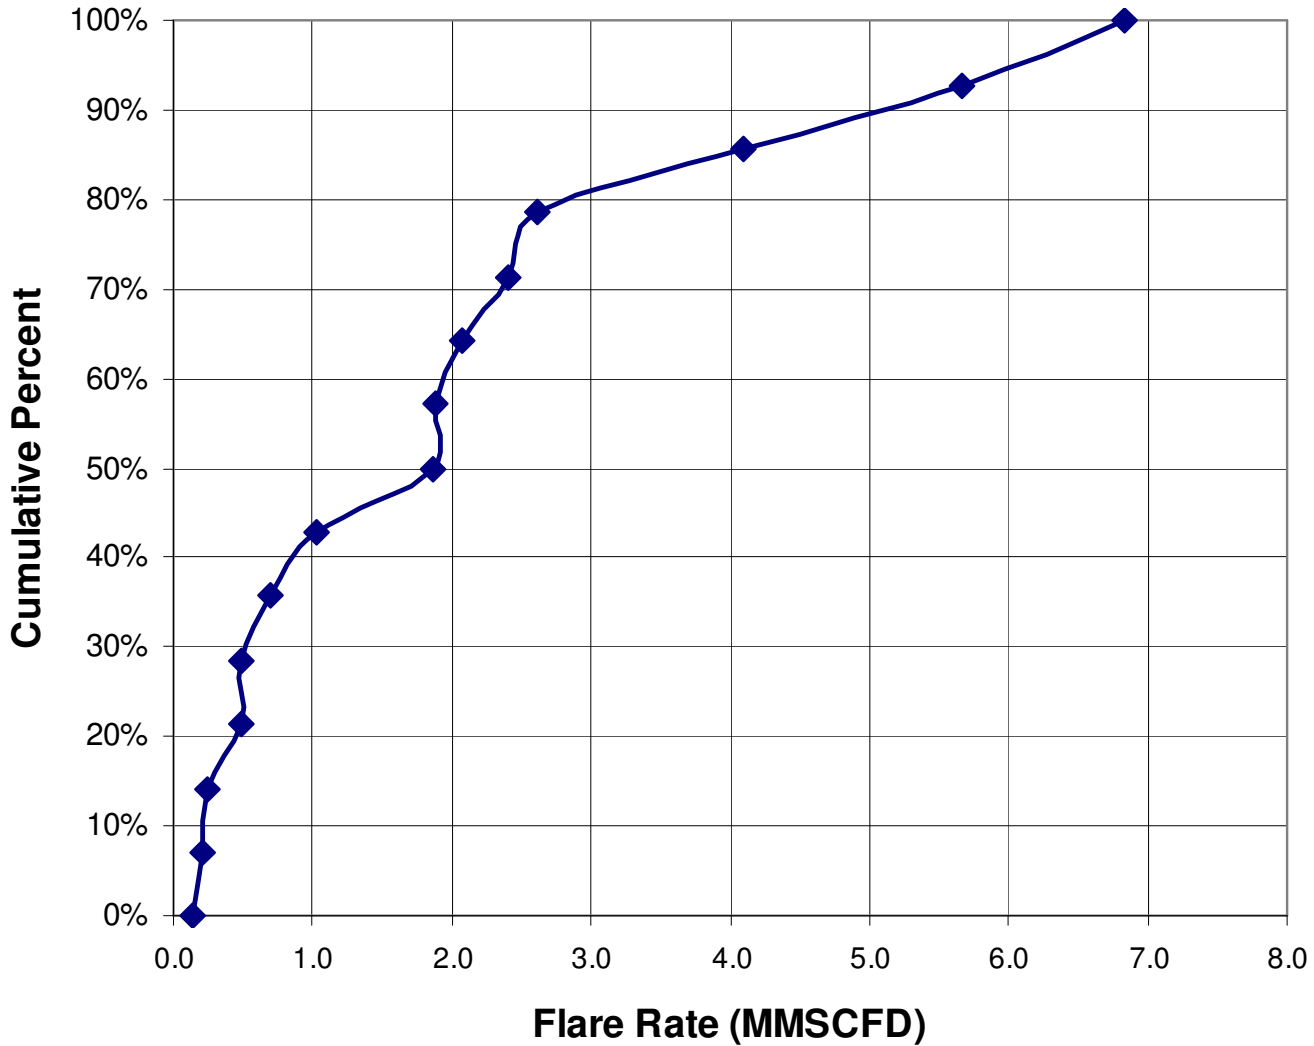
**Figure 10. Delayed Coking Area Flare Gas Flow Rates
(2005)**

Figure 10 depicts the average rates of flow to the flare for events occurring in 2005. These data indicate that approximately 80% of the flare events had event-average flow rates less than 3 million standard cubic feet per day. Actual instantaneous rates comprising the average are generally higher – often significantly – than these average rates.

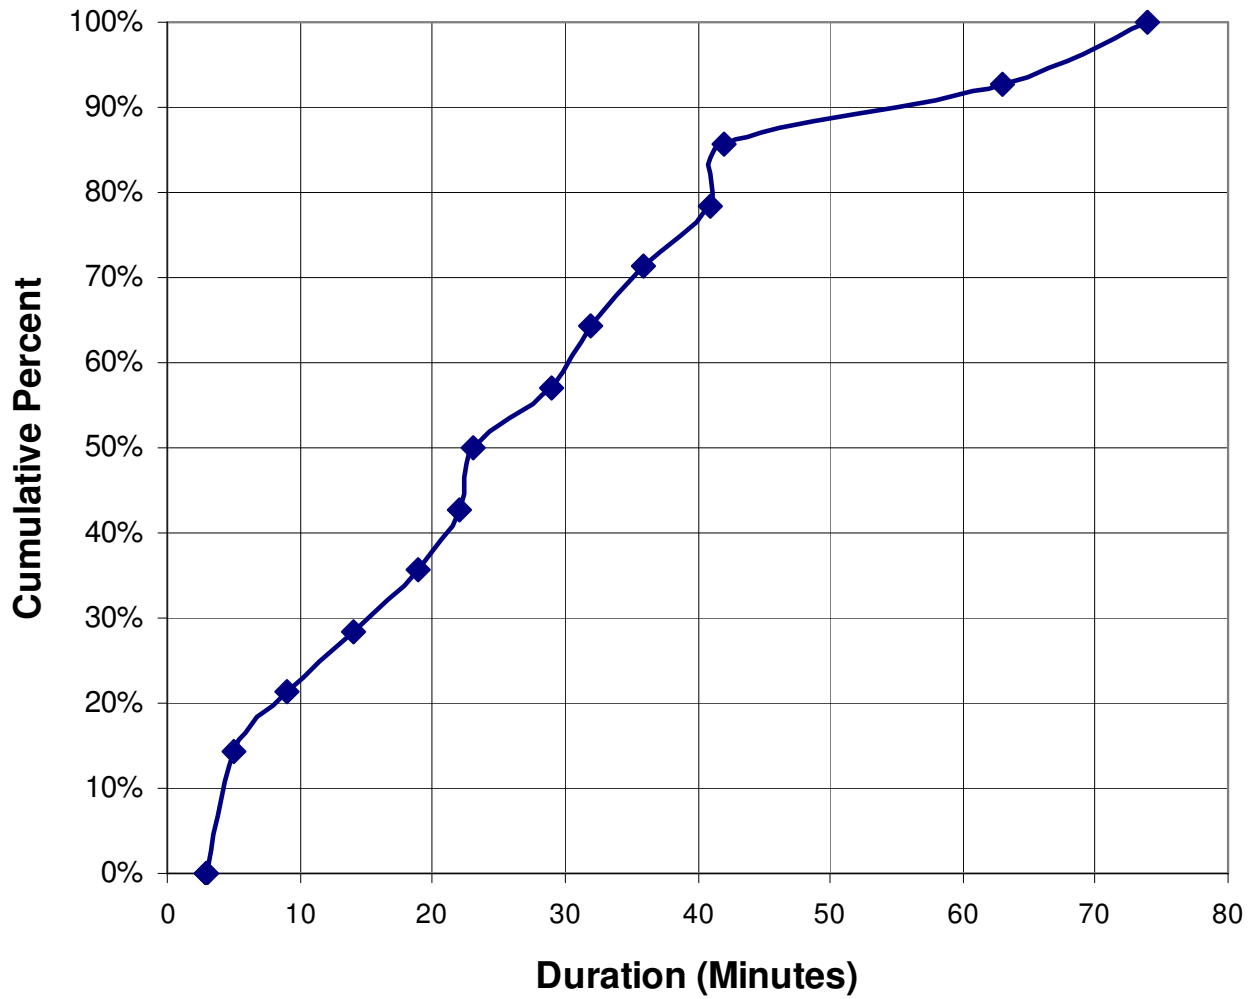
**Figure 11. Delayed Coking Area Flare Event Durations
(2005)**

Figure 11 depicts the distribution of flare event durations for 2005 where these data are available. 50% of the events lasted less than 30 minutes. This is consistent with other data characterizing the bulk of flare events being very brief.

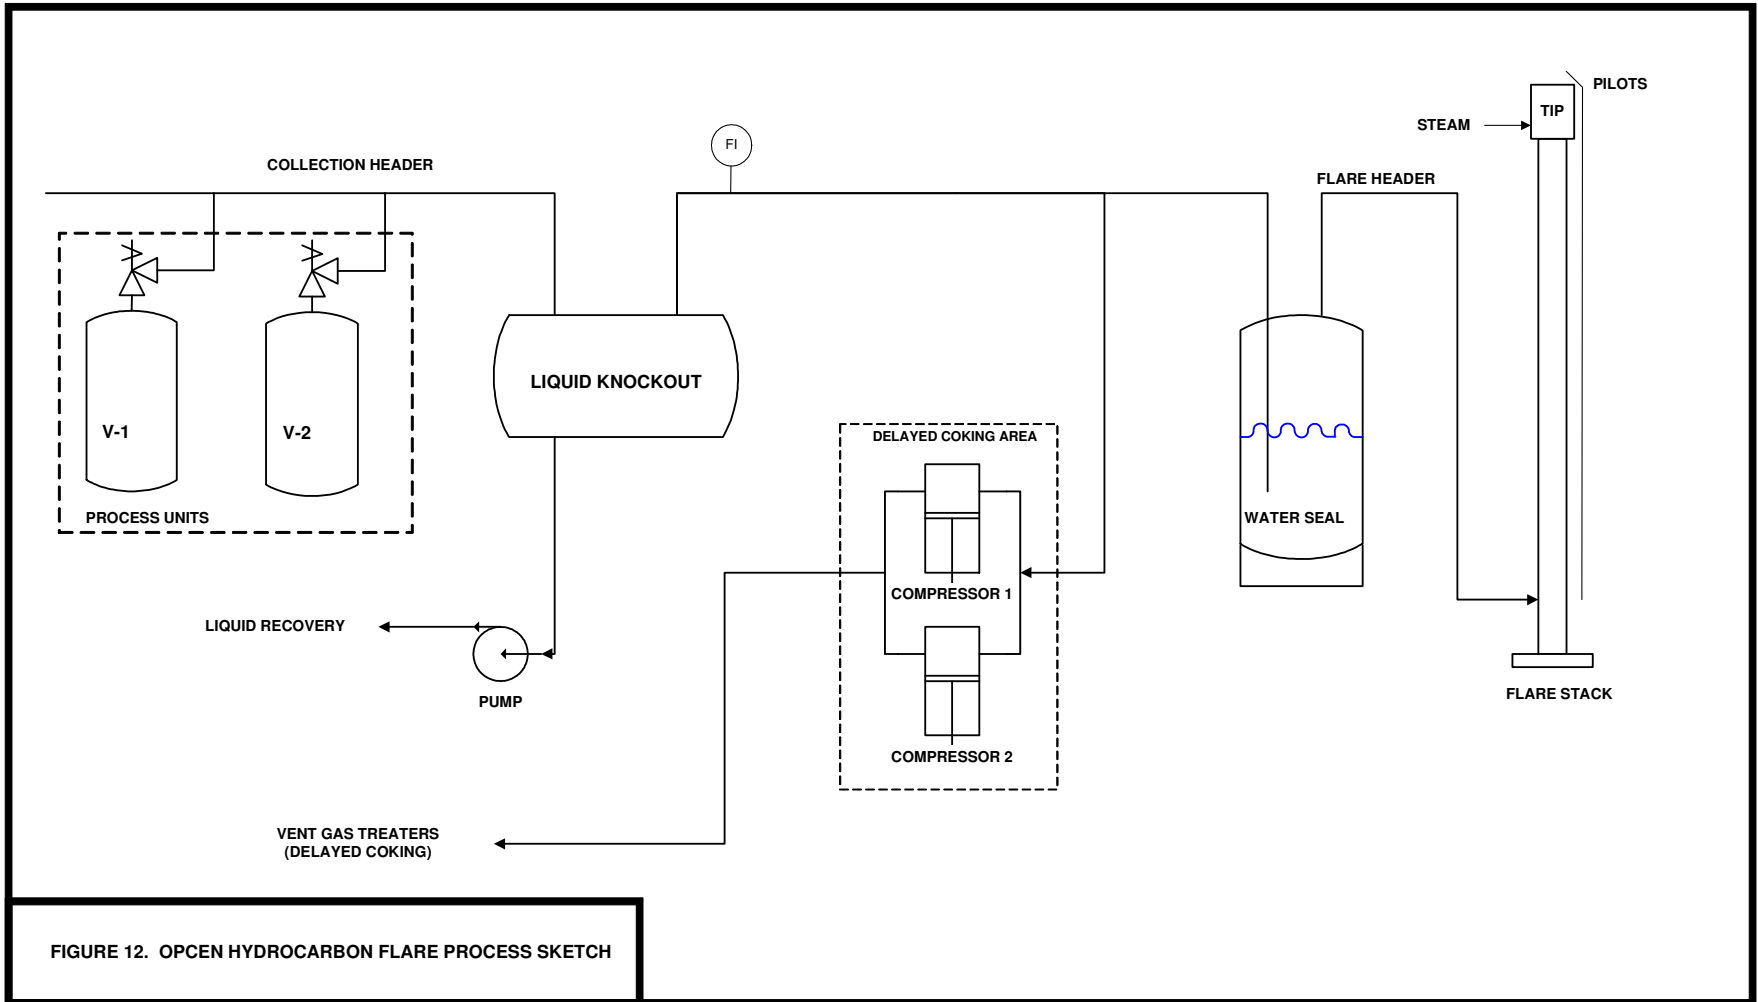
FIGURE 12. OPCEN HYDROCARBON FLARE PROCESS SKETCH

Recovered gas from OPCEN is treated to remove H₂S and routed to fuel and hydrogen plant feed along with the recovered gas from Delayed Coking. The normal routing for Delayed Coker Area recovered flare gas is the Vent Gas Treater. Sufficient capacity is available for the incremental flow (up to the total recovery compressor capacity of about 8 MMSCFD).

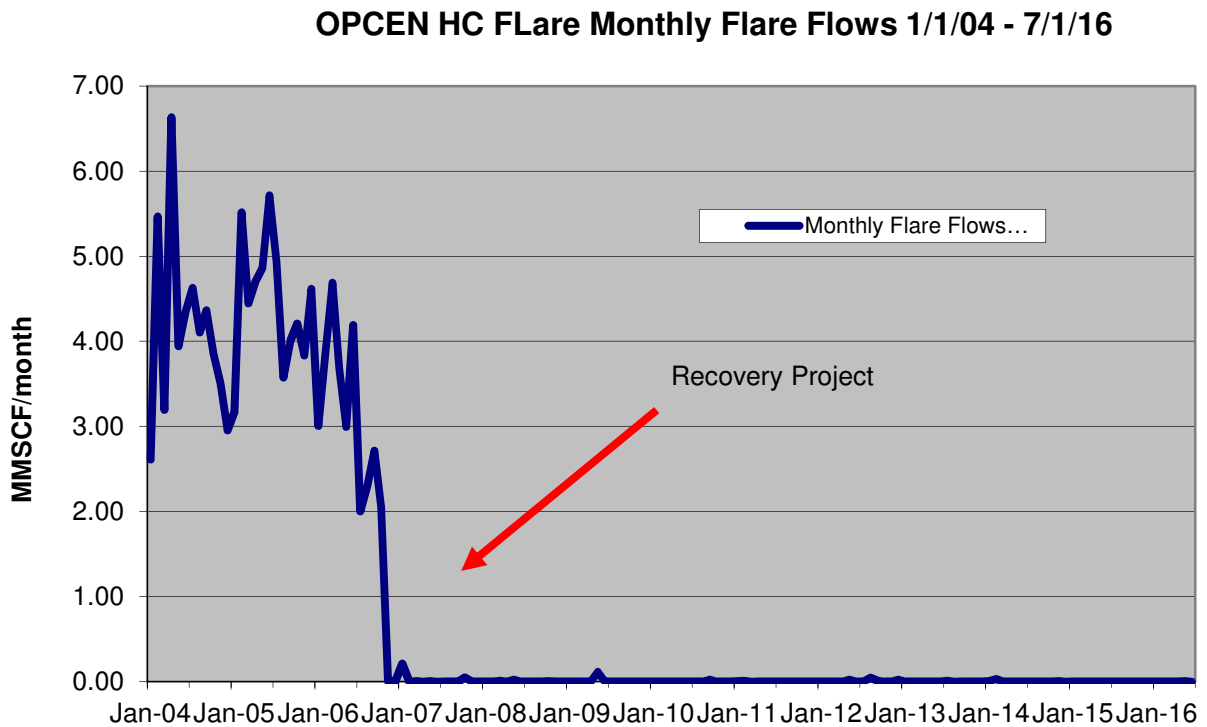
FIGURE 1

Figure 1 below has been updated through 7/1/16 and shows the continued success of the implementation of the flare recovery project that occurred in 2006 on this flare.

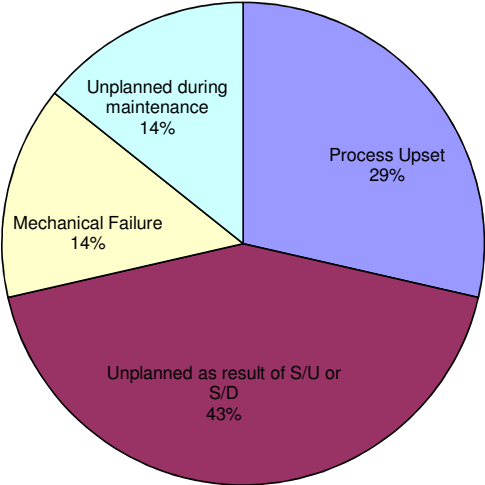
FIGURE 2008-4

OPCEN HC Flare- Cause of Flaring 11/1/06 - 6/1/08
7 Events
