Shell Martinez Refinery

FLARE MINIMIZATION PLAN

Updated October 1, 2016

Shell Oil Products US
Martinez Refinery
Martinez, California 94553
BAAQMD Plant No. A0011

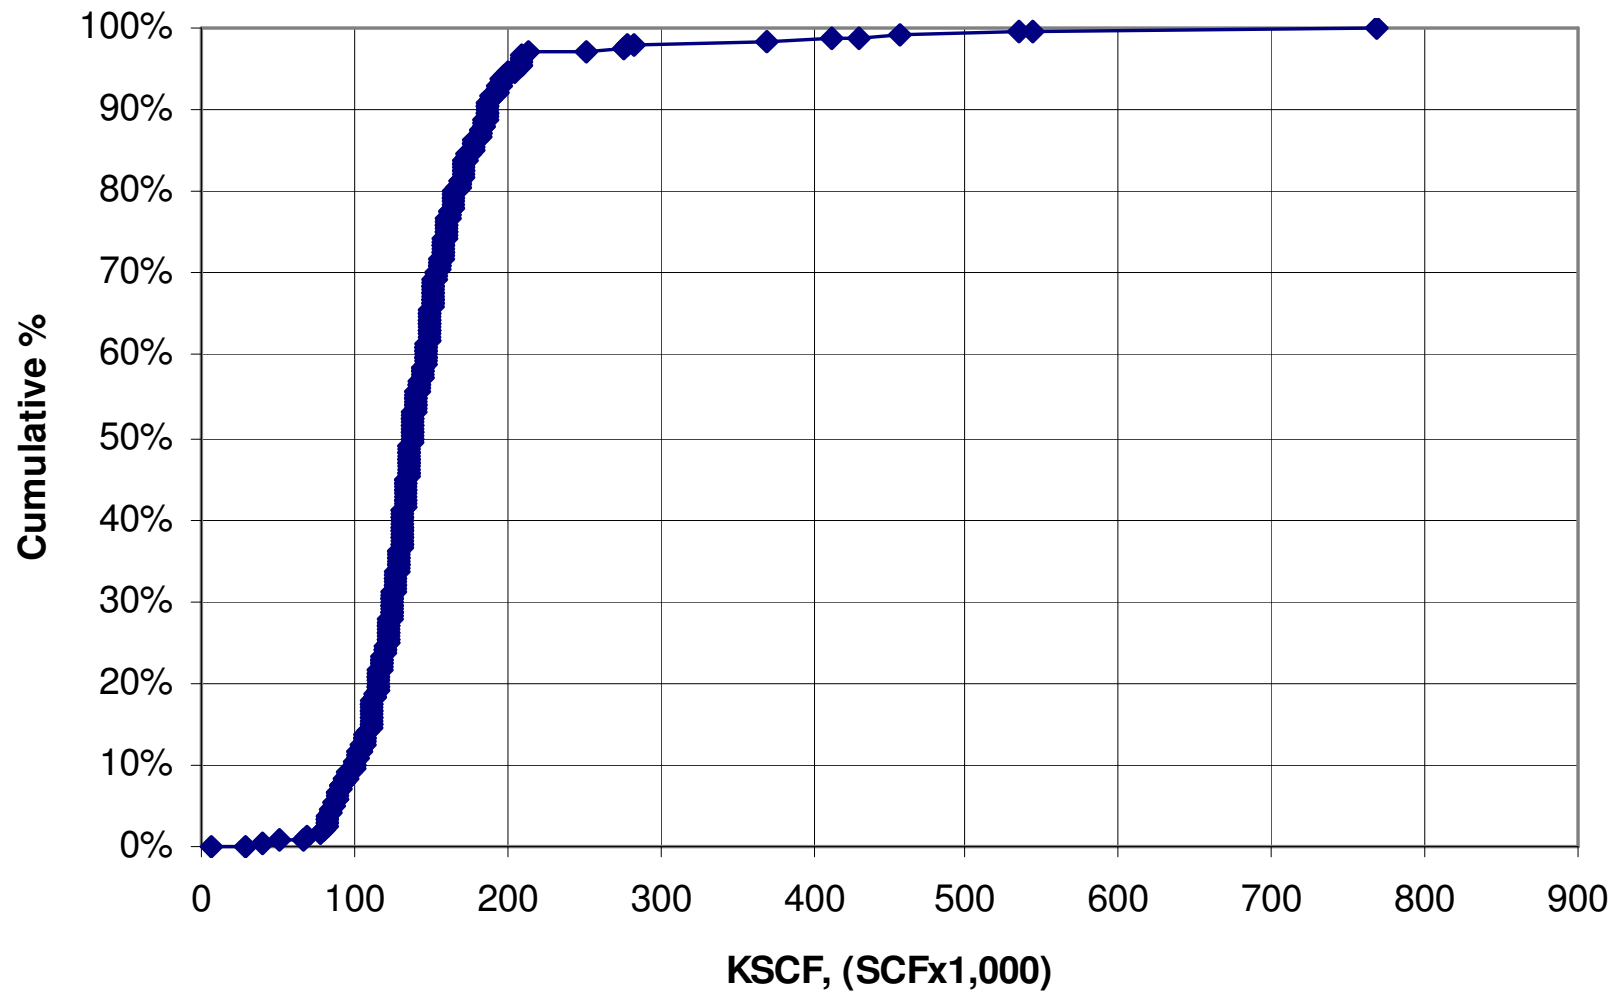
**Figure 13. OPCEN Hydrocarbon Flare Gas Volumes
(2005)**

With historical performance profoundly biased by absence of flare gas recovery, this review concentrated on calendar year 2005. Flare data are depicted in Figure 13. Total emissions of non-methane hydrocarbon during 2005 were approximately 30 tons. Emissions of SO₂ in 2005 were 0.3 tons.

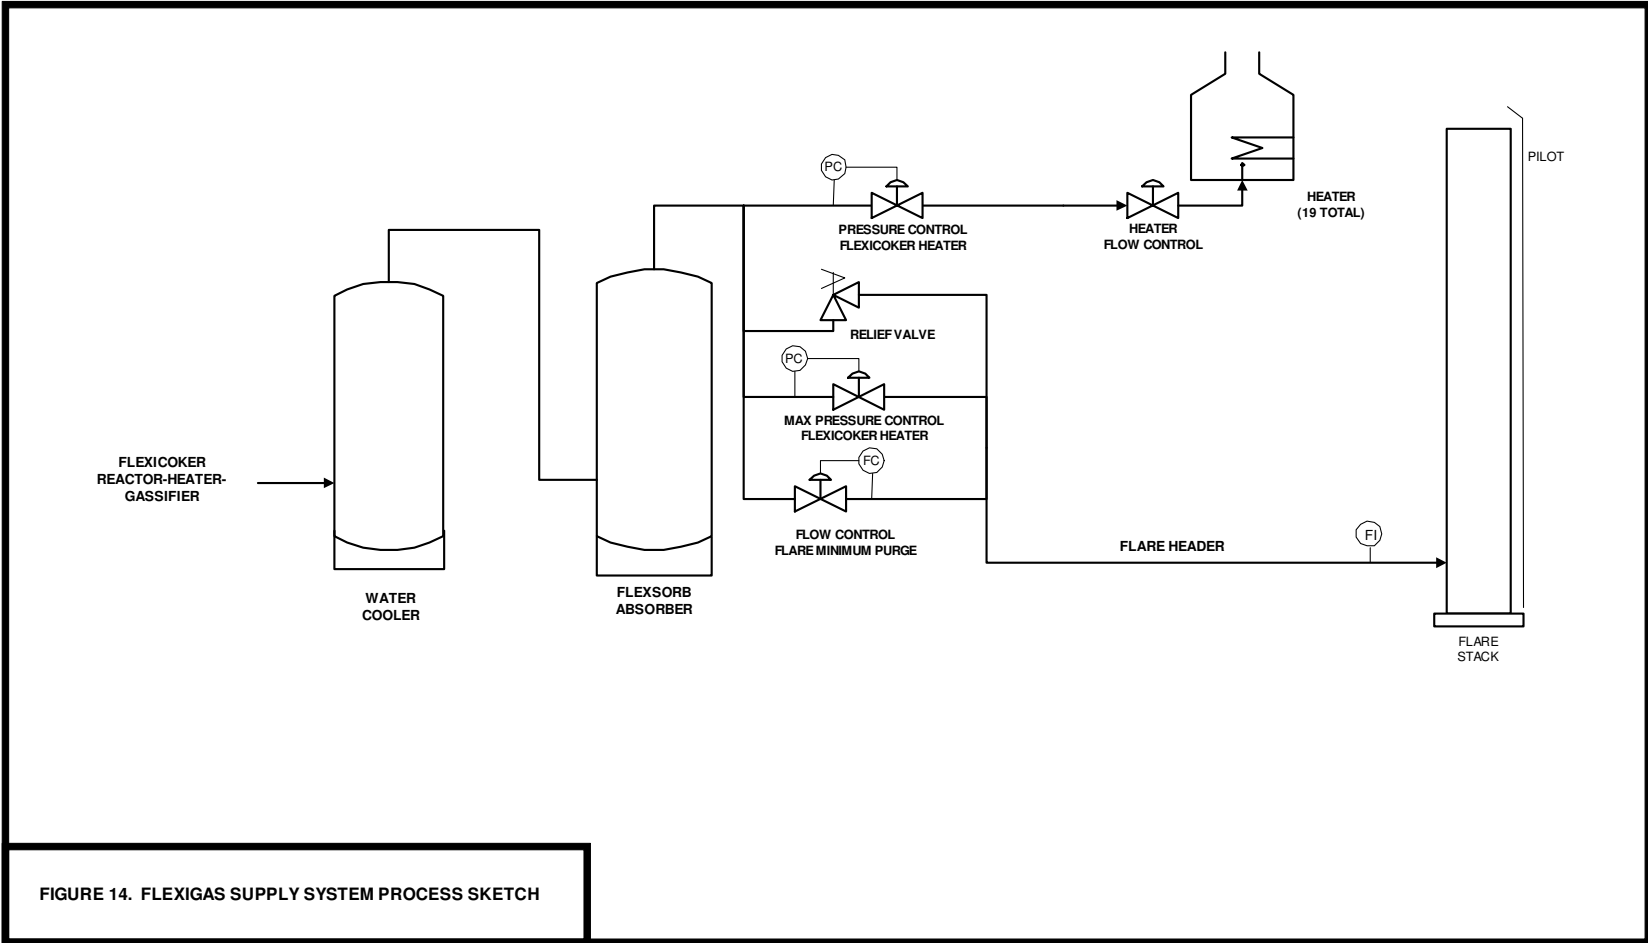
FIGURE 14. FLEXIGAS SUPPLY SYSTEM PROCESS SKETCH

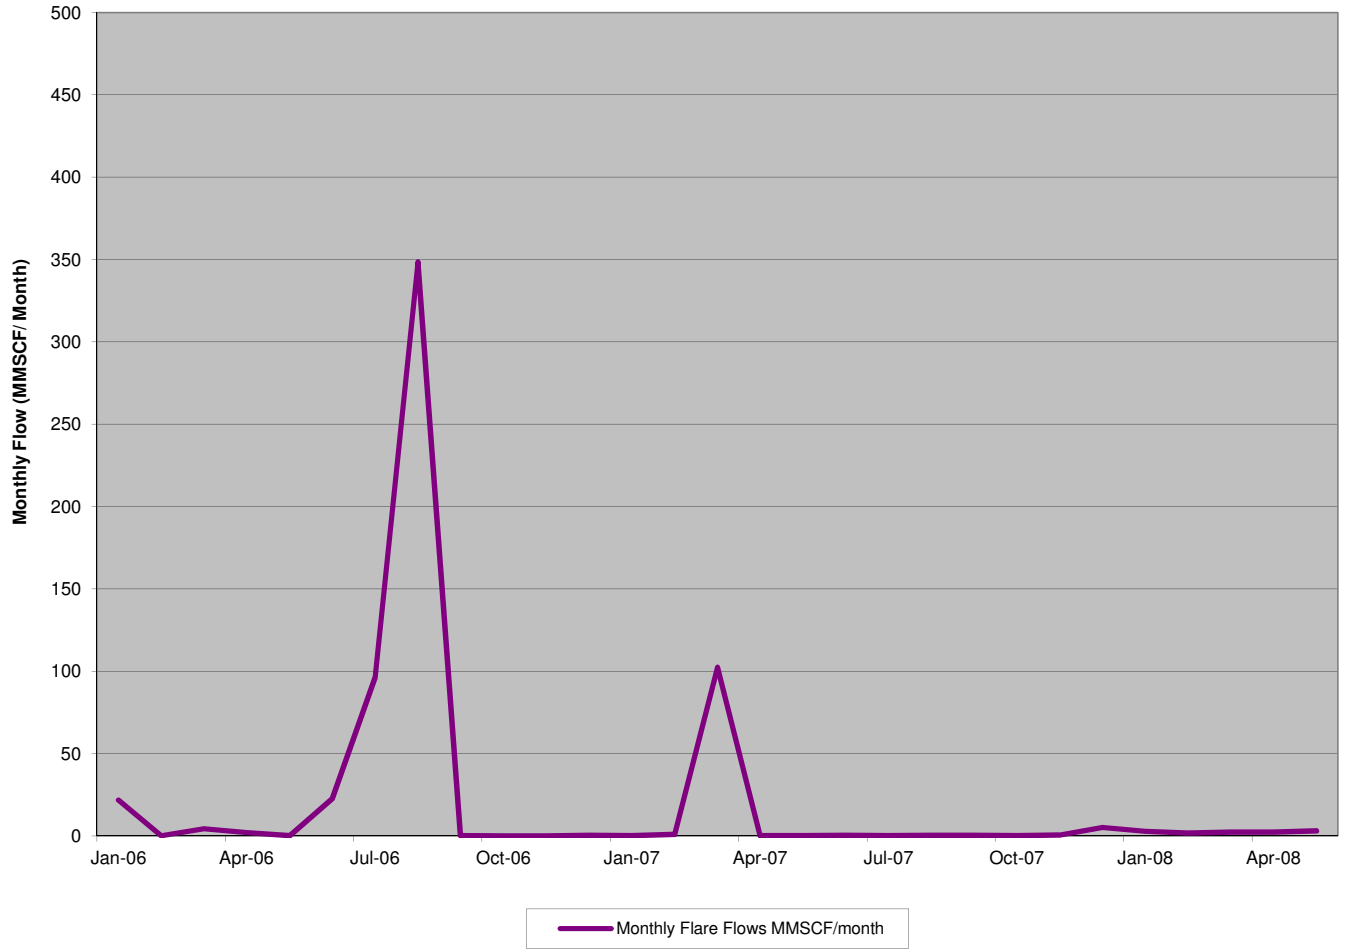
FIGURE 2008-5

FXG Flare Flows 1/1/06 - 6/1/08

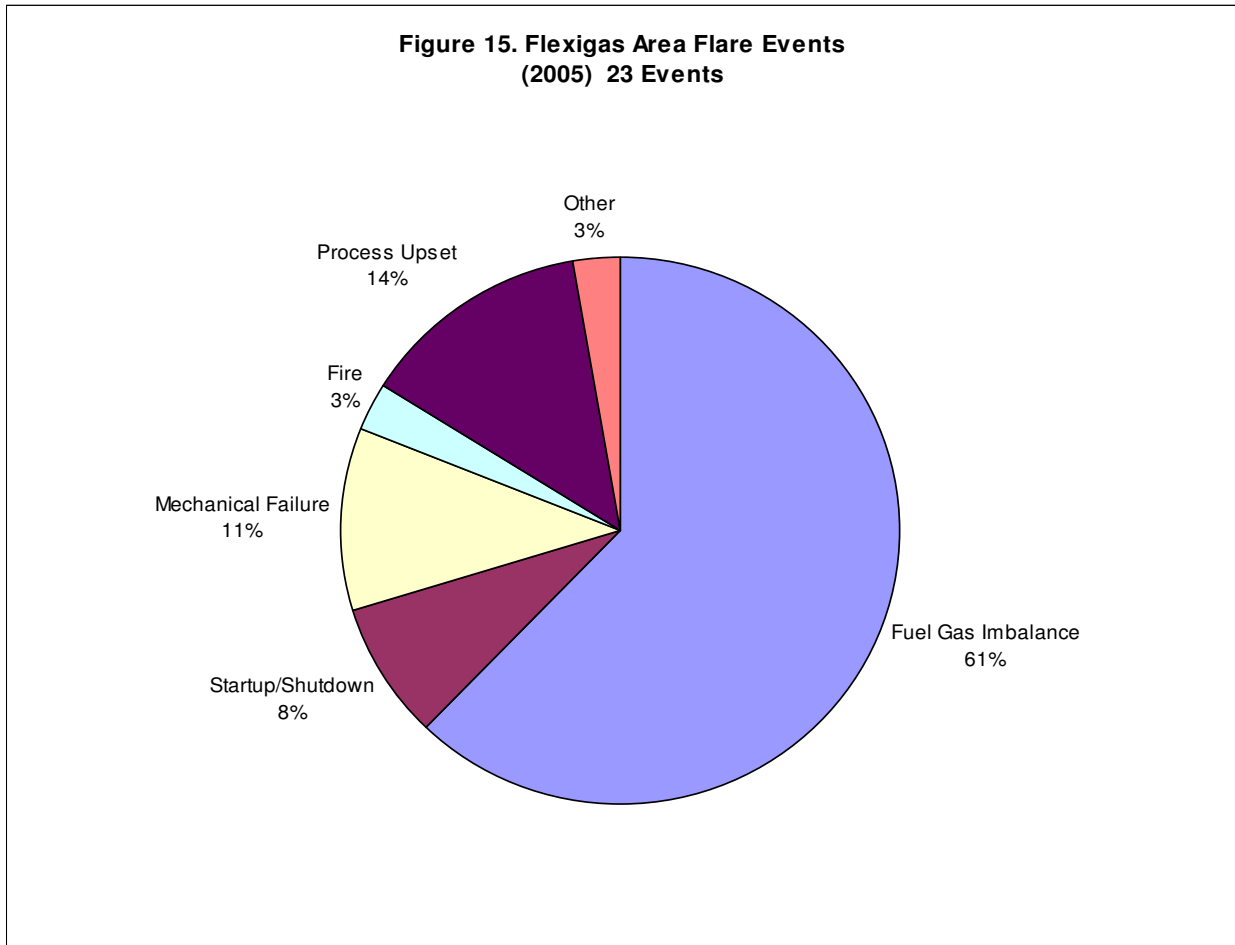
Historical flaring at the OPCEN Flexigas flare was reviewed to identify opportunities for potential mitigation. The highest quality data are available for the period from December 2003, to January 2006. This coincides with installation of the flare flow meter and BAAQMD flare reporting. Data for 2005 are plotted in Figure 15 and Figure 16.

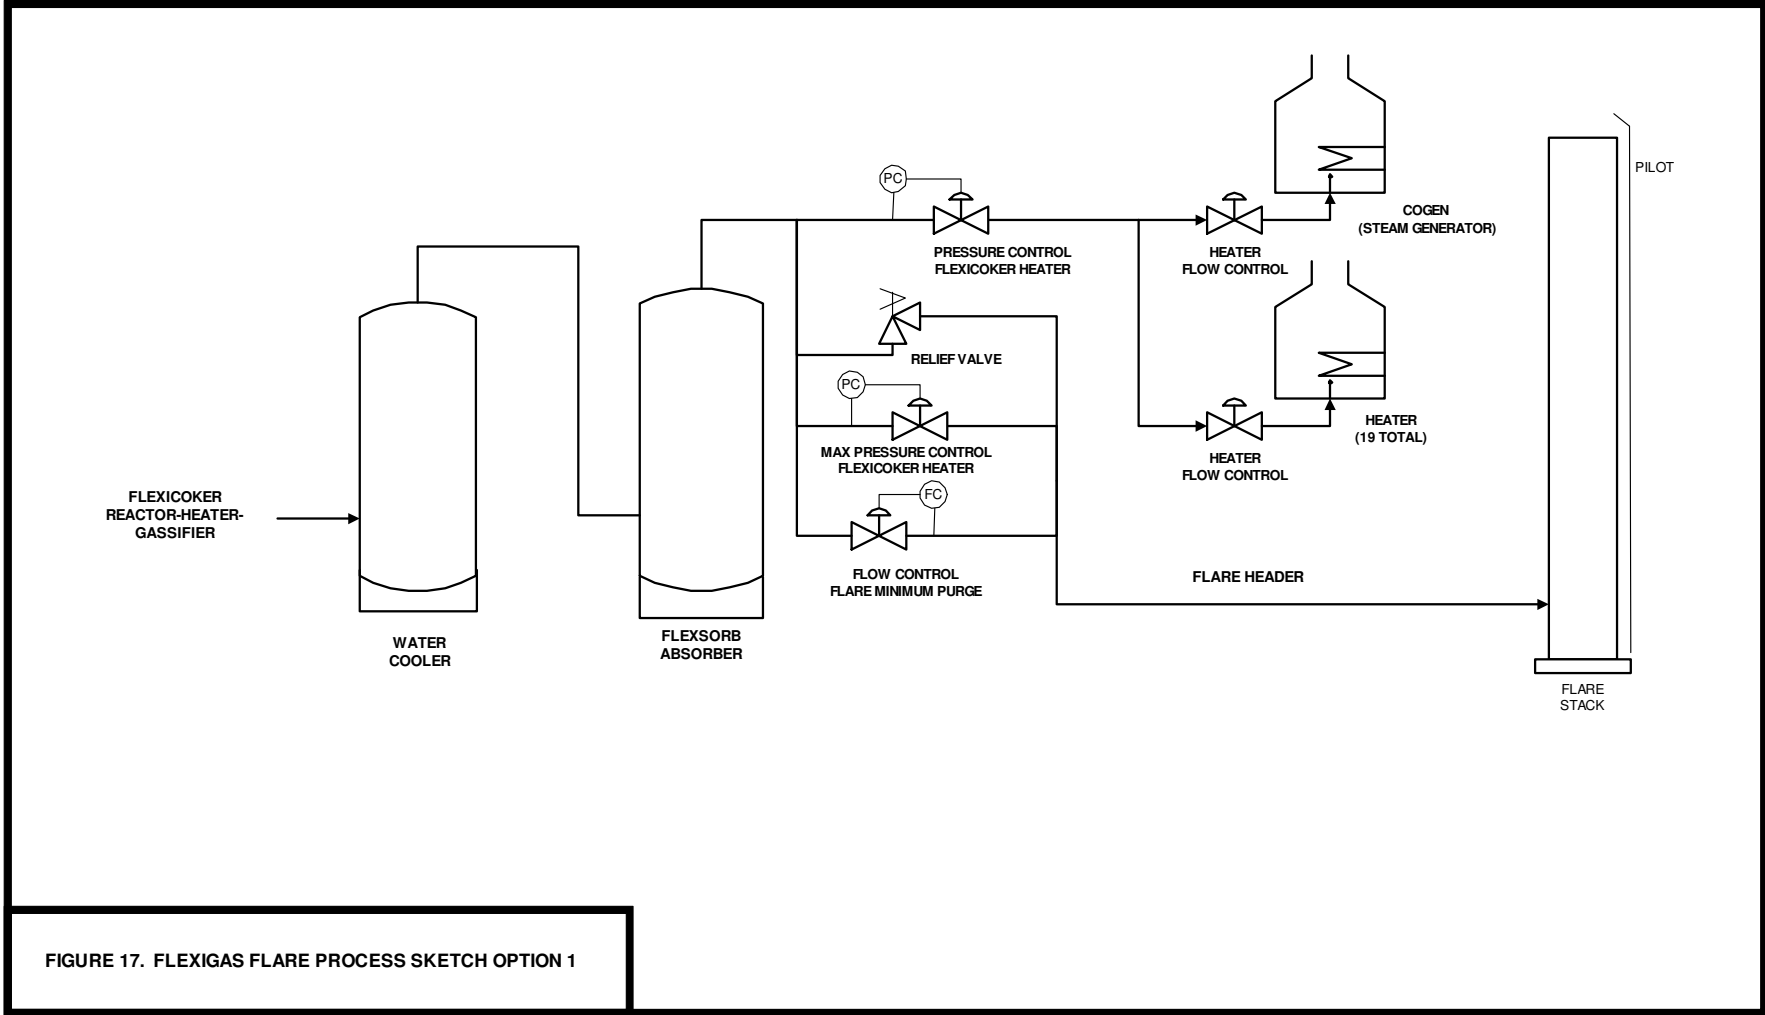
FIGURE 17. FLEXIGAS FLARE PROCESS SKETCH OPTION 1

OPTION 1: PROVIDE ADDITIONAL FLEXIGAS CONSUMERS (see Figure 17).

The objective of this project would be to provide an additional consumer that can rapidly pick up the Flexigas volumes made available by loss of another consumer (e.g., process heater) for any reason. Because excess Flexigas is available less than 10% of the time (based on the percent of days on which flaring occurred from Figure 16), and the current fuel system is roughly in balance, this consumer must essentially remain in hot standby until needed. This means it must be waiting to burn between 1 MMSCFD and 40 MMSCFD Flexigas when an existing consumer unexpectedly comes off line.

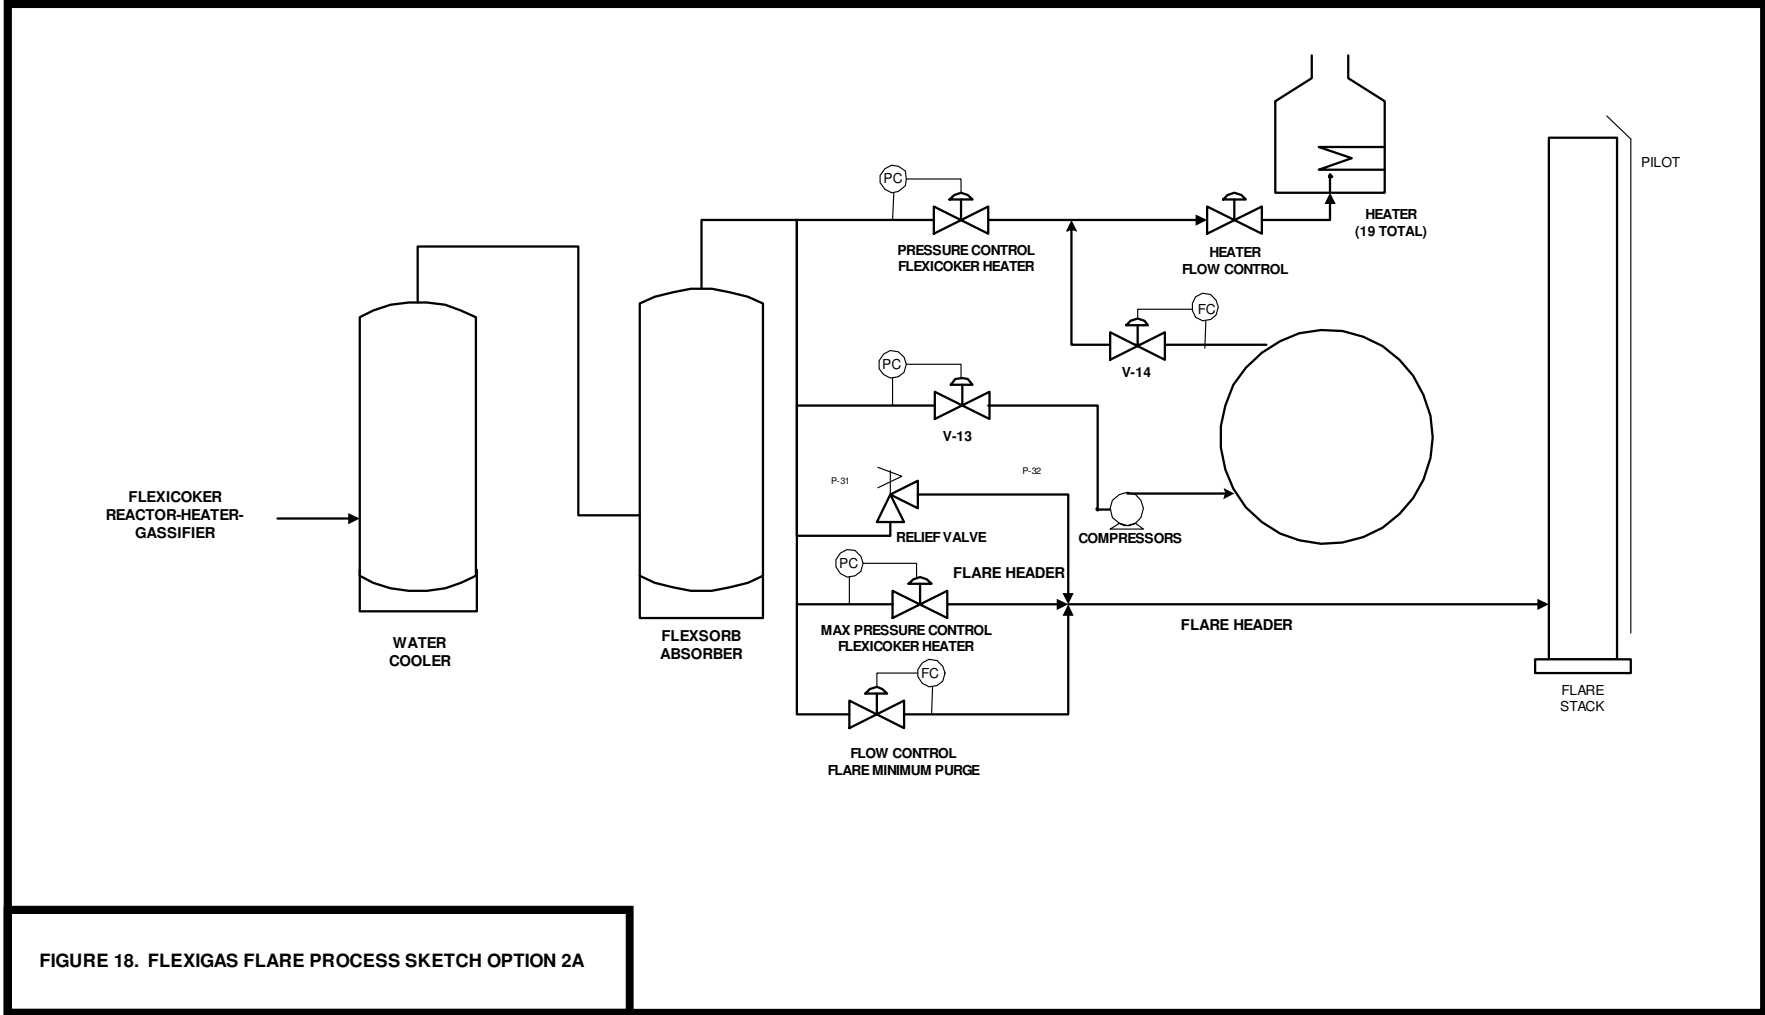
FIGURE 18. FLEXIGAS FLARE PROCESS SKETCH OPTION 2A

Option 2A consists of a pressurized vessel that would require a compressor with capacity ranging between 1 MMSCFD and 10 MMSCFD. This option is depicted in Figure 18. Flexigas in excess of consumer demand is routed to storage via compressor(s). A controlled flow is returned to the distribution system when enough consumers are available to avoid flaring. Due to the limited capacity of this storage, it has no real capability to accommodate prolonged fuel system imbalances. As a result, the expected best-case emission reductions are about the same as those available in 2005. A rough capital cost for the storage and large compressors is about \$27,000,000²². Annual electrical costs for the required compressors add another \$600,000. The annualized capital plus electrical costs to eliminate a ton of non-methane hydrocarbon result in a cost-effectiveness of approximately \$190 Million dollars per ton. Therefore, Option 2A is even less cost-effective for reducing flaring than Option 1.

²² Based on a nominal 1 MMSCF sphere (60' diameter) at 120 psig, and two 4 MMSCFD compressors. This system would handle only minor imbalances while the Flexicoker cuts rate.

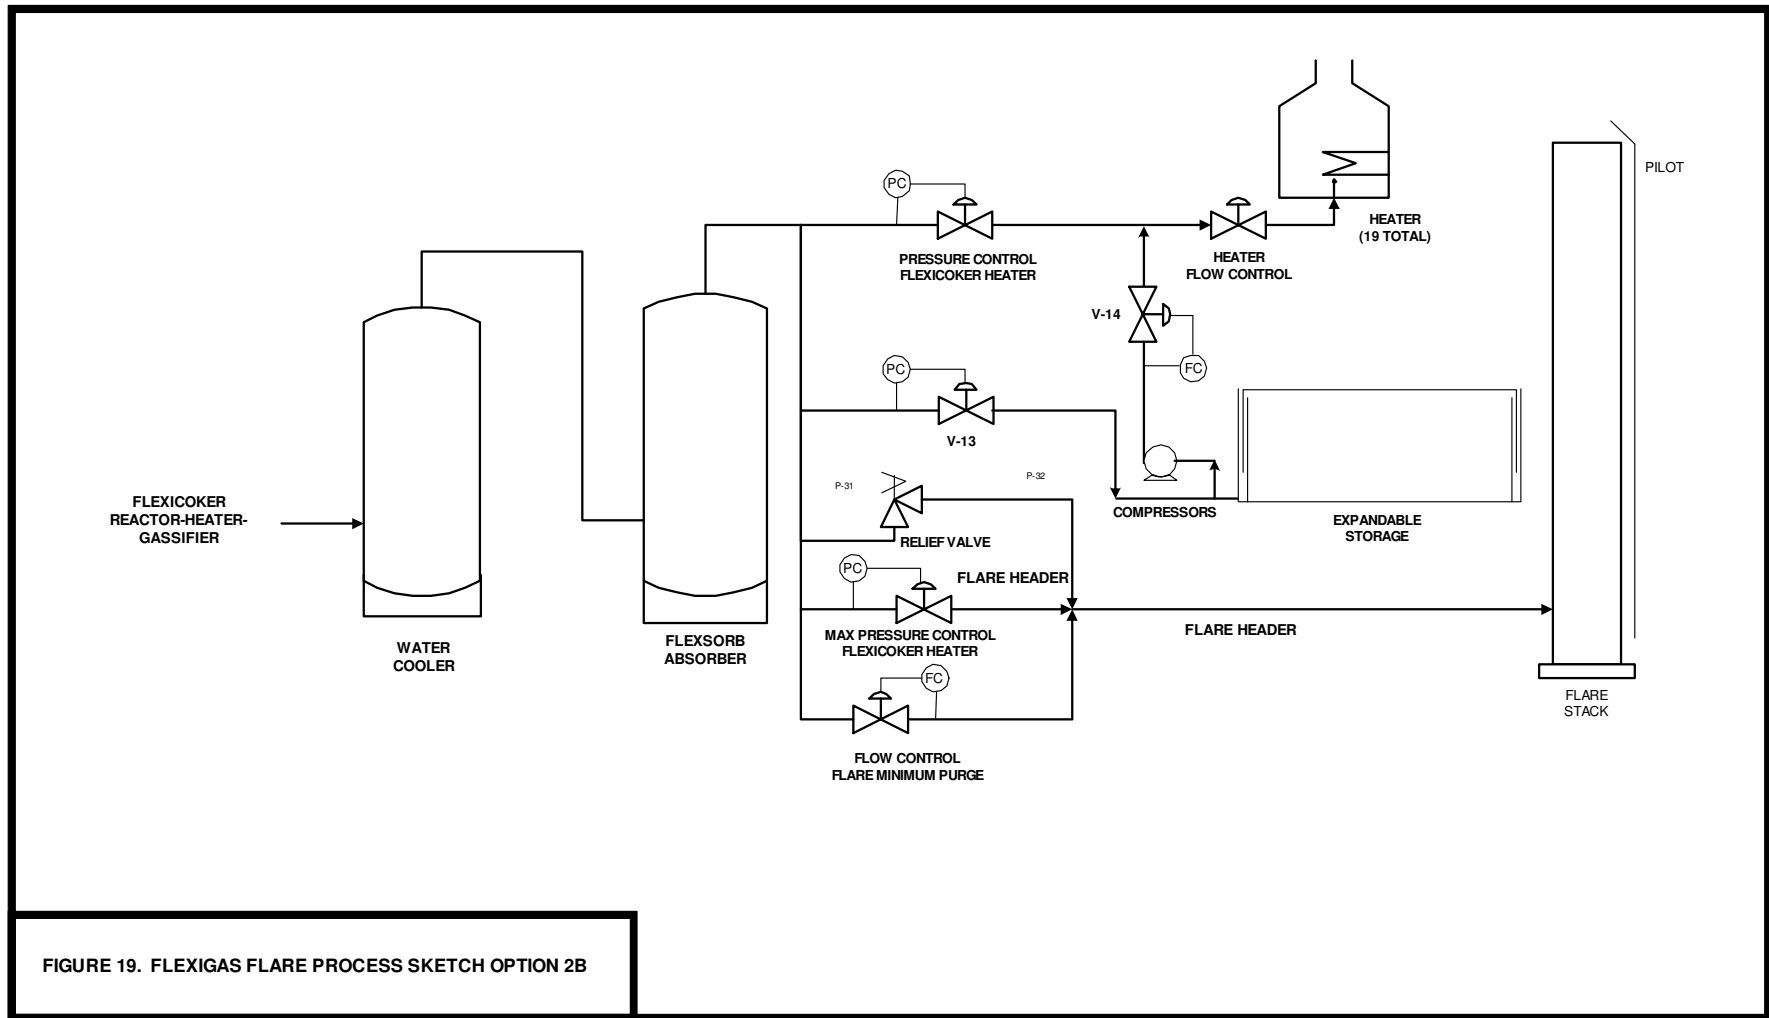
FIGURE 19. FLEXIGAS FLARE PROCESS SKETCH OPTION 2B

Option 2B uses low-pressure expandable gas storage. This option is depicted in Figure 19. This type of storage can be built significantly larger than the pressurized storage used in option 2A, and has the advantage of not requiring compressors in some cases. However, the concentration of carbon monoxide in the gas will likely require use of a water seal to limit leakage, restricting vessel height to a single lift. The requirement for a single lift, combined with low-pressure operation, significantly limits available storage volume²³. In any event, the installed cost is approximately \$21,000,000, providing cost-effectiveness of approximately \$276 Million dollars per ton of NMHC. As was the case for Option 2A, this option is even less cost-effective for reducing flaring than Option 1.

²³ The actual available storage volume is probably on the order of 1 MMSCFD, and will severely limit achievable emissions reductions. A 50% savings is premised for this analysis.
