Annual Update of Flare Minimization Plan - Public
Chevron Richmond Refinery

Flare Minimization Plan

Chevron Products Company - Richmond Refinery

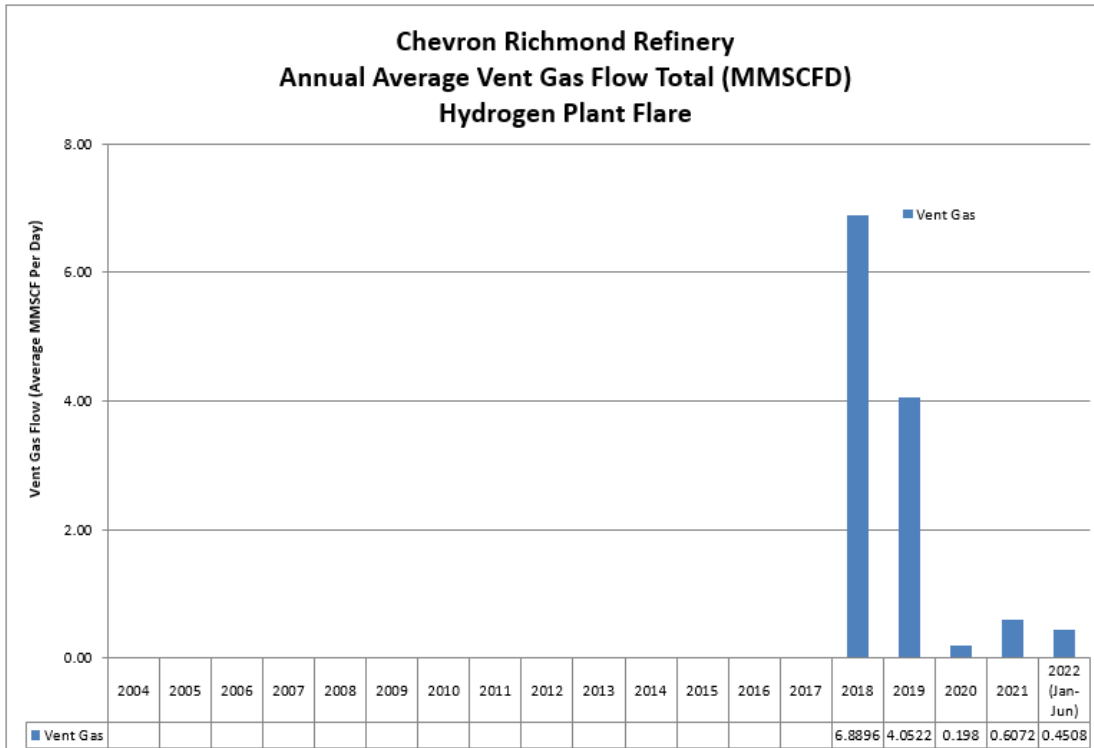
Graphics Depicting Progress of Flare Minimization

The following graphics demonstrate the reduction in flaring since 2004. The first two graphs display the annual average quantities of vent gas flow. The second two graphs display the annual average methane, non-methane hydrocarbon (NMHC), and sulfur dioxide (SO₂) emissions. Seven of the refinery flares have flare gas recovery and are reported in the same graphic. The Hydrogen Plant Flare does not have flare gas recovery and is designed to flare during scenarios including start-up and shutdown. In addition, the primary gases flared at the Hydrogen Plant differ from the gases flared at the other refinery flares. For these reasons, Hydrogen Plant Flare volumes and emissions are reported in separate graphs.

Vent gas flow and emissions from flares with water seals has significantly decreased since 2020. The vent gas, methane, NMHC, and SO₂ reduced on a daily average basis from the 2020 calendar year to first half of 2022. Table 1 quantifies the change in vent gas and emissions from January-December 2020 to January-June 2022 on a daily average basis.
