Martinez Refining Company

FLARE MINIMIZATION PLAN

Updated October 1, 2022

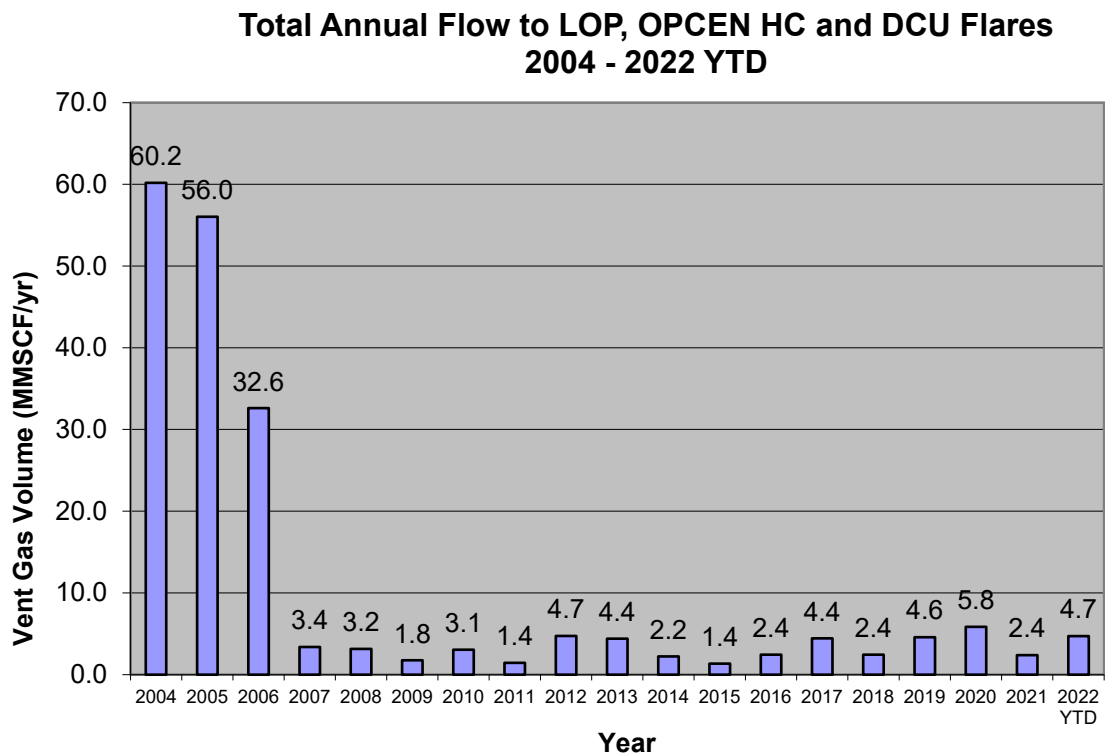
FIGURE ES-1

Figure ES-1 presents the total annual vent gas flow to the Light Oil Processing (LOP), Operations Central Hydrocarbon (OPCEN HC) and Delayed Coking Unit (DCU) Flares at the refinery from 2004 through June 30, 2022. Flare flow continues to be very low.

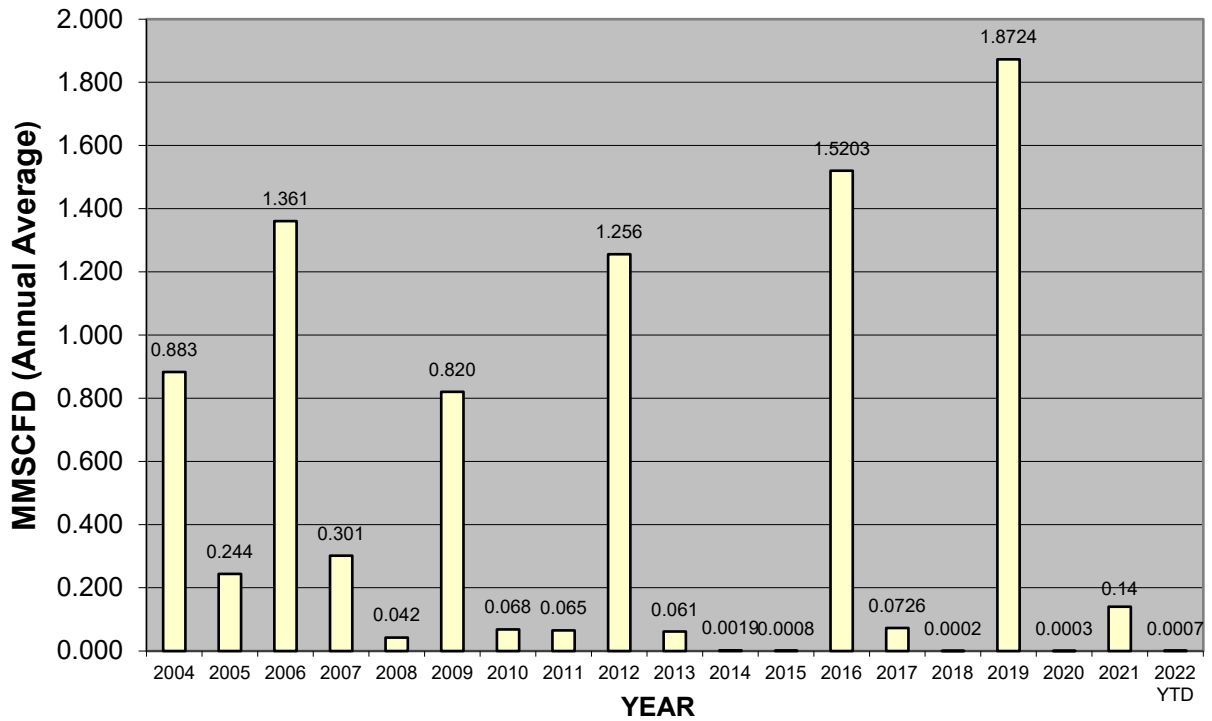
Flexigas Flare Flow 2004 - 2022 YTD

Figure ES-2 shows the annualized vent gas flow from the Flexigas Flare. This figure shows a cyclic increase in Flexigas flaring which occurs during years with startup and shutdown of the Flexicoker due to the nature of the Flexicoking and Flexsorb processes. The flaring of treated flexigas during startups and shutdowns of the Flexicoker is allowed up to specified limits in MRC's Title V permit. Flexigas is a very low BTU gas used as a supplemental refinery fuel gas in refinery process heaters. Flexigas is treated for sulfur removal in the Flexsorb Unit before being combusted either in refinery process heaters or if necessary, in the Flexigas Flare. When FXG is flared, the volume of gas is typically large compared to the volume flared in the other refinery process flares, but emissions are significantly less because Flexigas contains very low concentrations of non-methane hydrocarbon and sulfur.

Flexigas flaring can also occur due to refinery fuel gas imbalance. MRC continues to fine-tune the Flexigas pressure control scheme to minimize flexigas flaring due to small imbalances in fuel gas. Improvements in this system, most notably addition of COGEN to the pressure control scheme, contribute to the very low flexigas flare flow rate seen in non-turnaround years including 2013, 2014, 2015, 2017, 2018, 2020, and 2021. **FIGURE ES-2**

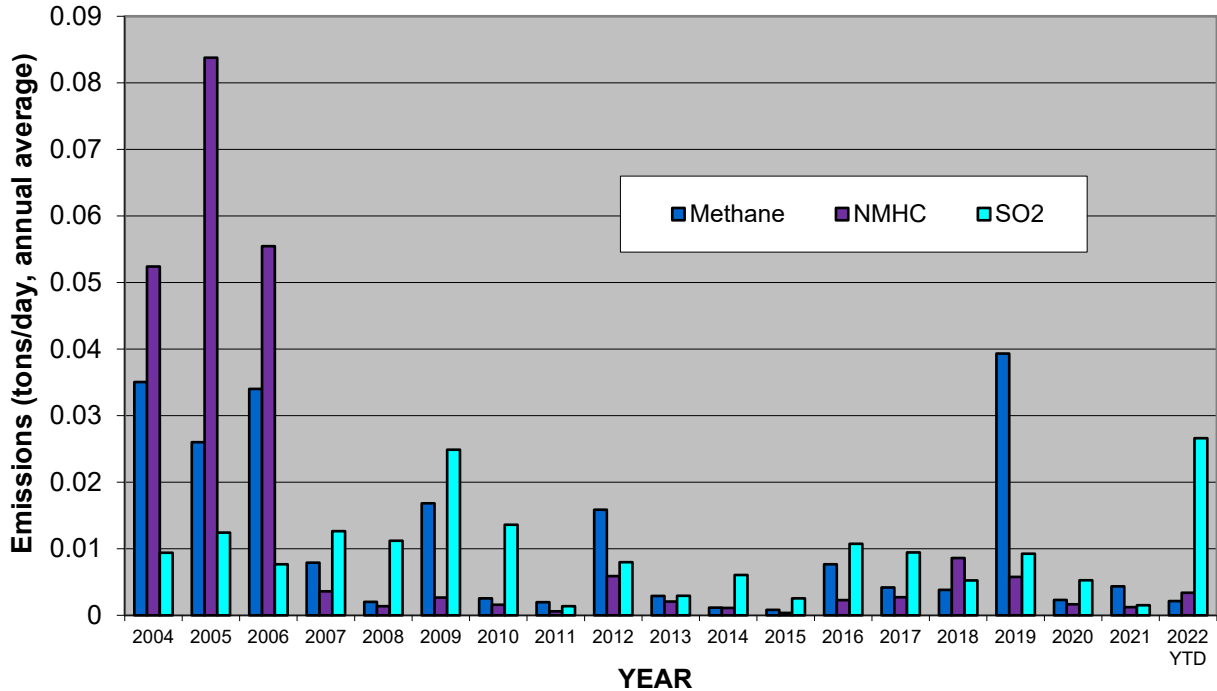
FIGURE ES-3

Figure ES-3 shows the methane, non-methane hydrocarbon, and sulfur dioxide emissions from all four refinery process flares from 2004 through June 30 of this year.

**MRC Flare Emissions - All Flares
2004 - 2022 YTD**

Figure ES-3 shows the overall significant reduction in emissions that has occurred since the implementation of the Flare Minimization Plan in 2006 and highlights that even with large volumes of flexigas flaring during turnaround years, overall emissions from flaring are low.

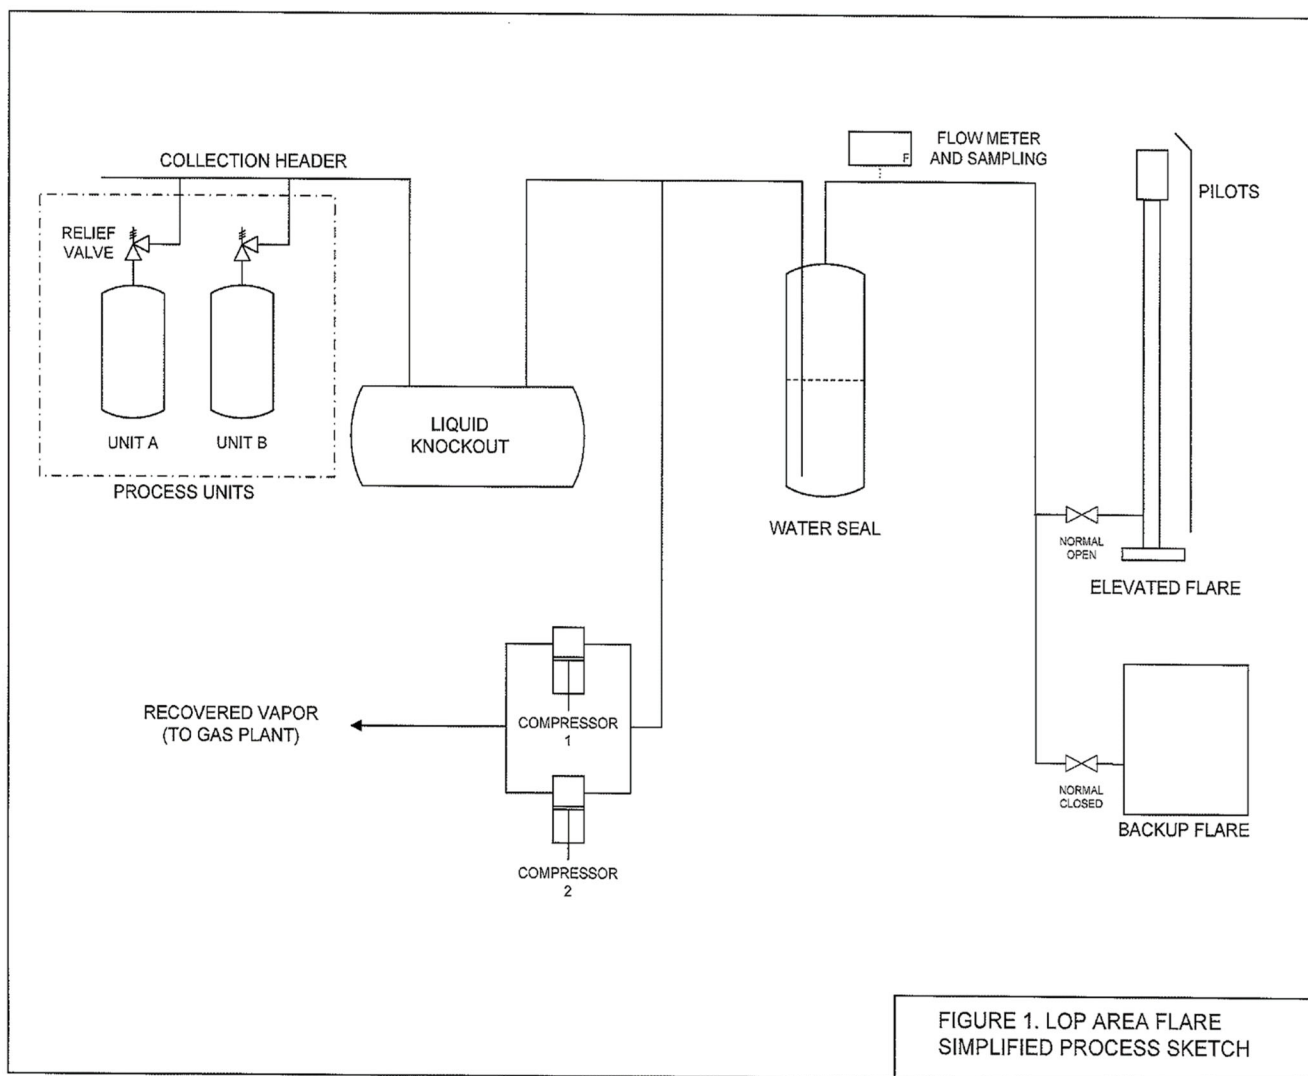
FIGURE 1. LOP AREA FLARE SIMPLIFIED PROCESS SKETCH

The LOP Flare system is comprised of collection headers, liquid knockout vessels, two flare vapor recovery compressors, piping to route recovered gas to fuel gas treaters, a water seal vessel, the flare header proper, and the flare stack. The LOP flare is an elevated, steam-assisted flare with nitrogen purge to prevent air intrusion. Piping and valves provide sufficient flexibility to operate in various configurations, allowing continuous and reliable operation during turnarounds, inspection and maintenance activities without flaring. Maintenance of the elevated flare (S#1471) is accomplished by putting an alternate flare in service. This alternate flare (Backup Can Flare, S#1472) is normally blinded and is only used when the elevated flare is out of service for inspection or repair. A sketch of the LOP Flare system is provided in Figure 1. Technical details of the system are provided in Appendix A².

Recovered flare gas is treated to remove hydrogen sulfide and condensable liquids. Treated gas is routed to the fuel gas system. The fuel gas treaters typically used for LOP recovered flare gas are located in the Catalytic Cracker Gas Plant (CGP). When this unit is unavailable for any reason, recovered gas may be routed to the Saturates Gas Plant (SGP). Sufficient capacity can be made available in both sets of treaters for the incremental flow up to the total capacity of both compressors of about 6.4 MMSCFD.

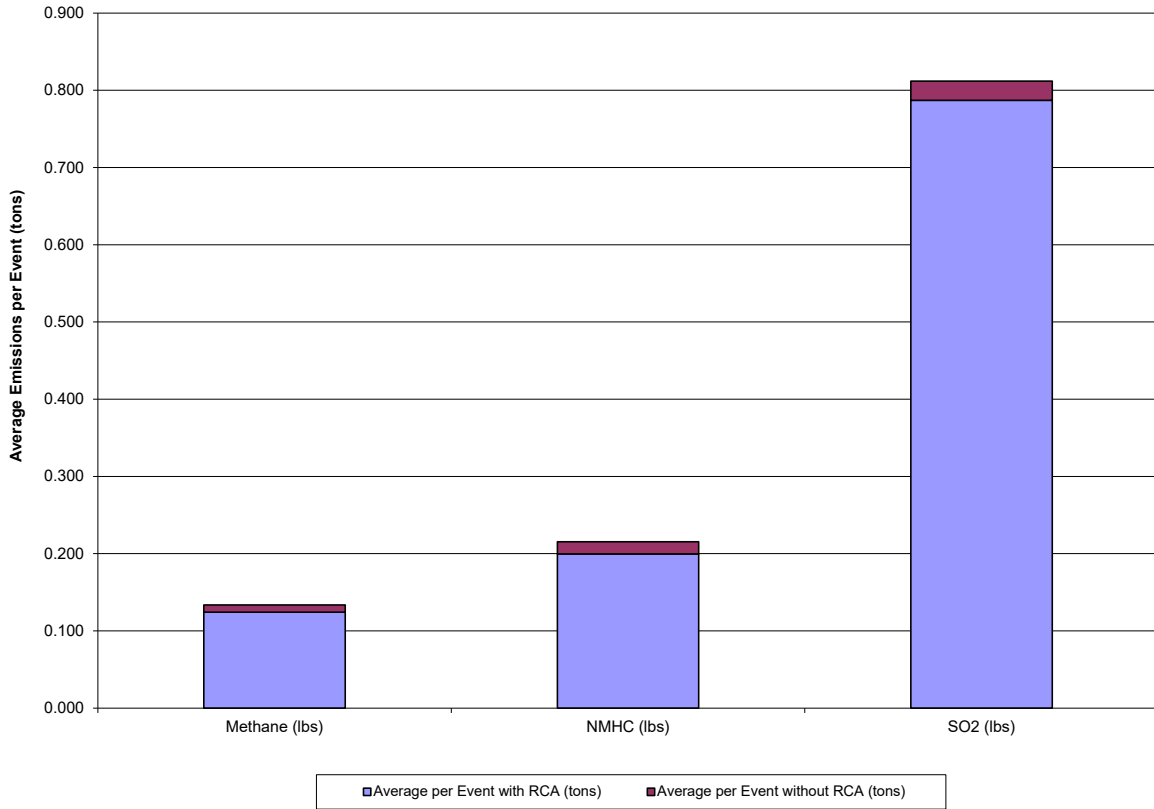
FIGURE 2008 -1

LOP Flare Events w/ Causal Analysis vs. Small Events
1/1/06 - 6/1/08

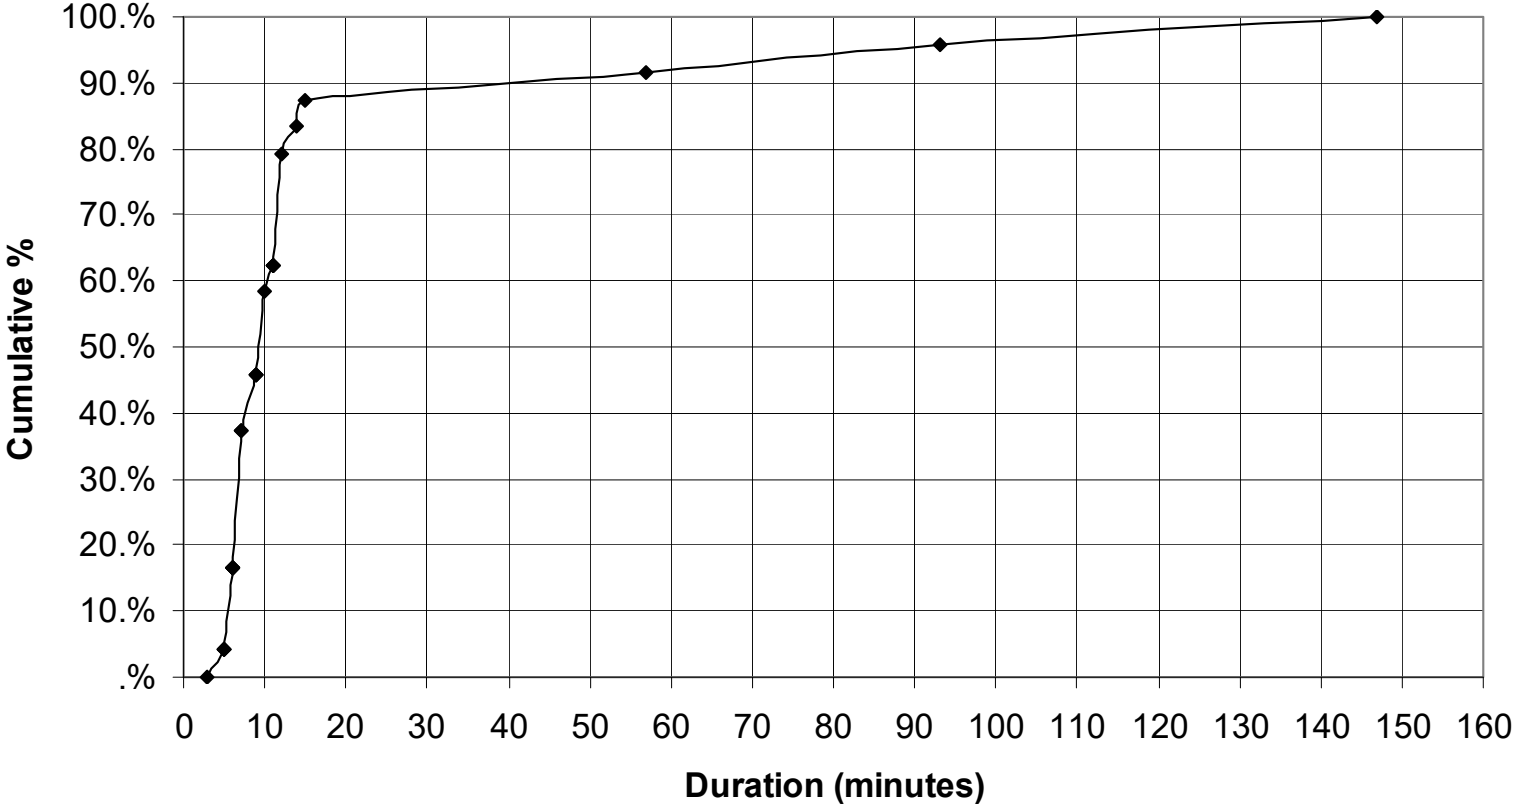
Figure 5. LOP Flare Durations
(2005 - 25 Events)

Figure 5 depicts the distribution of flare event durations for 2005, the year for which these data are available. Most flare events have very short durations with small volumes of gas flared. From

Figure 5 it can be seen that half of the flare events had durations of less than 10 minutes. By combining event durations with additional data on the volume flared during each event, it can be shown that the 50% of events with durations less than 10 minutes contributed less than 10% to the total volume of gas flared. The 85% of events which lasted 15 minutes or less contributed less than 40% to the total volume flared. Only three of the flare events during this period lasted longer than one hour. All of the event durations were less than three hours.

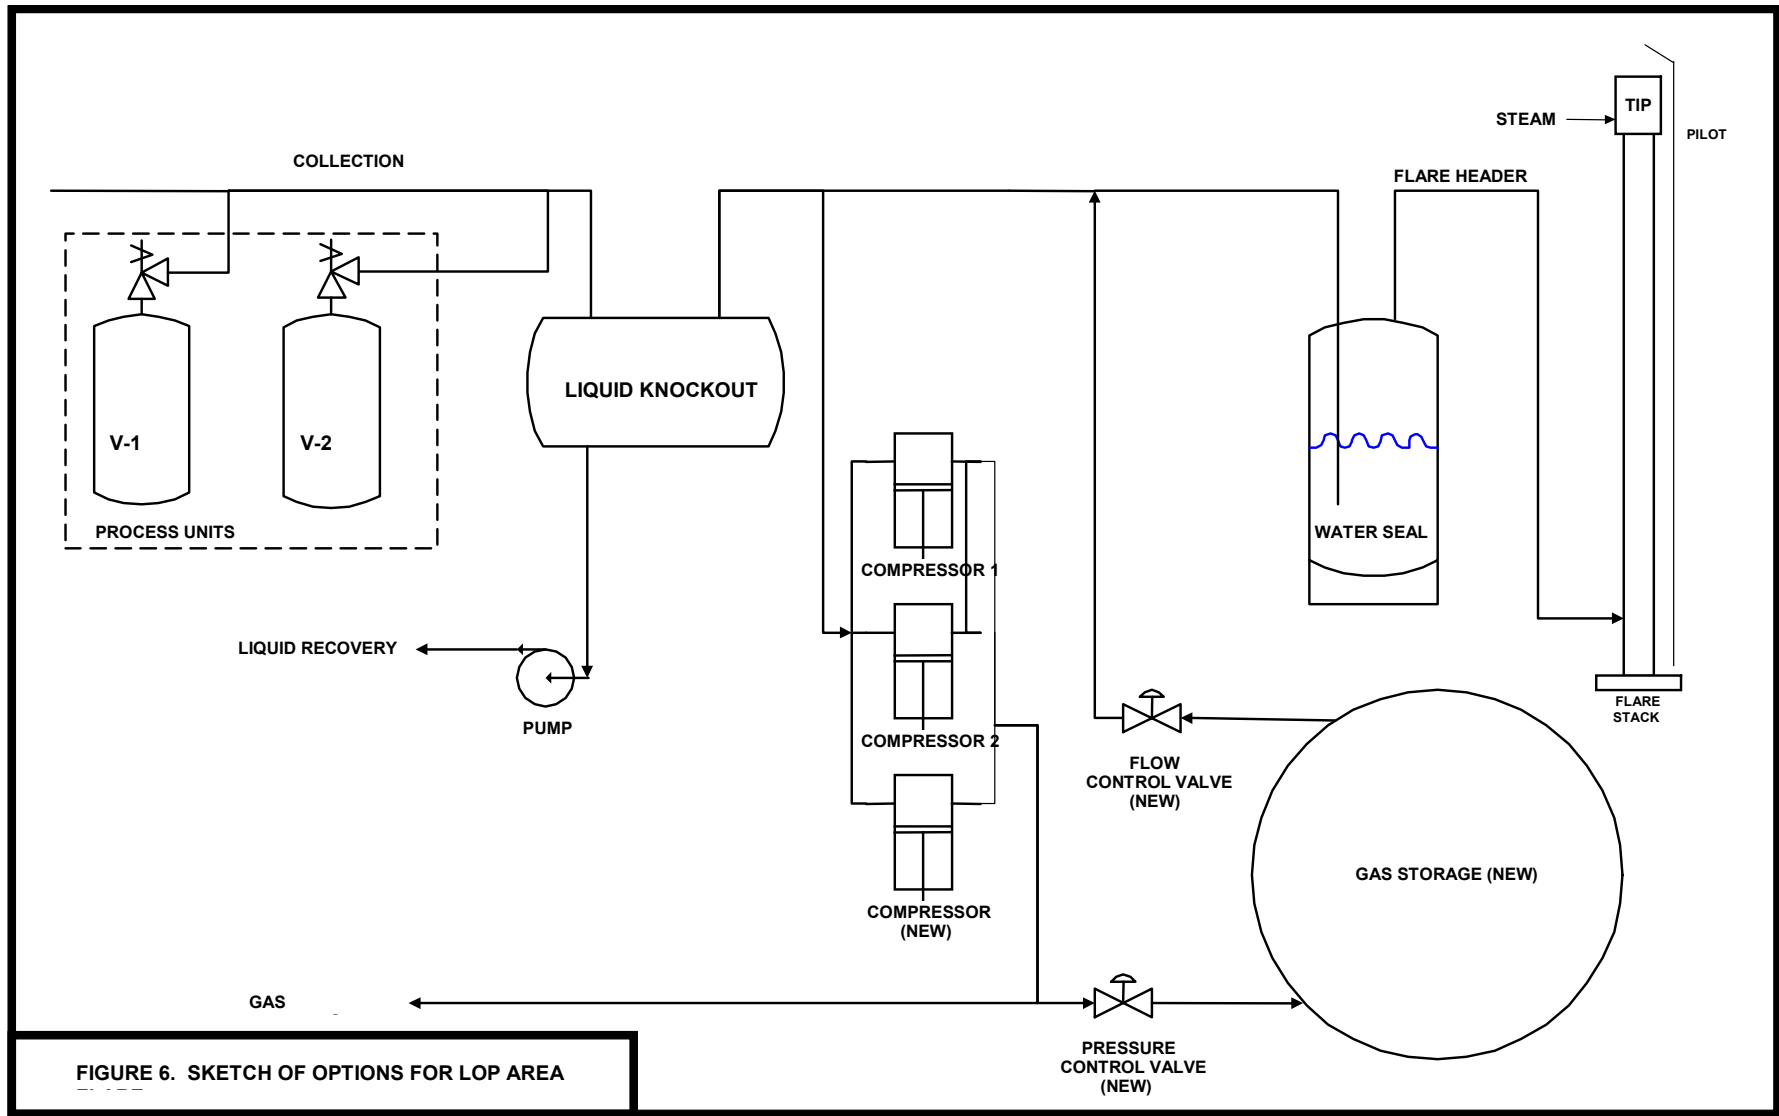
FIGURE 6. SKETCH OF OPTIONS FOR LOP AREA

Prevention Measure Options Considered for Recovery, Storage and Treatment: Costs and potential benefits of improving gas recovery and reducing flare emissions from the current 99.7% recovery efficiency are addressed by considering the addition of flare gas recovery compression and flare gas storage. Gas treating capacity is expected to be adequate for all options evaluated. A sketch of the potential options is provided in Figure 6.

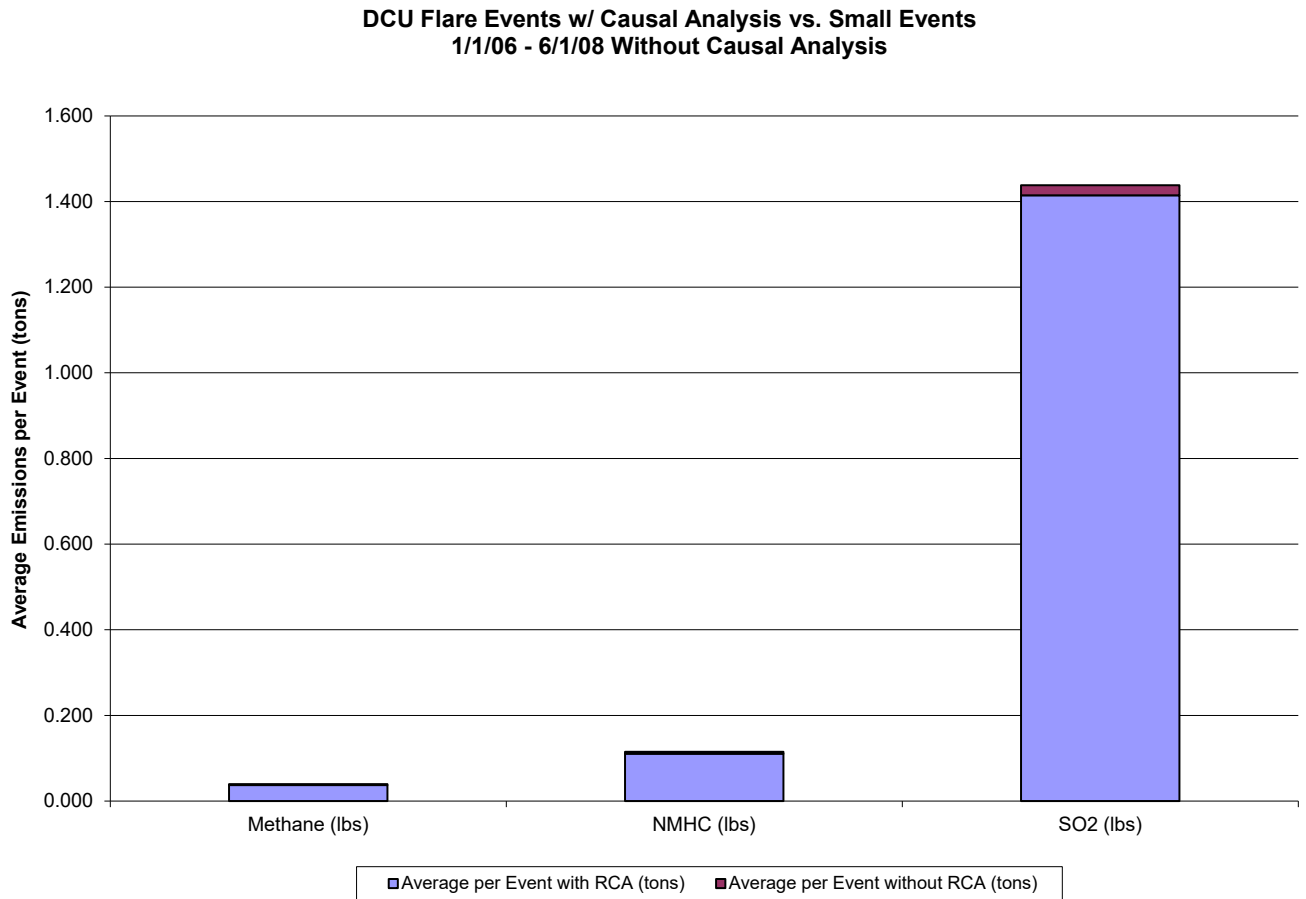
FIGURE 2008-2

Beginning in November 2006 with the adoption of the Flare Procedures described in the Common Measures Section, pertinent information, when available, was captured immediately after a flaring event to determine the cause of any flaring and what could be done to prevent it from happening again. Total emissions from all flaring during this 30-month period were: 0.17 tons of methane, 0.45 tons of non-methane hydrocarbon and 4.19 tons of SO₂. Figure 2008-2 presents a comparison of the average emissions per large reportable events over this time period vs. the average emissions per small event for the DCU Flare. This figure shows that small events contributed < 6% of the emissions of a large event. Figure 2008-2 reinforces the appropriateness of the causal analysis trigger of 0.5 MMSCF/ 500 lbs SO₂ to ensure the resources to conduct a Causal Analysis are most effectively applied to address high emission events.

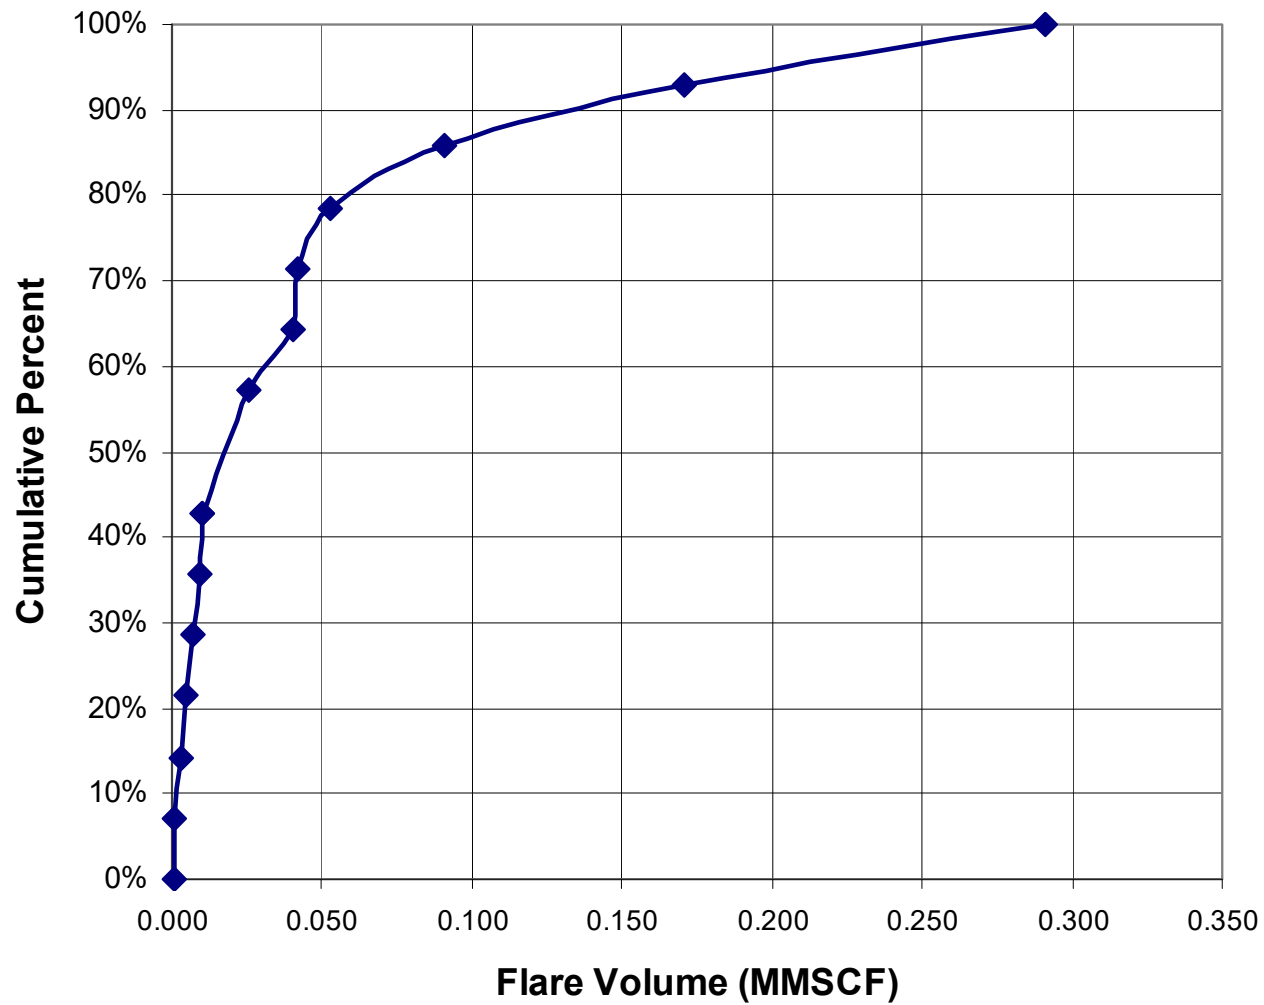
**Figure 9. Delayed Coking Area Flare Gas Volumes
(2005)**

Figure 9 depicts the amount of material flared during the reported incidents of flare activity in 2005. All flaring was below 500,000 scf. Approximately 70% of the incidents of reported flaring involved volumes of gas of 50,000 SCF or less. All were below 300,000 standard cubic feet.

is provided in figures 9 through 11. These data, together with knowledge of the various process units and hardware served by the flare, provide no new alternative mitigations beyond those already presented for the LOP Area flare.¹⁴

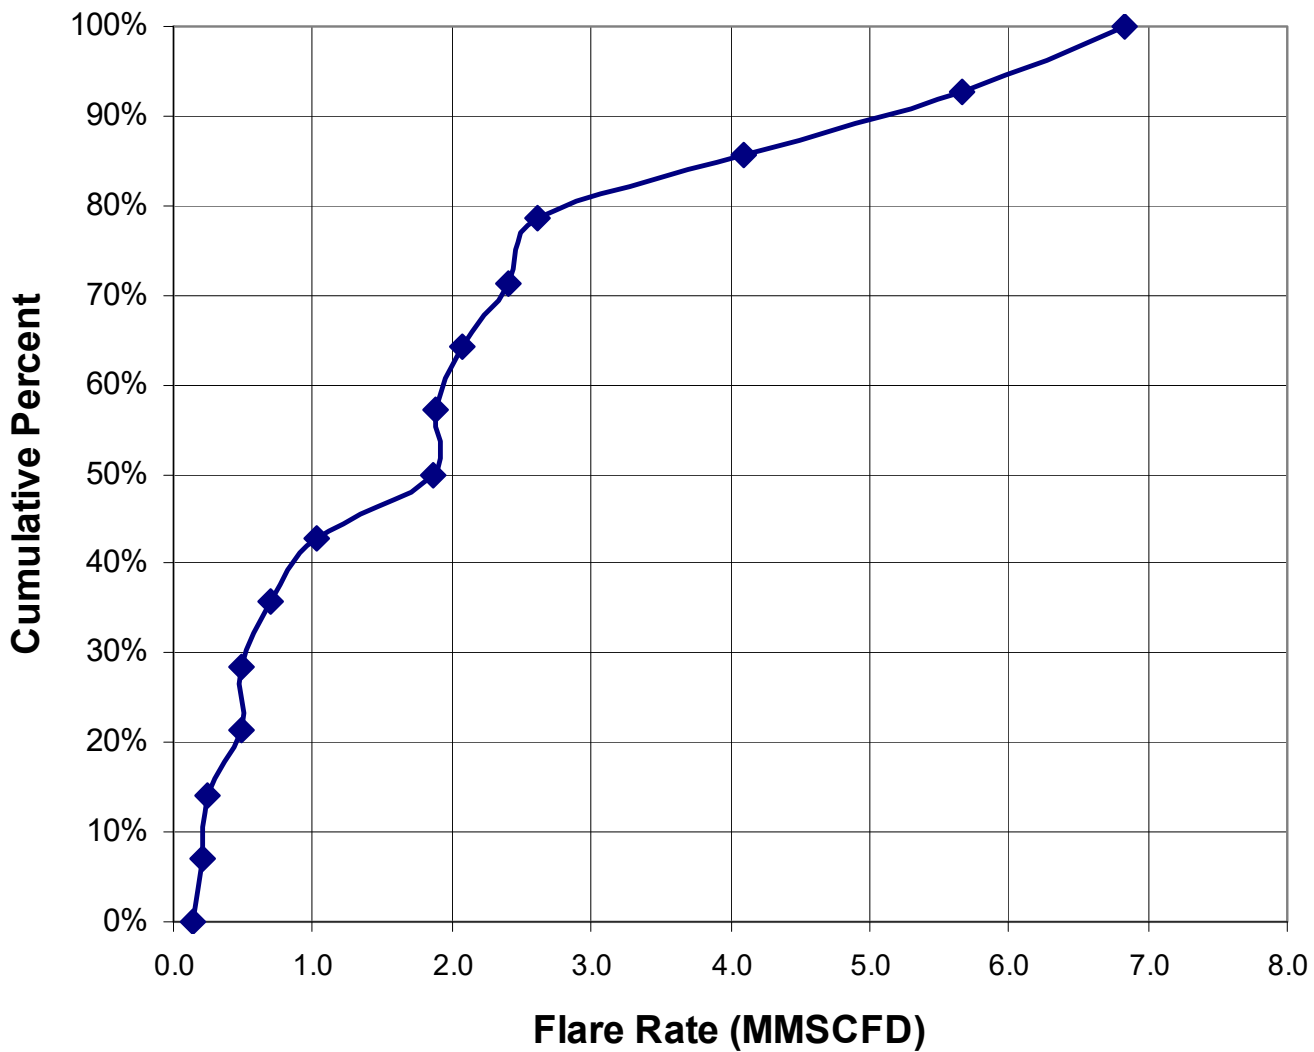
**Figure 10. Delayed Coking Area Flare Gas Flow Rates
(2005)**

Figure 10 depicts the average rates of flow to the flare for events occurring in 2005. These data indicate that approximately 80% of the flare events had event-average flow rates less than 3 million standard cubic feet per day. Actual instantaneous rates comprising the average are generally higher – often significantly – than these average rates.

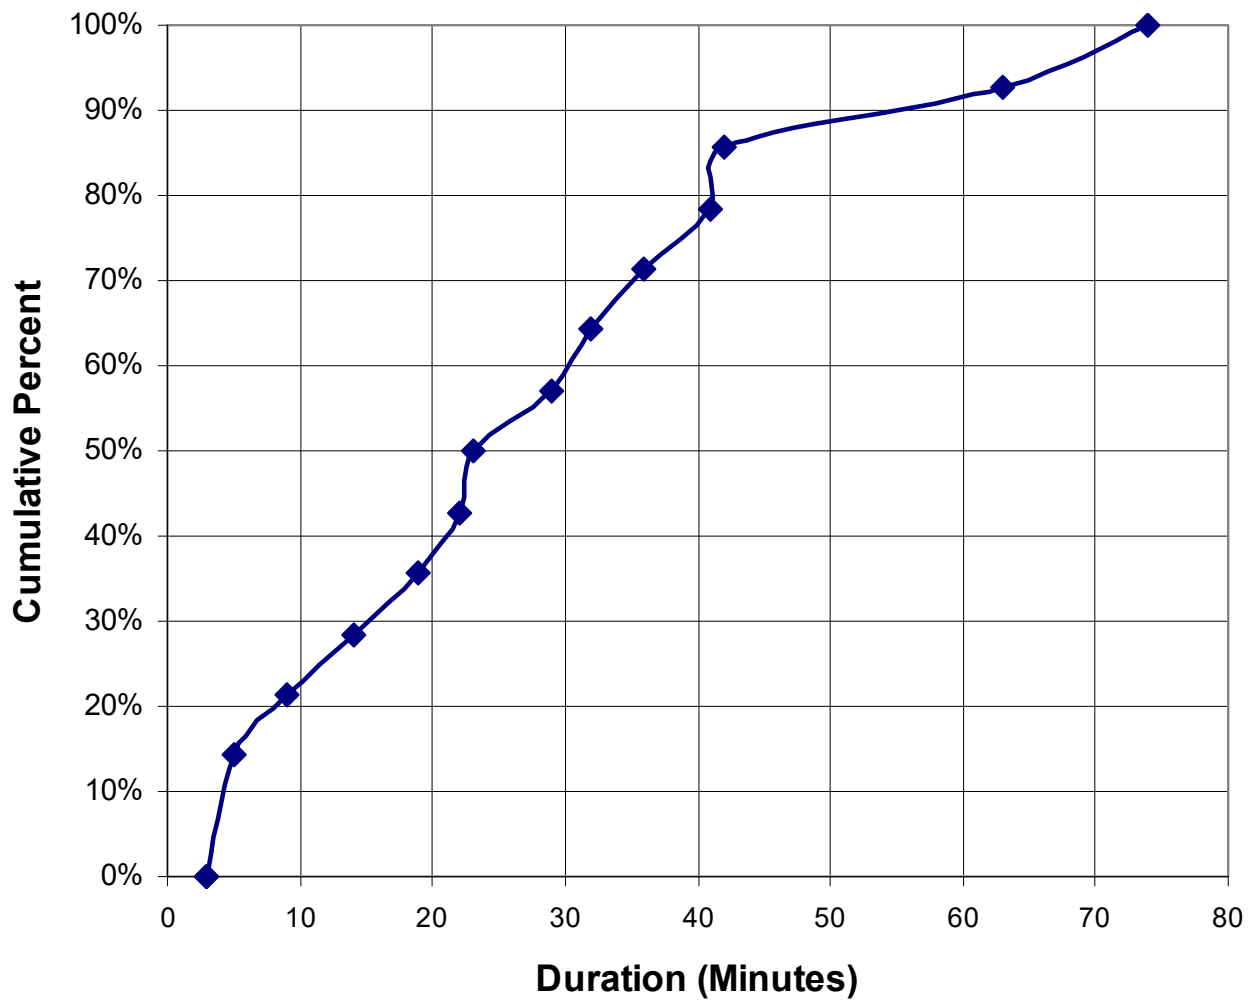
**Figure 11. Delayed Coking Area Flare Event Durations
(2005)**

Figure 11 depicts the distribution of flare event durations for 2005 where these data are available. 50% of the events lasted less than 30 minutes. This is consistent with other data characterizing the bulk of flare events being very brief.

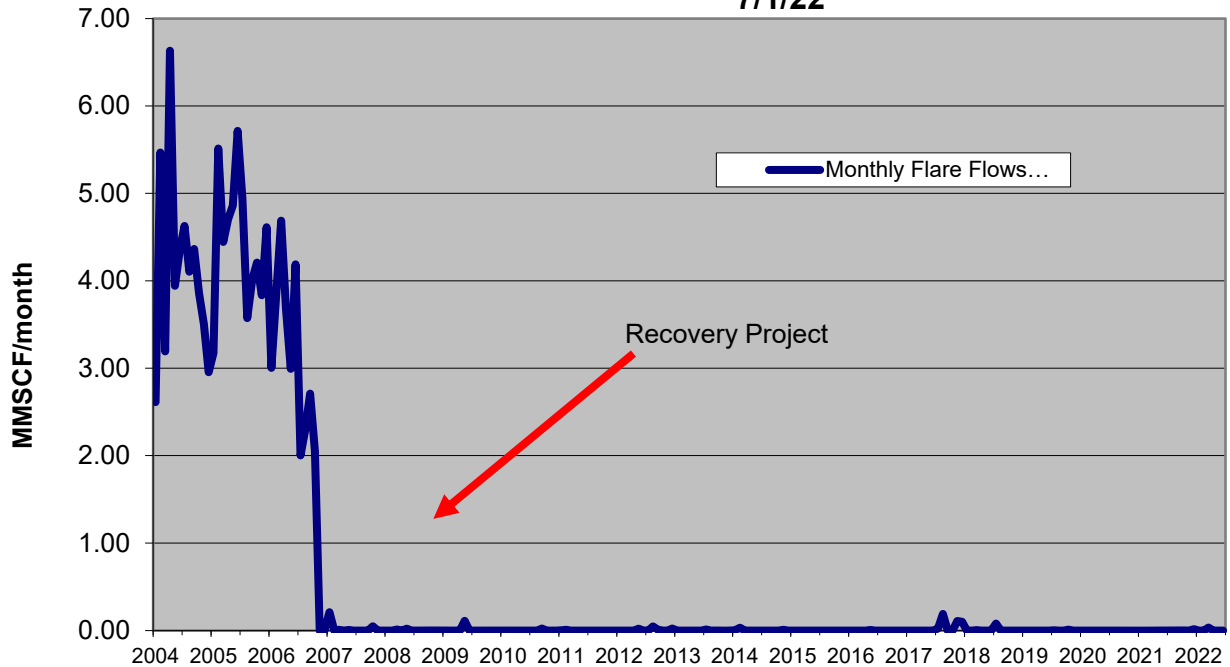
Figure 2006-1 OPCEN HC FLare Monthly Flare Flows 1/1/04 - 7/1/22

The figure below has been updated through 7/1/22 and shows the continued success of the implementation of the flare recovery project that occurred in 2006 for this flare.

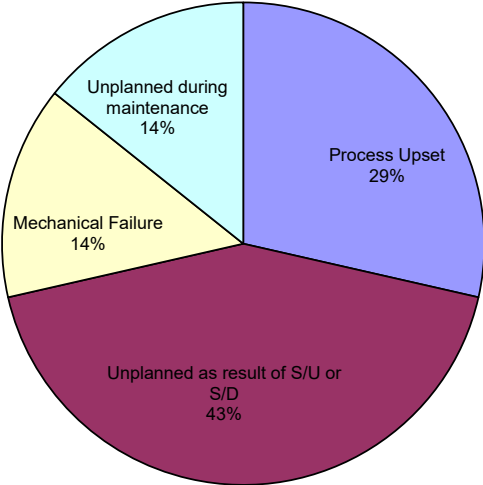
FIGURE 2008-4

OPCEN HC Flare- Cause of Flaring 11/1/06 - 6/1/08
7 Events

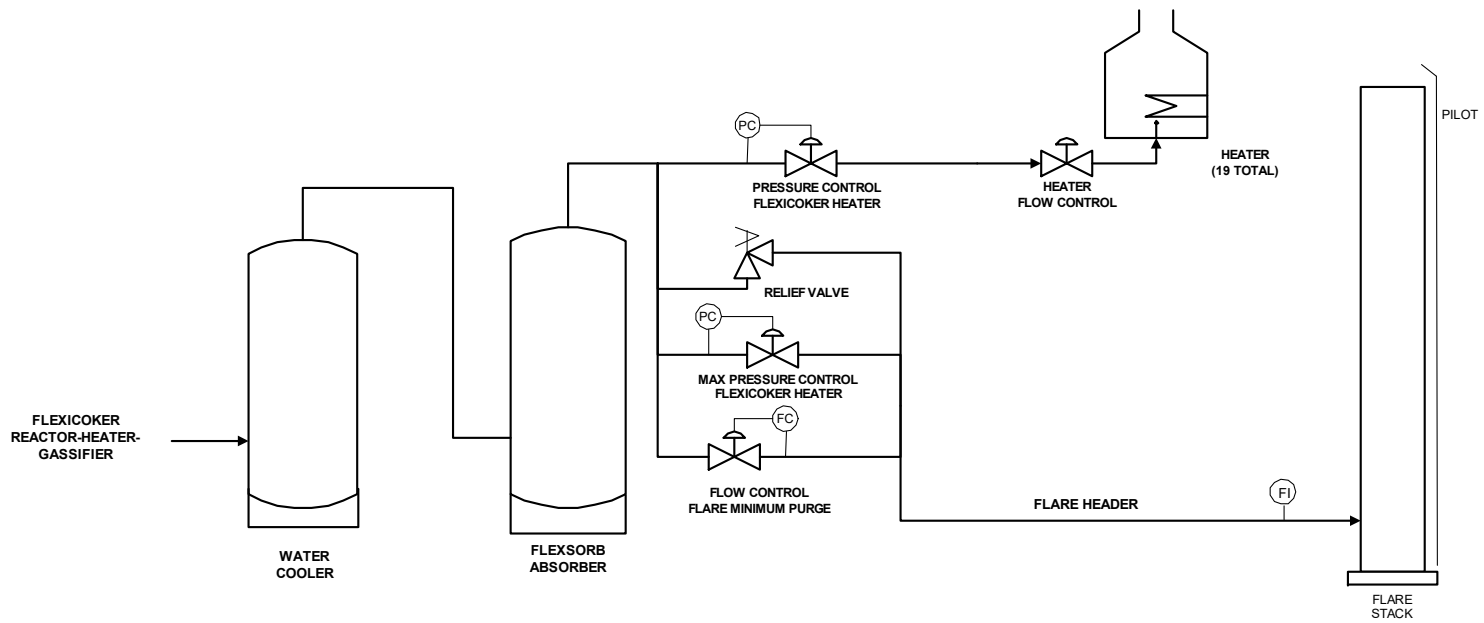
FIGURE 14. FLEXIGAS SUPPLY SYSTEM PROCESS SKETCH

The OPCEN Flexigas flare is a dedicated flare serving the Flexicoker Reactor/Heater/Gasifier. The Flexigas flare only combusts flexigas (FXG). This flare differs significantly from all other process flares serving Bay Area refineries for reasons described below. A simplified process sketch is provided in Figure 14. Details of the system are provided in Appendix D.

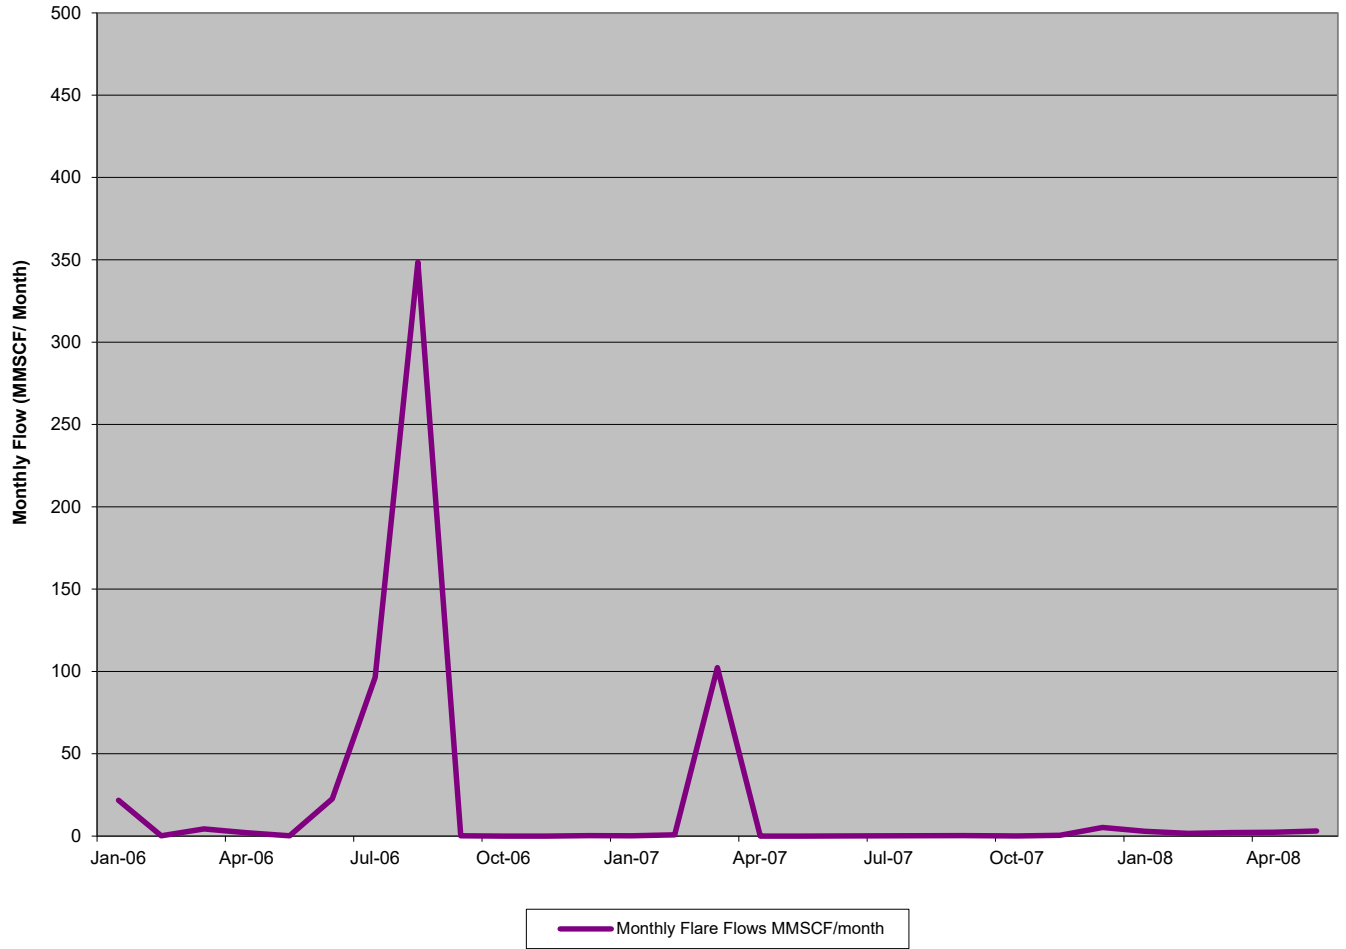
FIGURE 2008-5

Flexigas flare activity since 1/1/06 was reviewed for potential reduction opportunities. Figure 2008-5 shows the FXG flare flows over this time period. There were 11 events that required Causal Analysis. All of these flaring events were investigated and prevention measures identified and implemented (see Part 3 of this Section – Reductions Previously Realized). The results of the investigations into these events were reported to the District in Causal Analysis reports.

FXG Flare Flows 1/1/06 - 6/1/08

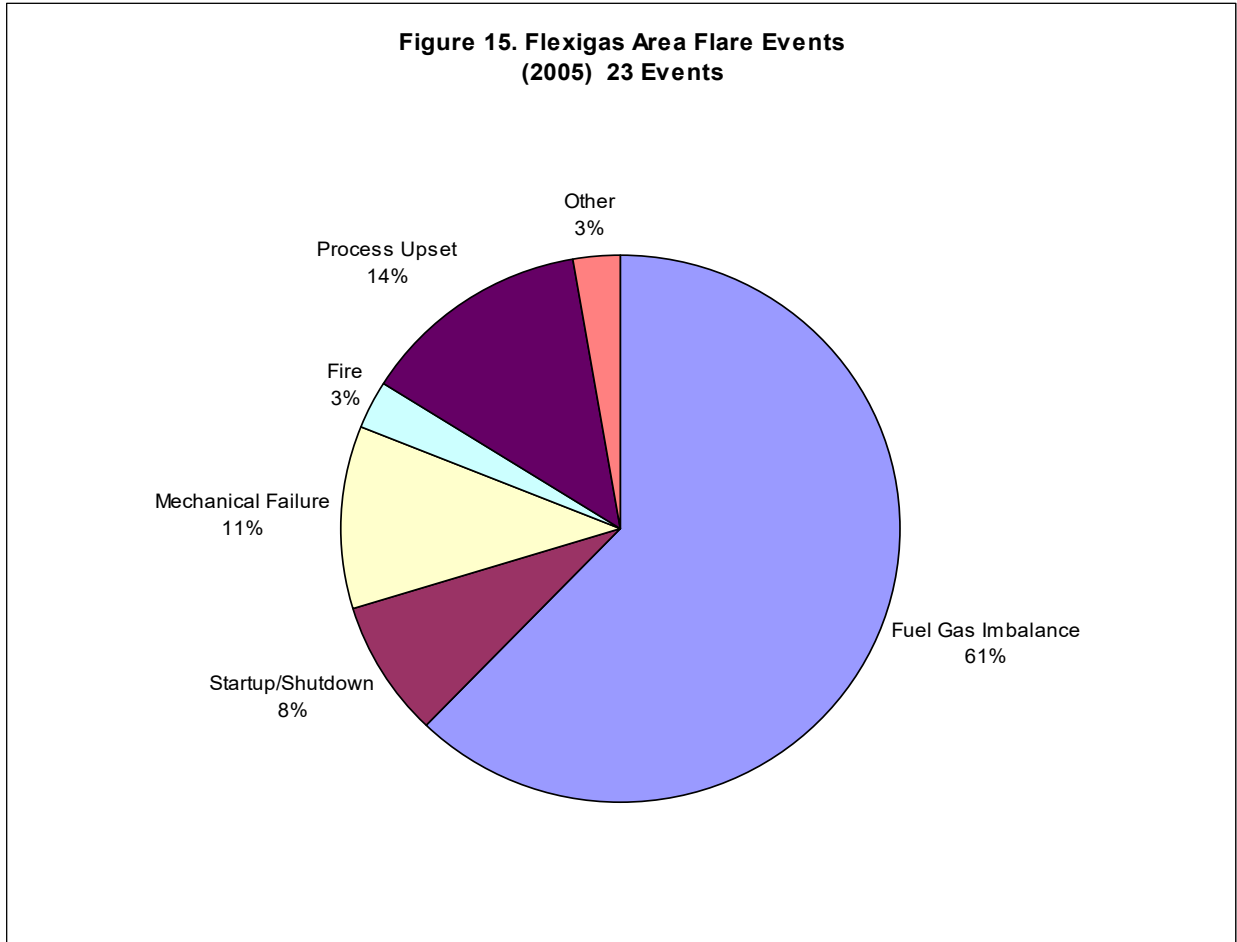
Historical flaring at the OPCEN Flexigas flare was reviewed to identify opportunities for potential mitigation. The highest quality data are available for the period from December 2003, to January 2006. This coincides with installation of the flare flow meter and BAAQMD flare reporting. Data for 2005 are plotted in Figure 15 and Figure 16.

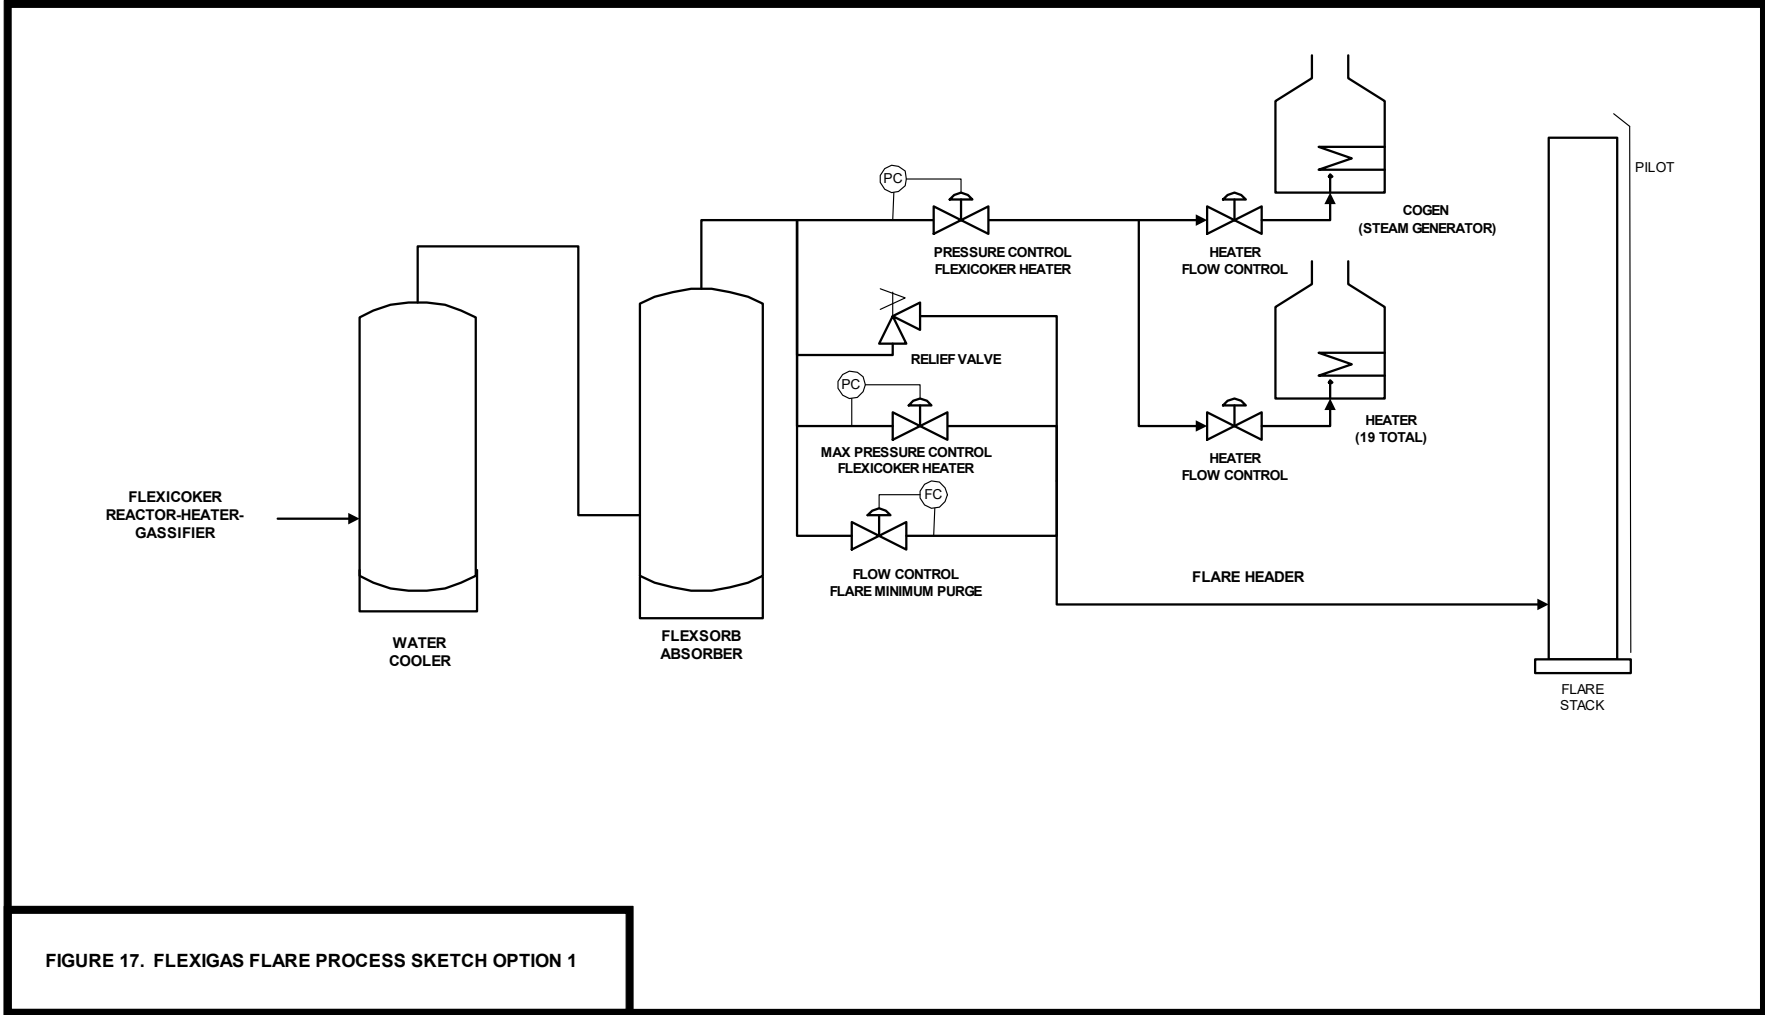
FIGURE 17. FLEXIGAS FLARE PROCESS SKETCH OPTION 1

OPTION 1: PROVIDE ADDITIONAL FLEXIGAS CONSUMERS (see Figure 17).

The objective of this project would be to provide an additional consumer that can rapidly pick up the Flexigas volumes made available by loss of another consumer (e.g., process heater) for any reason. Because excess Flexigas is available less than 10% of the time (based on the percent of days on which flaring occurred from Figure 16), and the current fuel system is roughly in balance, this consumer must essentially remain in hot standby until needed. This means it must be waiting to burn between 1 MMSCFD and 40 MMSCFD Flexigas when an existing consumer unexpectedly comes off line.
