Martinez Refining Company

FLARE MINIMIZATION PLAN

Updated October 1, 2022

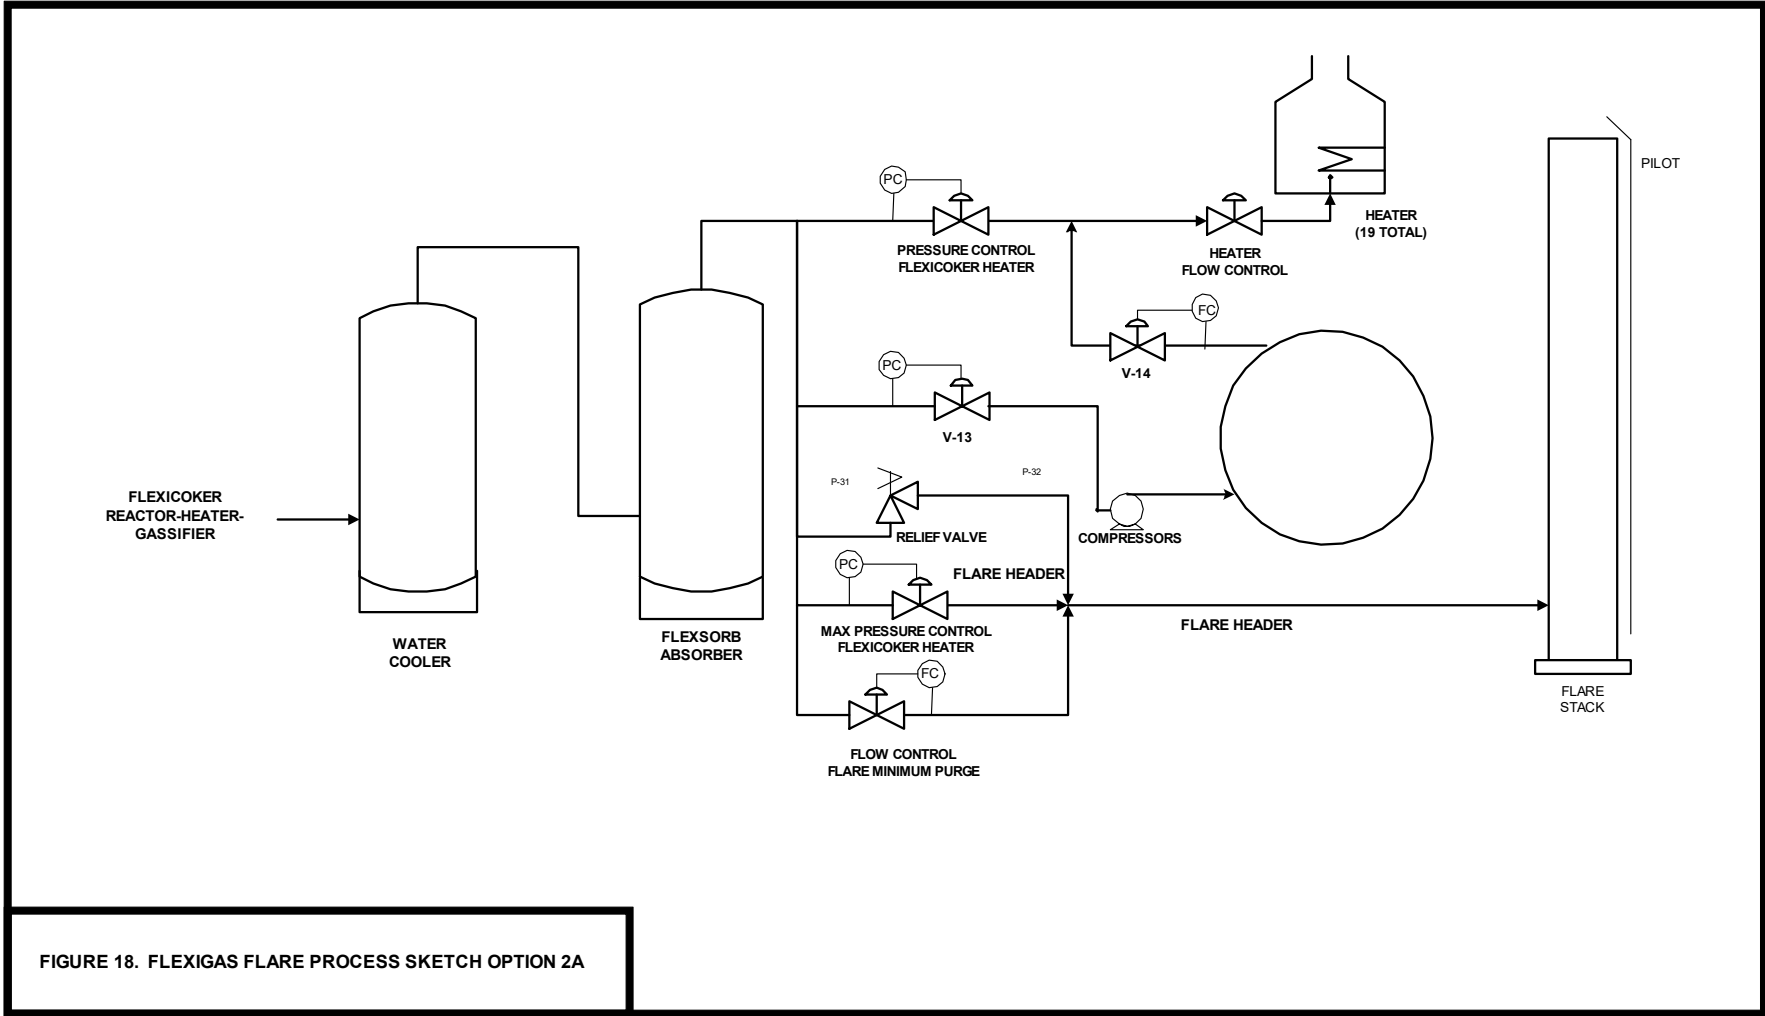
FIGURE 18. FLEXIGAS FLARE PROCESS SKETCH OPTION 2A

Option 2A consists of a pressurized vessel that would require a compressor with capacity ranging between 1 MMSCFD and 10 MMSCFD. This option is depicted in Figure 18. Flexigas in excess of consumer demand is routed to storage via compressor(s). A controlled flow is returned to the distribution system when enough consumers are available to avoid flaring. Due to the limited capacity of this storage, it has no real capability to accommodate prolonged fuel system imbalances. As a result, the expected best-case emission reductions are about the same as those available in 2005. A rough capital cost for the storage and large compressors is about \$27,000,000²². Annual electrical costs for the required compressors add another \$600,000. The annualized capital plus electrical costs to eliminate a ton of non-methane hydrocarbon result in a cost-effectiveness of approximately \$190 Million dollars per ton. Therefore, Option 2A is even less cost-effective for reducing flaring than Option 1.

²² Based on a nominal 1 MMSCF sphere (60' diameter) at 120 psig, and two 4 MMSCFD compressors. This system would handle only minor imbalances while the Flexicoker cuts rate.

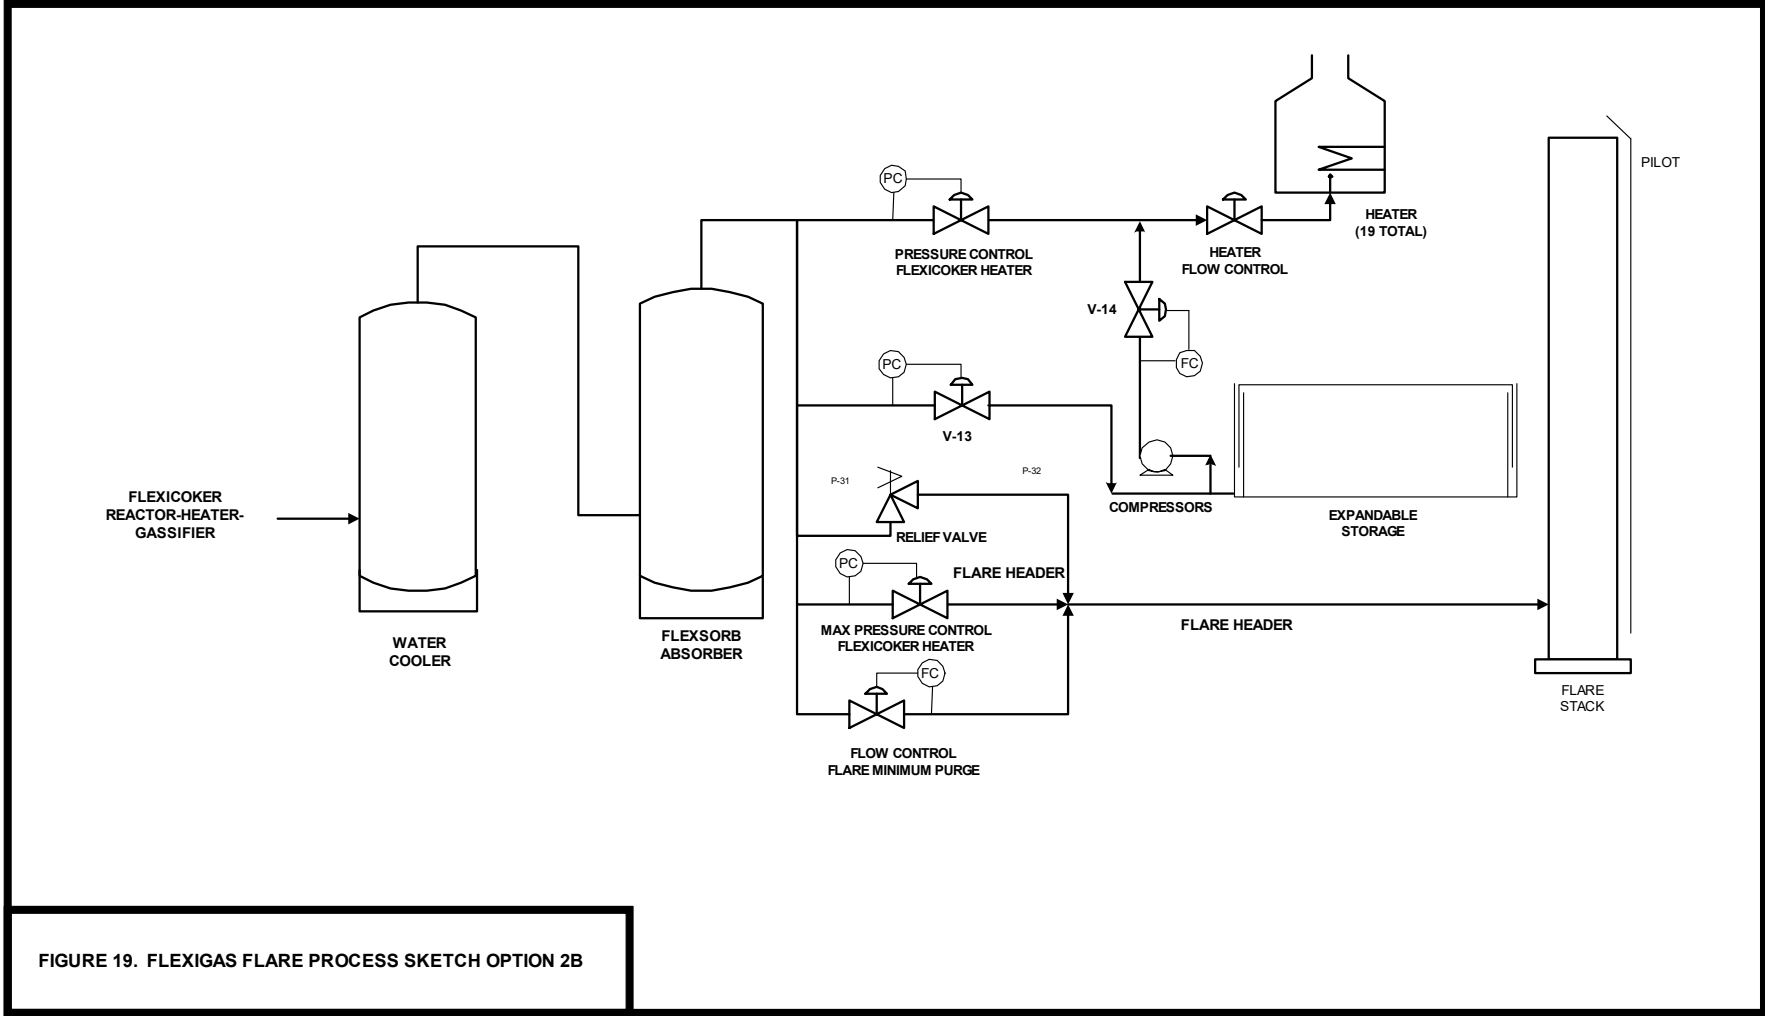
FIGURE 19. FLEXIGAS FLARE PROCESS SKETCH OPTION 2B

Option 2B uses low-pressure expandable gas storage. This option is depicted in Figure 19. This type of storage can be built significantly larger than the pressurized storage used in option 2A, and has the advantage of not requiring compressors in some cases. However, the concentration of carbon monoxide in the gas will likely require use of a water seal to limit leakage, restricting vessel height to a single lift. The requirement for a single lift, combined with low-pressure operation, significantly limits available storage volume²³. In any event, the installed cost is approximately \$21,000,000, providing cost-effectiveness of approximately \$276 Million dollars per ton of NMHC. As was the case for Option 2A, this option is even less cost-effective for reducing flaring than Option 1.
