Revised Annual Update of Flare Minimization Plan - Public
Chevron Richmond Refinery

Flare Minimization Plan

Chevron Products Company - Richmond Refinery

Public Version

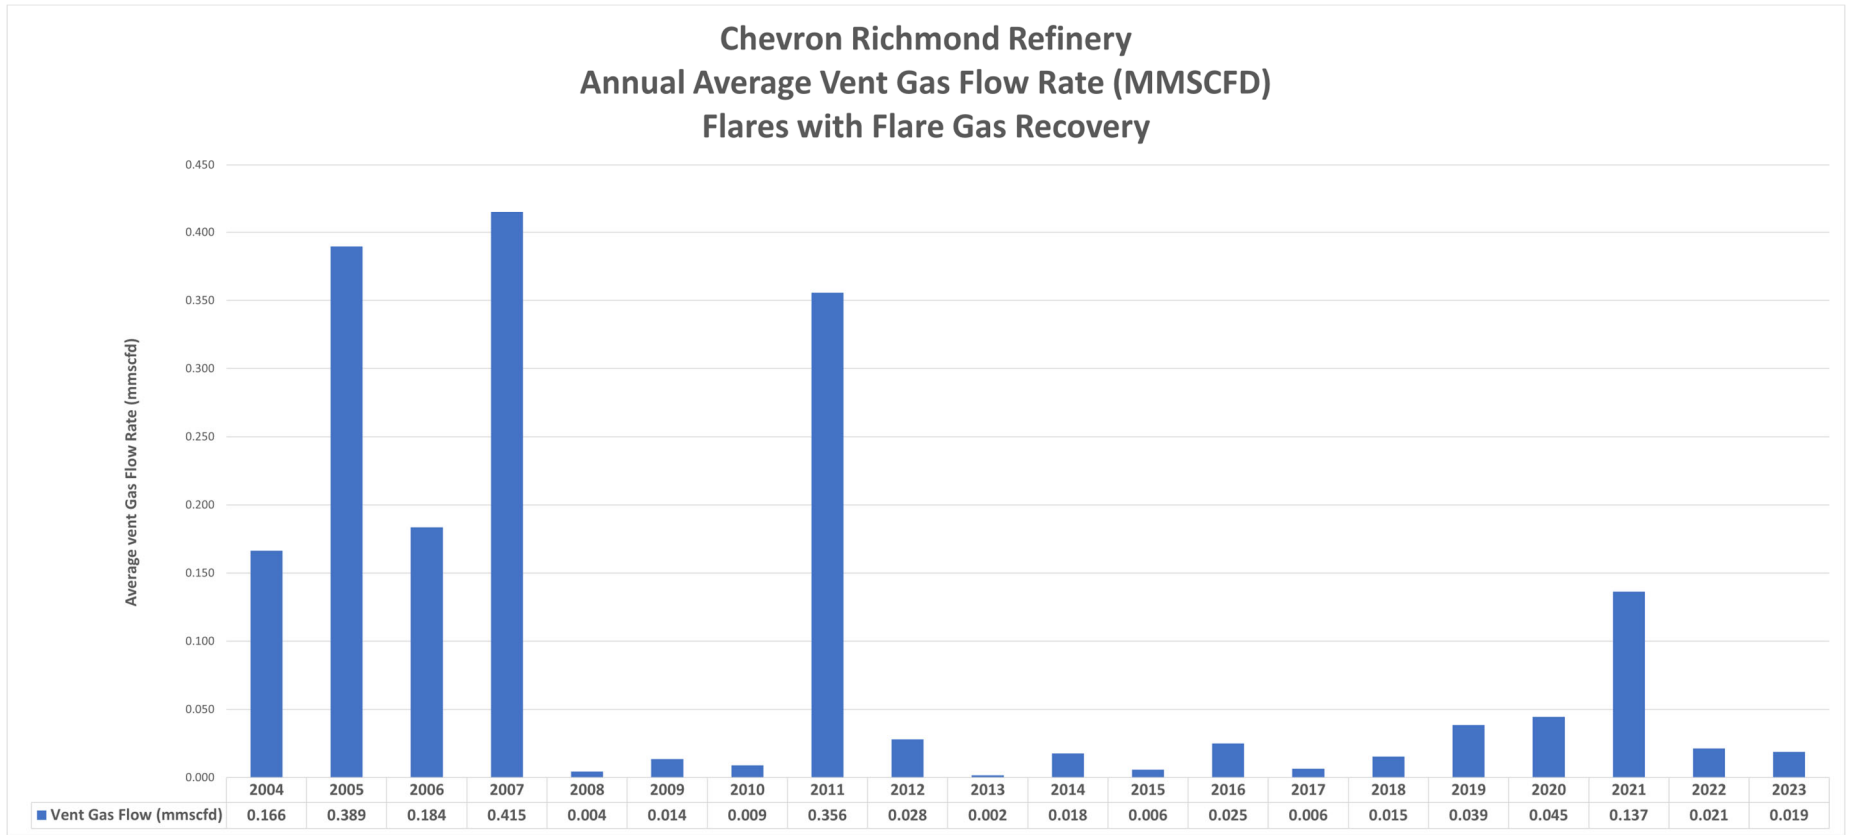
The following graphics demonstrate the reduction in flaring since 2004. The first two graphs display the annual average quantities of vent gas flow. The second two graphs display the annual average methane, non-methane hydrocarbon (NMHC), and sulfur dioxide (SO₂) emissions. Seven of the refinery flares have flare gas recovery and are reported in the same graphic. The Hydrogen Plant Flare does not have flare gas recovery and is designed to flare during scenarios including start-up and shutdown. In addition, the primary gases flared at the Hydrogen Plant differ from the gases flared at the other refinery flares. For these reasons, Hydrogen Plant Flare volumes and emissions are reported in separate graphs.
