Martinez Refining Company

Regulation 12 Rule 12

FLARE MINIMIZATION PLAN

Updated October 1, 2023

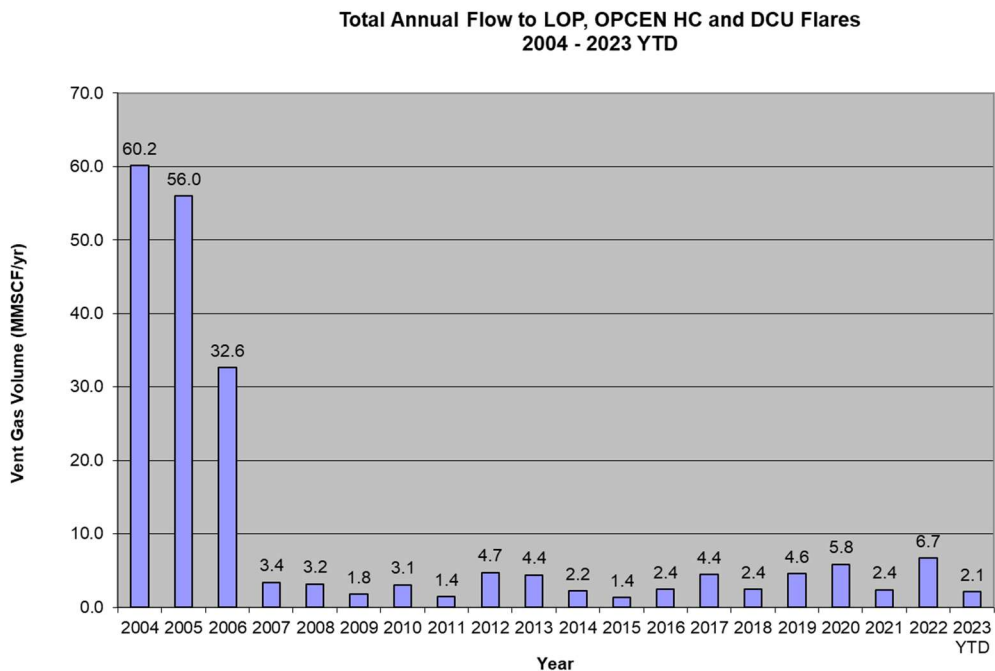
FIGURE ES-1

Figure ES-1 presents the total annual vent gas flow to the Light Oil Processing (LOP), Operations Central Hydrocarbon (OPCEN HC) and Delayed Coking Unit (DCU) Flares at the refinery from 2004 through June 30, 2023. Flare flow continues to be very low.

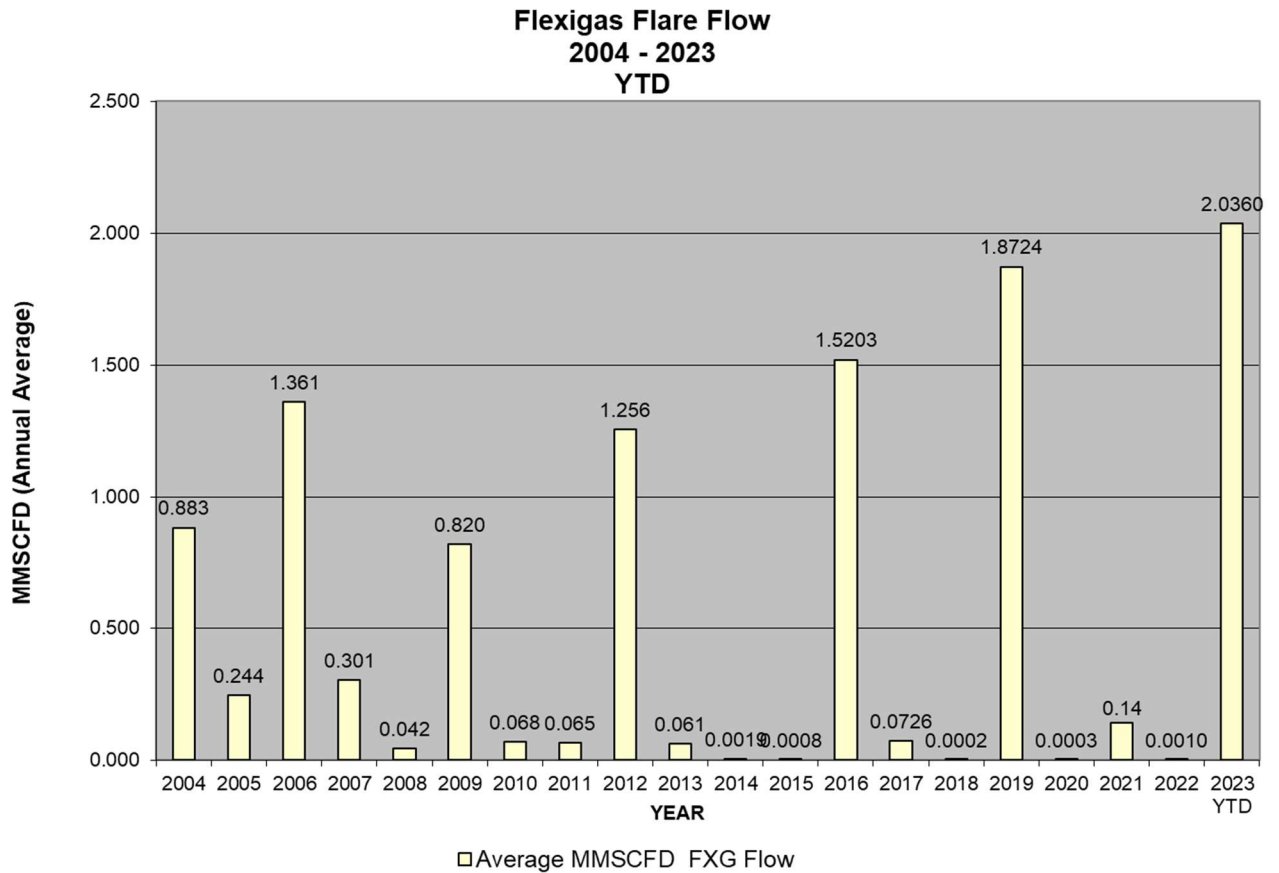
FIGURE ES-2

Figure ES-2 shows the annualized vent gas flow from the Flexigas Flare. This figure shows a cyclic increase in Flexigas flaring which occurs during years with startup and shutdown of the Flexicoker due to the nature of the Flexicoking and Flexsorb processes. The flaring of treated flexigas during startups and shutdowns of the Flexicoker is allowed up to specified limits in MRC's Title V permit. Flexigas is a very low BTU gas used as a supplemental refinery fuel gas in refinery process heaters. Flexigas is treated for sulfur removal in the Flexsorb Unit before being combusted either in refinery process heaters or if necessary, in the Flexigas Flare. When FXG is flared, the volume of gas is typically large compared to the volume flared in the other refinery process flares, but emissions are significantly less because Flexigas contains very low concentrations of non-methane hydrocarbon and sulfur.

Flexigas flaring can also occur due to refinery fuel gas imbalance. MRC continues to fine-tune the Flexigas pressure control scheme to minimize flexigas flaring due to small imbalances in fuel gas. Improvements in this system, most notably addition of COGEN to the pressure control scheme, contribute to the very low flexigas flare flow rate seen in non-turnaround years including 2013, 2014, 2015, 2017, 2018, 2020, 2021, and 2022.

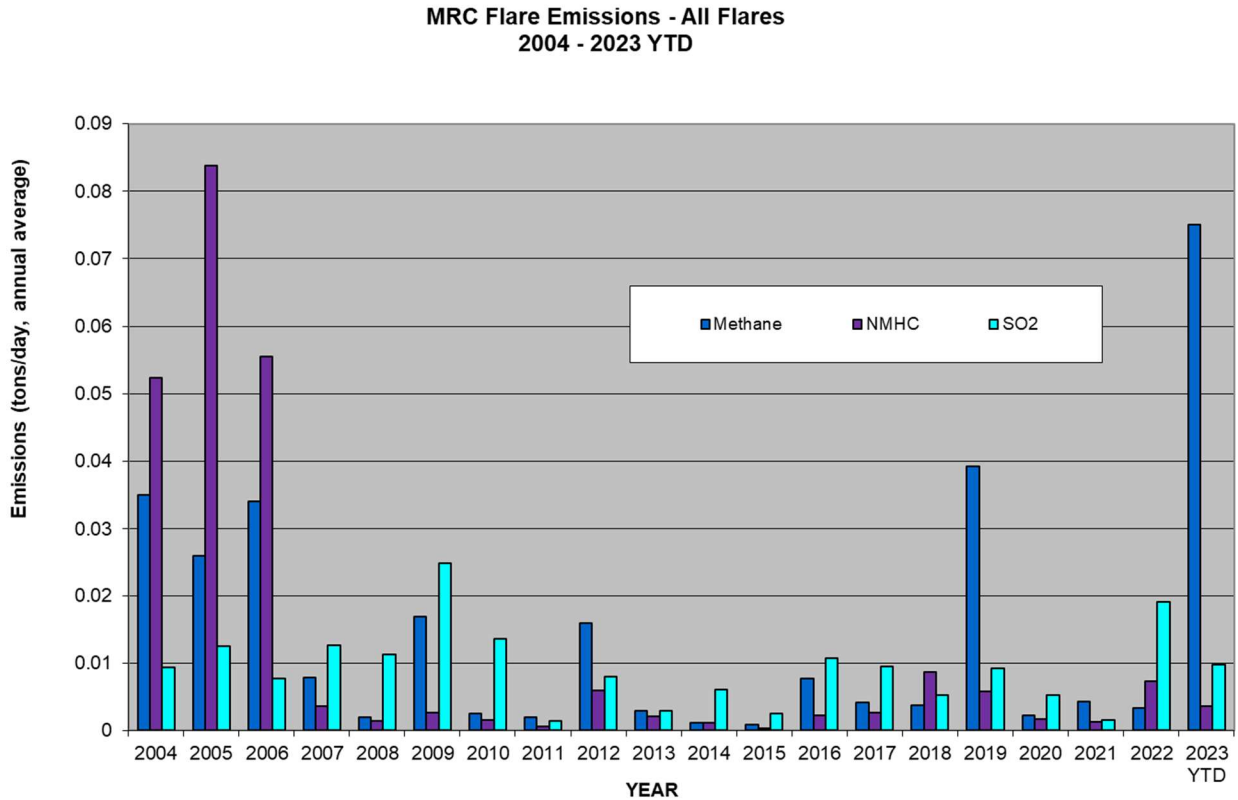
FIGURE ES-3

Figure ES-3 shows the methane, non-methane hydrocarbon, and sulfur dioxide emissions from all four refinery process flares from 2004 through June 30 of this year.

Figure ES-3 shows the overall significant reduction in emissions that has occurred since the implementation of the Flare Minimization Plan in 2006 and highlights that even with large volumes of flexigas flaring during turnaround years, overall emissions from flaring are low.

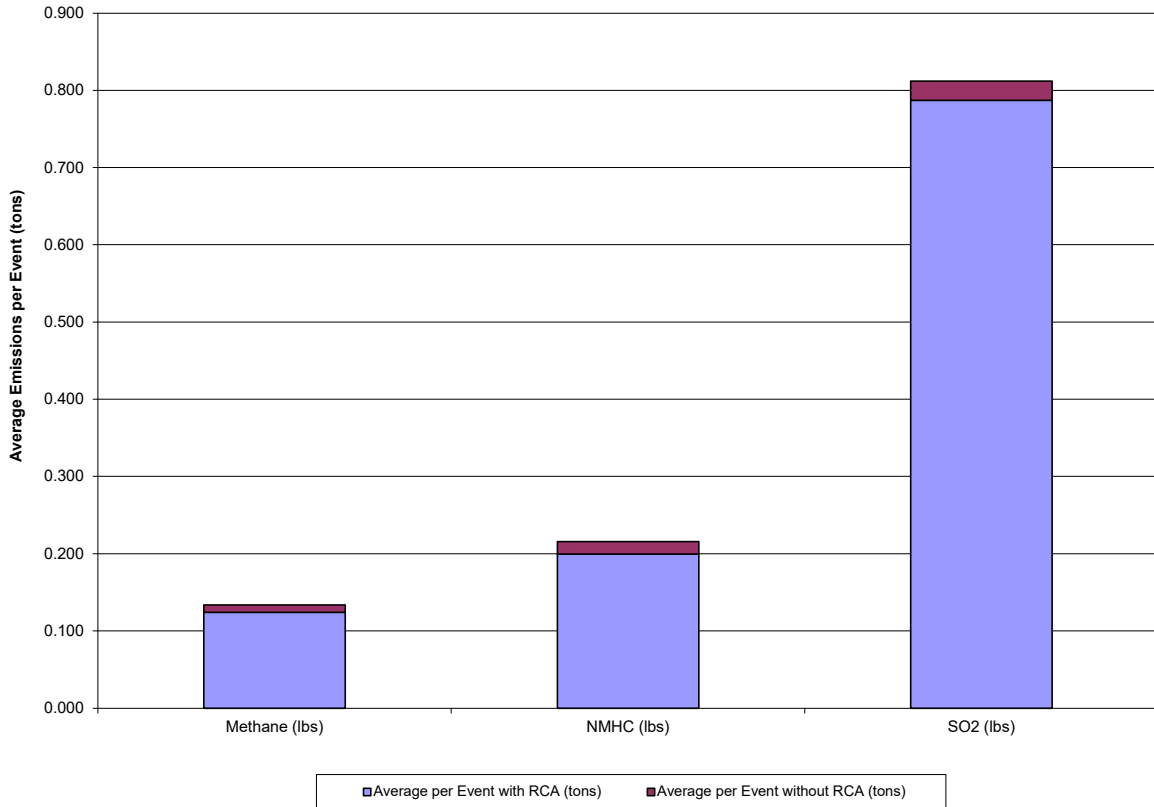
FIGURE 2008 -1

LOP Flare Events w/ Causal Analysis vs. Small Events
1/1/06 - 6/1/08

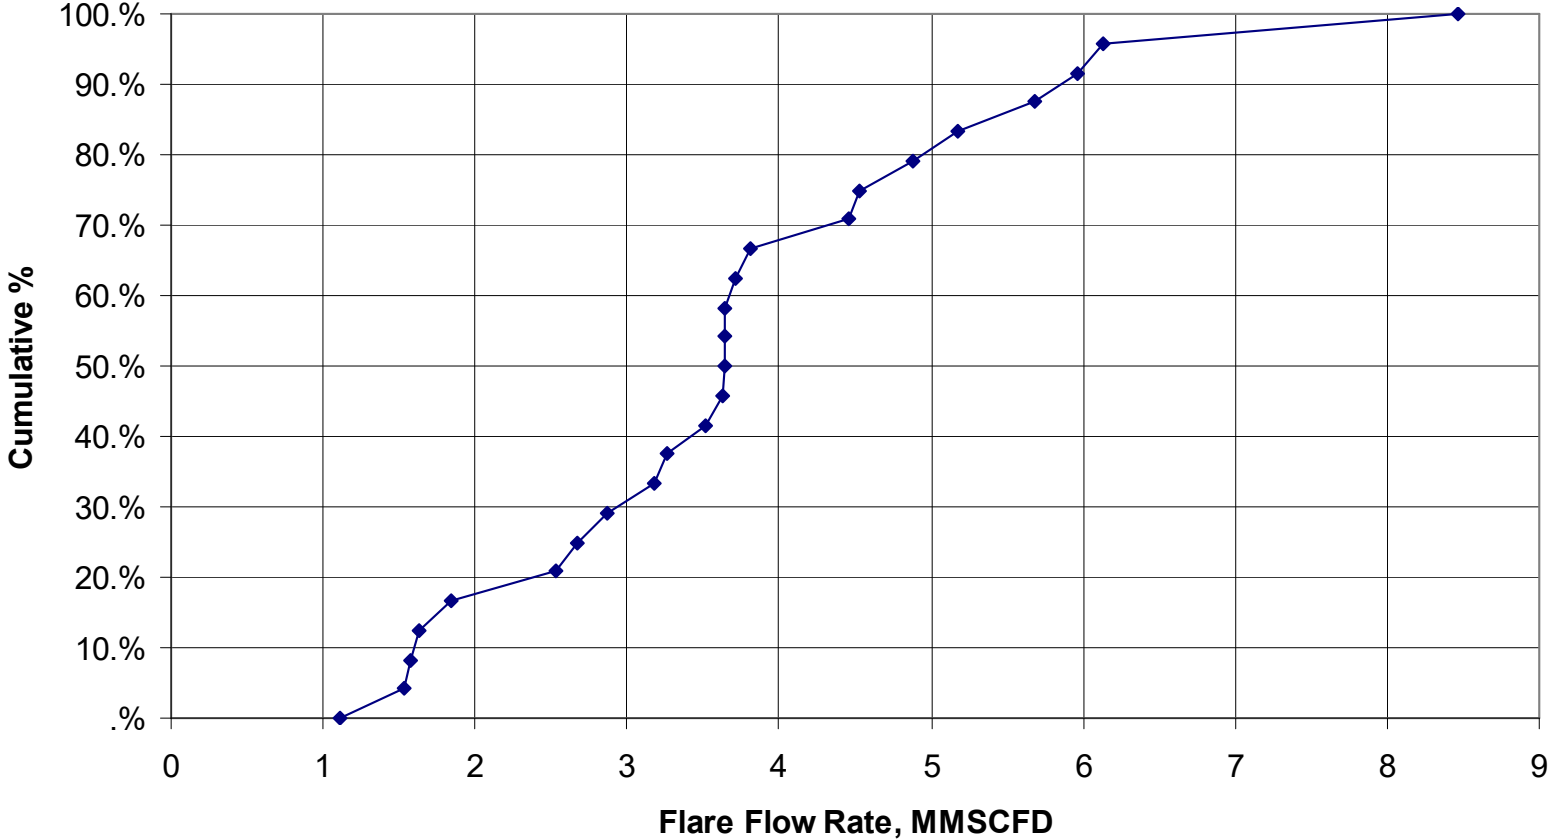
**Figure 4. LOP Flare Gas Flow Rates
(2005)**

Figure 4 depicts the average rates of flow to the flare for events occurring in 2005. These data indicate that approximately 30% of the flare events had event-average flow rates of less than 3 million standard cubic feet per day. Actual instantaneous rates are generally higher – often significantly – than these average rates. This difference between the average rate for an event and instantaneous flare gas rate during an event is important because once the instantaneous rate exceeds the available compressor capacity the water seal is typically broken and flaring occurs. Once flaring begins, backpressure in the flare header provided by the water seal is significantly reduced. Due to the lower header pressure, flare gas recovery rates are typically significantly reduced from their rated capacity.

Data from Figure 4 were used to evaluate the leverage provided by additional flare gas recovery in LOP. As each increment of compressor capacity was added, the corresponding events with average flows within the newly revised total capacity were considered to be recovered rather than flared. Similarly, the reported emissions for these events were presumed not to occur. This provided the basis for emissions reductions as a function of compressor capacity.

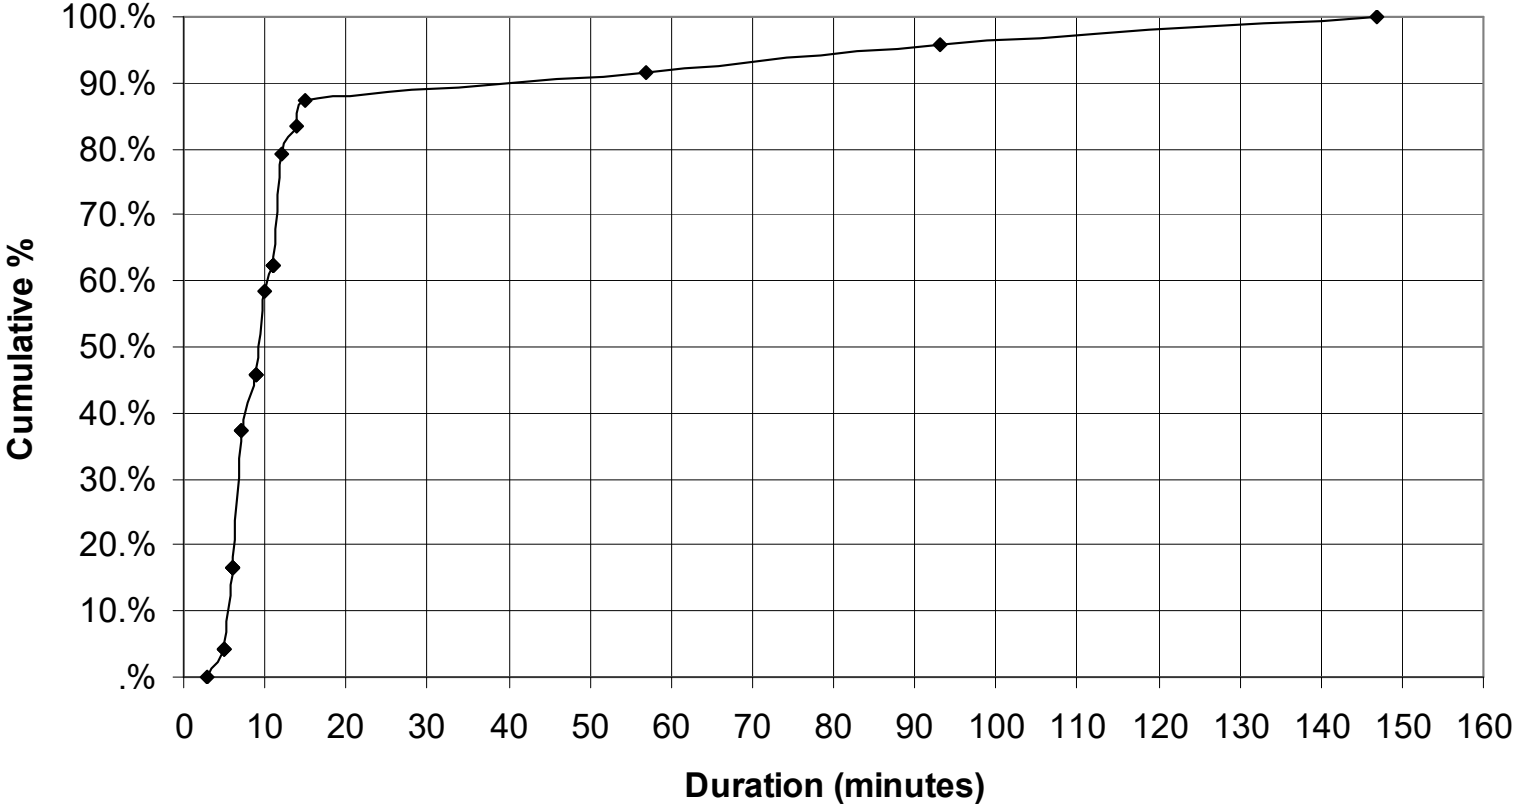
Figure 5. LOP Flare Durations
(2005 - 25 Events)

Figure 5 depicts the distribution of flare event durations for 2005, the year for which these data are available. Most flare events have very short durations with small volumes of gas flared. From

An additional consideration is that the brief duration of many flare events makes it more difficult to determine their cause. Often excess flow to the flare gas header has stopped before significant troubleshooting activity can be undertaken to determine its source.

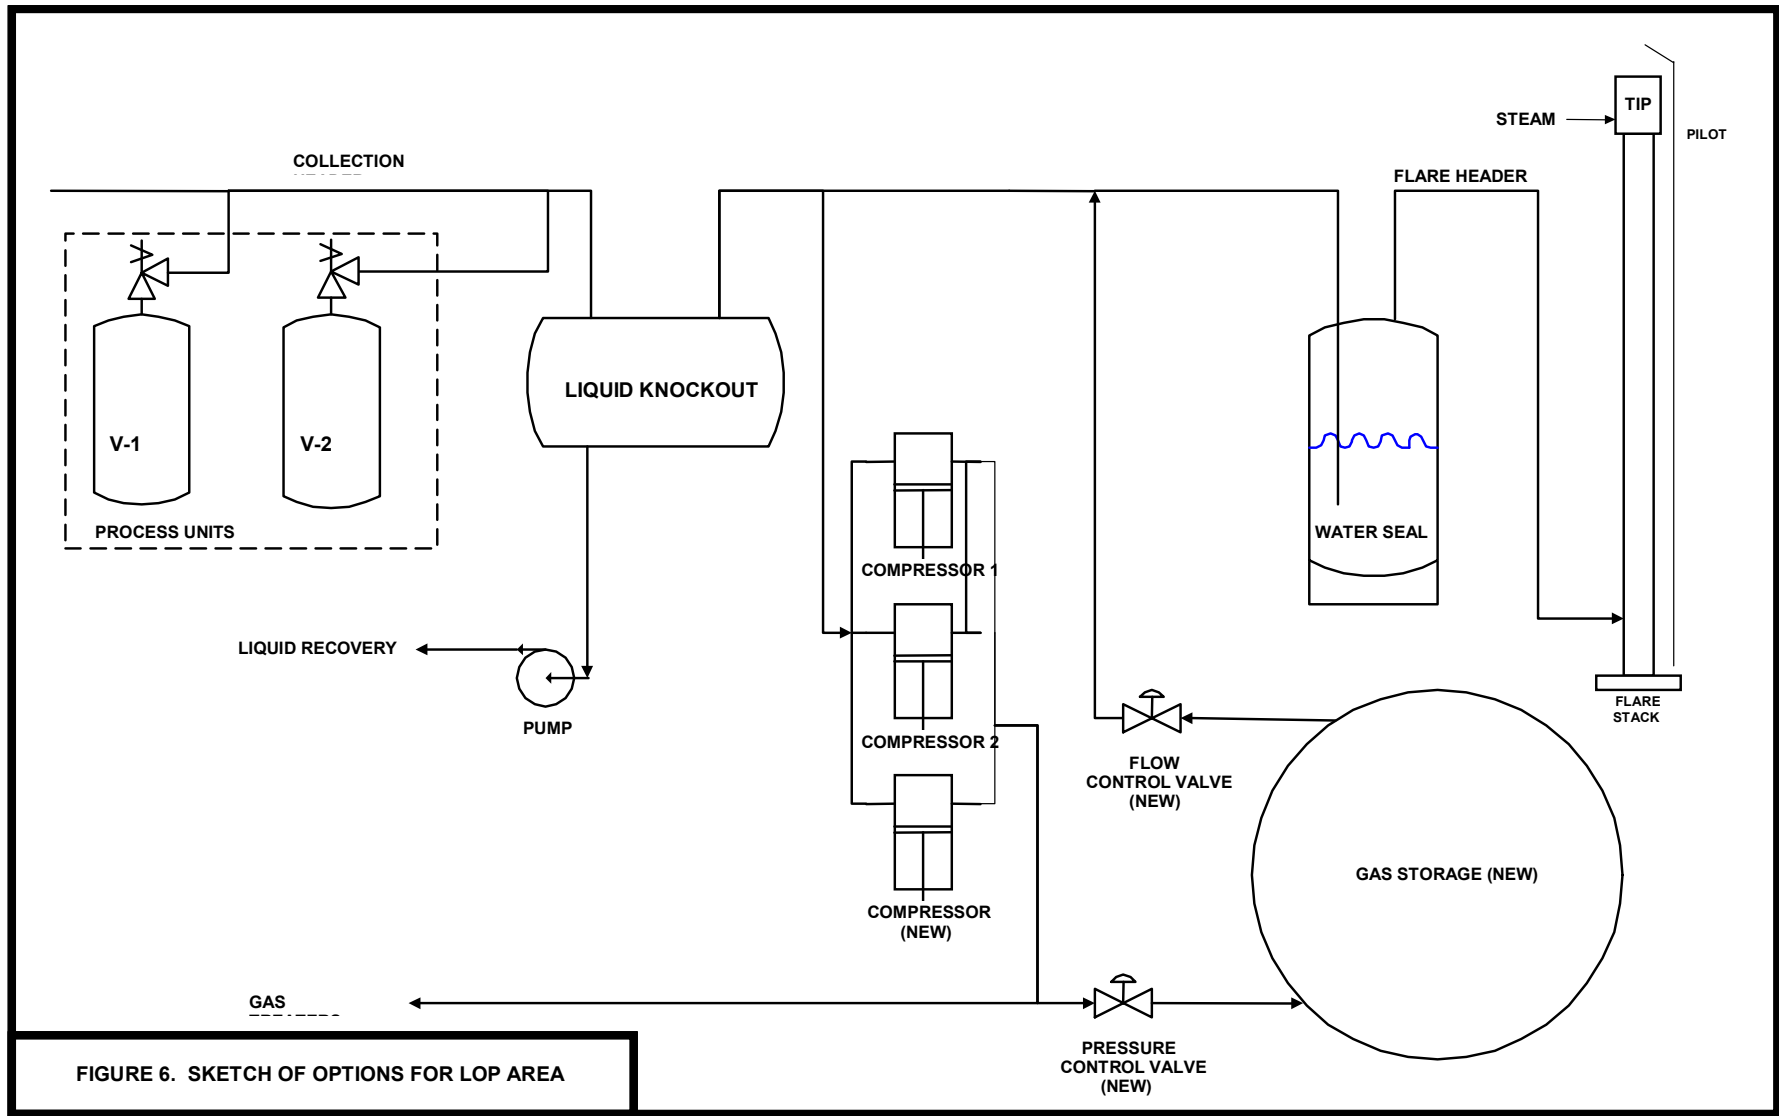
FIGURE 6. SKETCH OF OPTIONS FOR LOP AREA

Prevention Measure Options Considered for Recovery, Storage and Treatment: Costs and potential benefits of improving gas recovery and reducing flare emissions from the current 99.7% recovery efficiency are addressed by considering the addition of flare gas recovery compression and flare gas storage. Gas treating capacity is expected to be adequate for all options evaluated. A sketch of the potential options is provided in Figure 6.

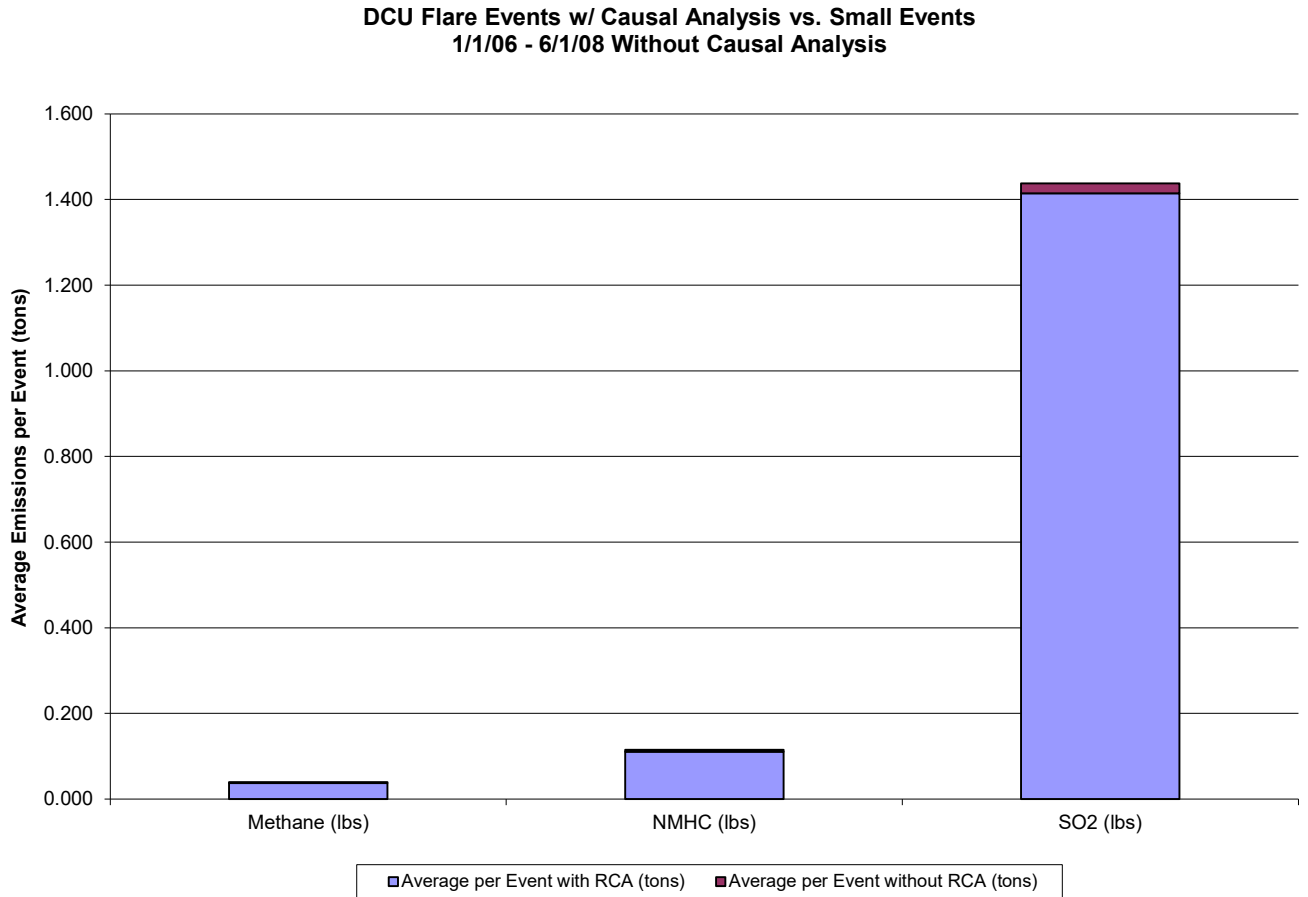
FIGURE 2008-2

Beginning in November 2006 with the adoption of the Flare Procedures described in the Common Measures Section, pertinent information, when available, was captured immediately after a flaring event to determine the cause of any flaring and what could be done to prevent it from happening again. Total emissions from all flaring during this 30-month period were: 0.17 tons of methane, 0.45 tons of non-methane hydrocarbon and 4.19 tons of SO₂. Figure 2008-2 presents a comparison of the average emissions per large reportable events over this time period vs. the average emissions per small event for the DCU Flare. This figure shows that small events contributed < 6% of the emissions of a large event. Figure 2008-2 reinforces the appropriateness of the causal analysis trigger of 0.5 MMSCF/ 500 lbs SO₂ to ensure the resources to conduct a Causal Analysis are most effectively applied to address high emission events.

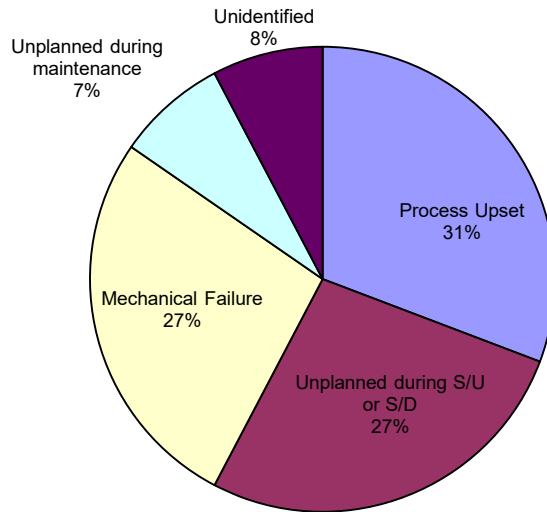
FIGURE 2008 - 3

The DCU flare events that occurred from 1/1/06 – 6/1/08 were categorized by probable cause in Figure 2008-3. None of the flaring was planned. Most of the events were < 10 minutes long. The majority of the events were caused by process upset, mechanical failure or were unplanned during startup and shutdowns.

**Probable Cause of Flaring on DCU Flare 1/1/06-6/1/08
26 Events**

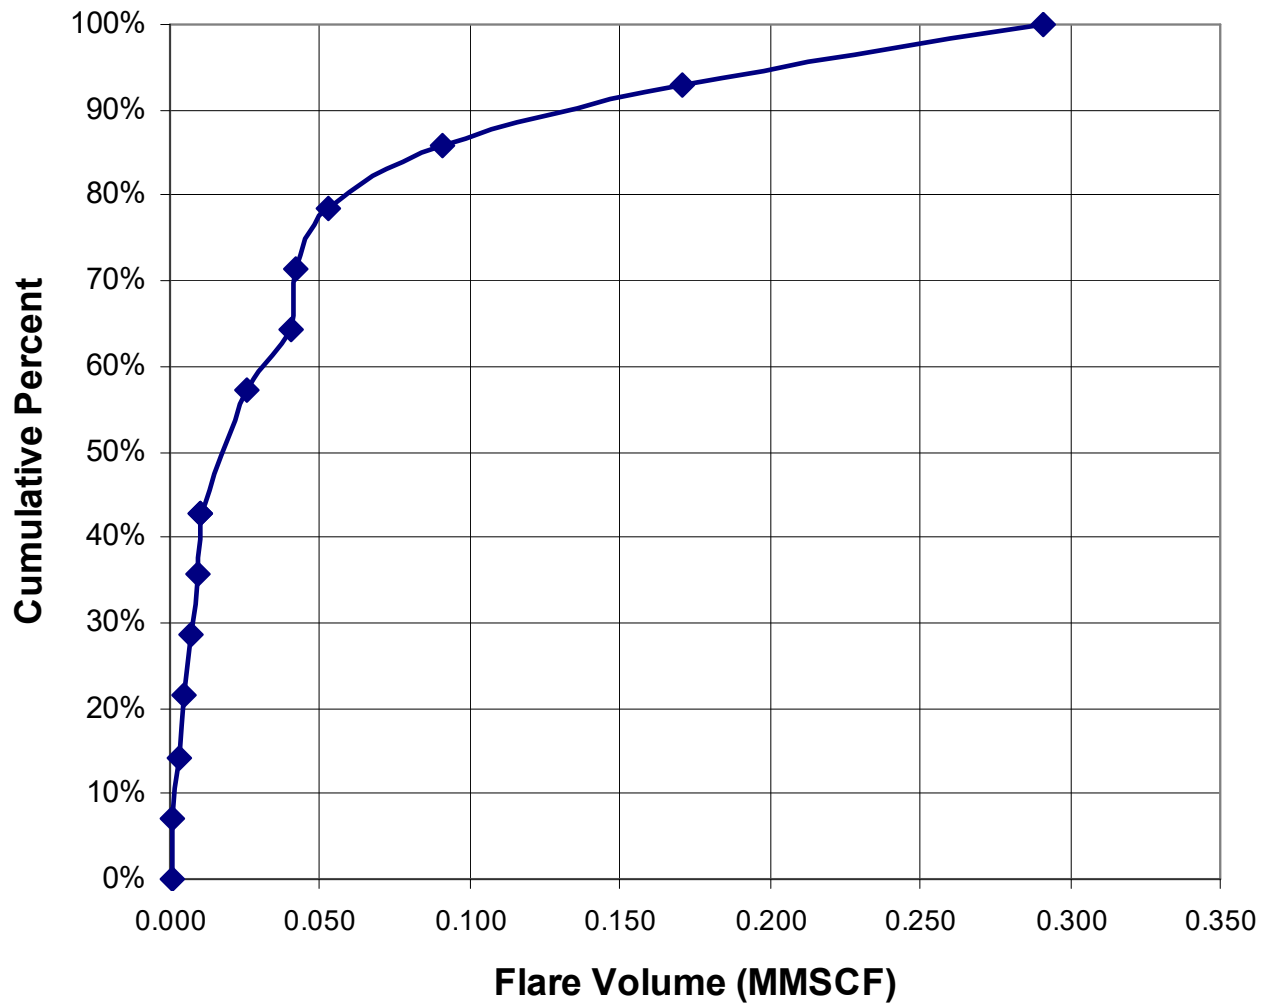
**Figure 9. Delayed Coking Area Flare Gas Volumes
(2005)**

Figure 9 depicts the amount of material flared during the reported incidents of flare activity in 2005. All flaring was below 500,000 scf. Approximately 70% of the incidents of reported flaring involved volumes of gas of 50,000 SCF or less. All were below 300,000 standard cubic feet.

Flaring during 2005. The highest quality data are available for the period from January 2005 to January 2006. Data is available during this period from flare flow meters and monthly BAAQMD flare reporting. Available data for flare event volumes and durations are provided in Figures 9 through 11 below.

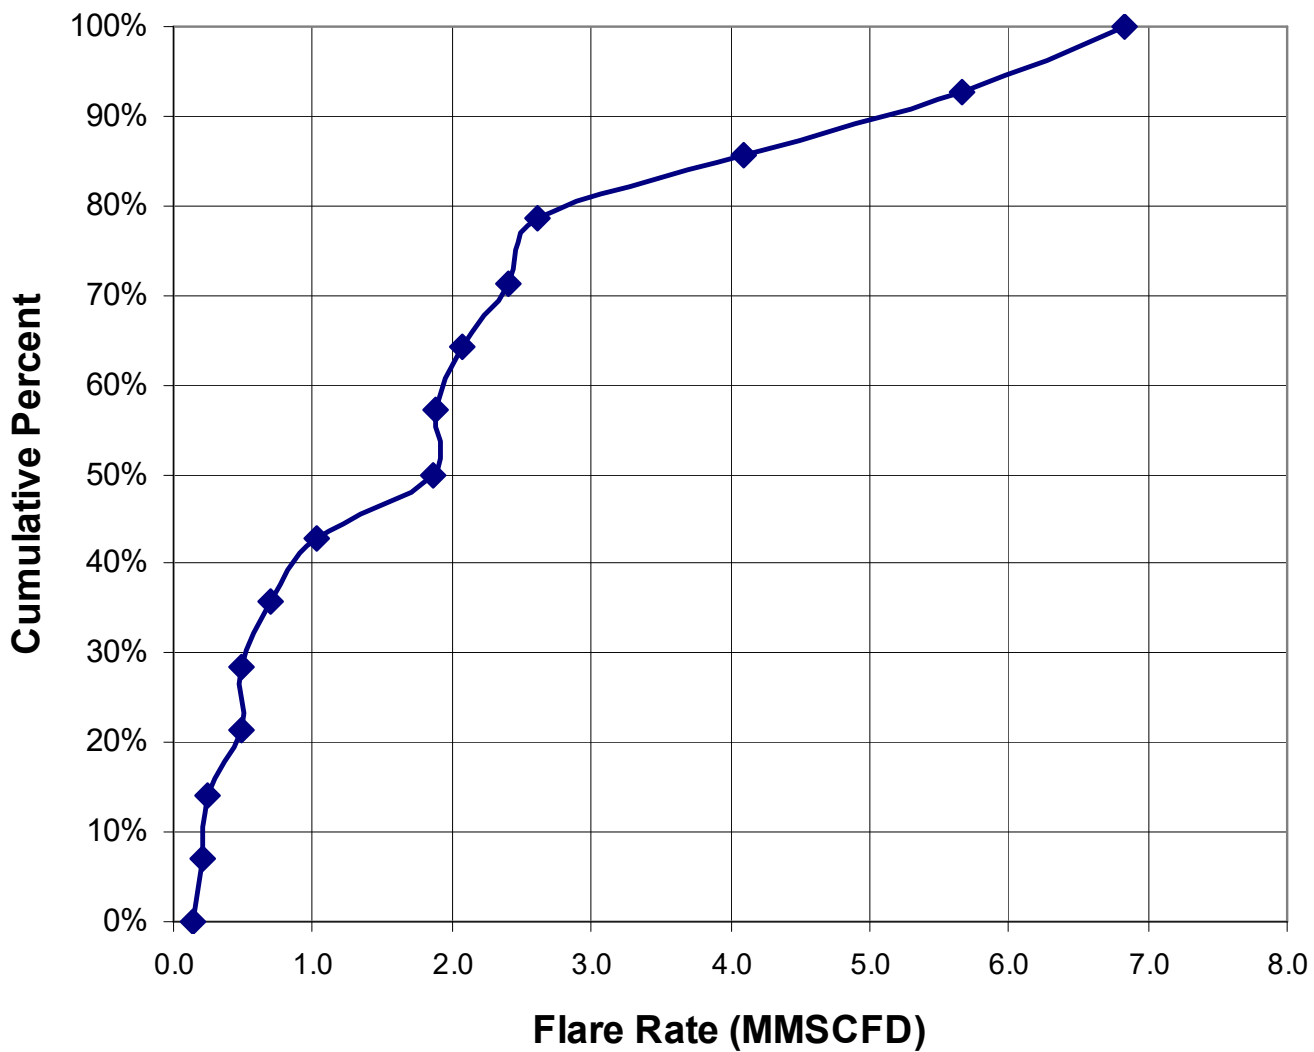
**Figure 10. Delayed Coking Area Flare Gas Flow Rates
(2005)**

Figure 10 depicts the average rates of flow to the flare for events occurring in 2005. These data indicate that approximately 80% of the flare events had event-average flow rates less than 3 million standard cubic feet per day. Actual instantaneous rates comprising the average are generally higher – often significantly – than these average rates.

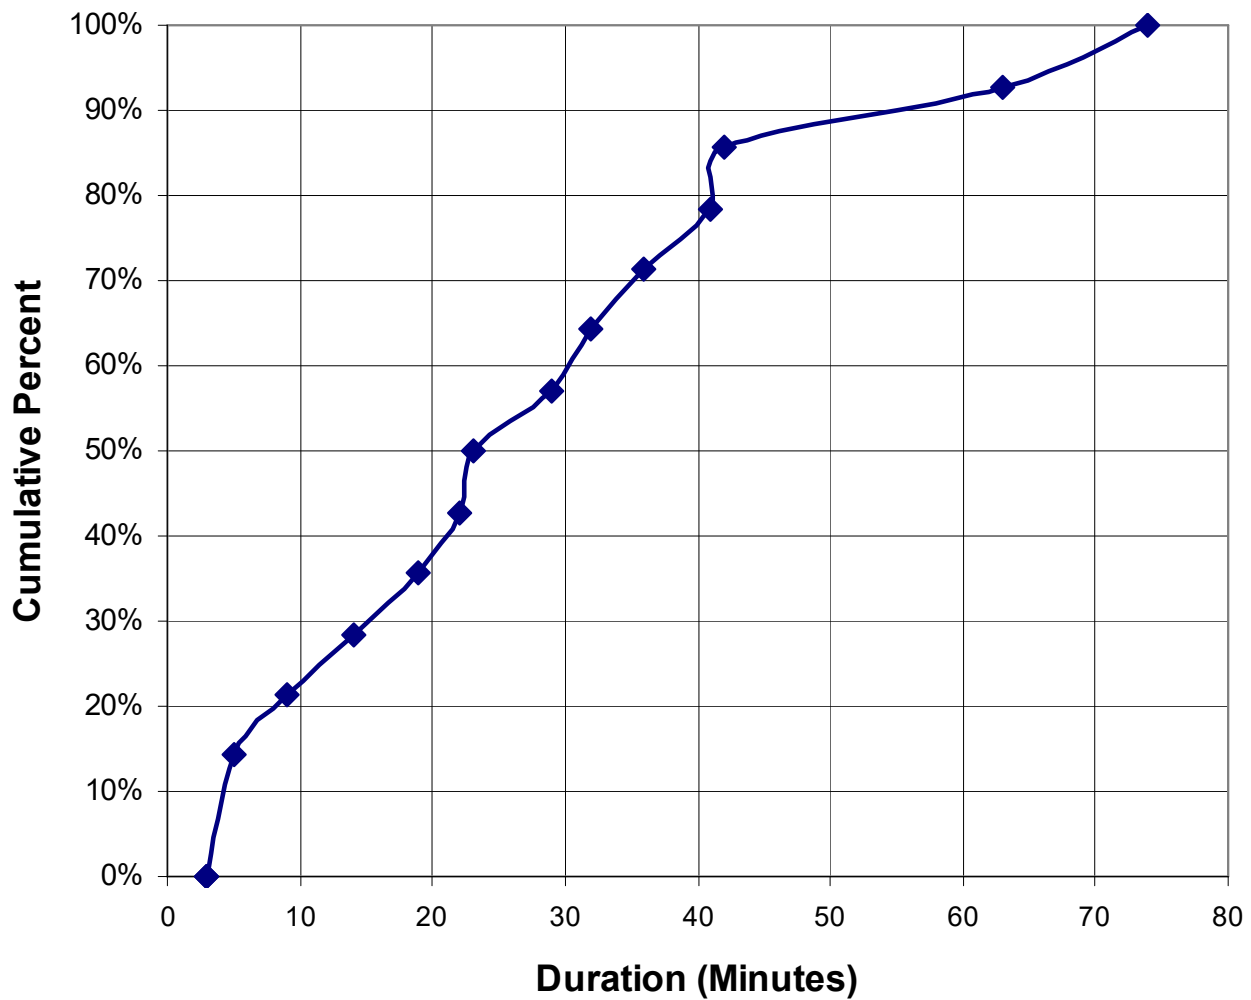
**Figure 11. Delayed Coking Area Flare Event Durations
(2005)**

Figure 11 depicts the distribution of flare event durations for 2005 where these data are available. 50% of the events lasted less than 30 minutes. This is consistent with other data characterizing the bulk of flare events being very brief.

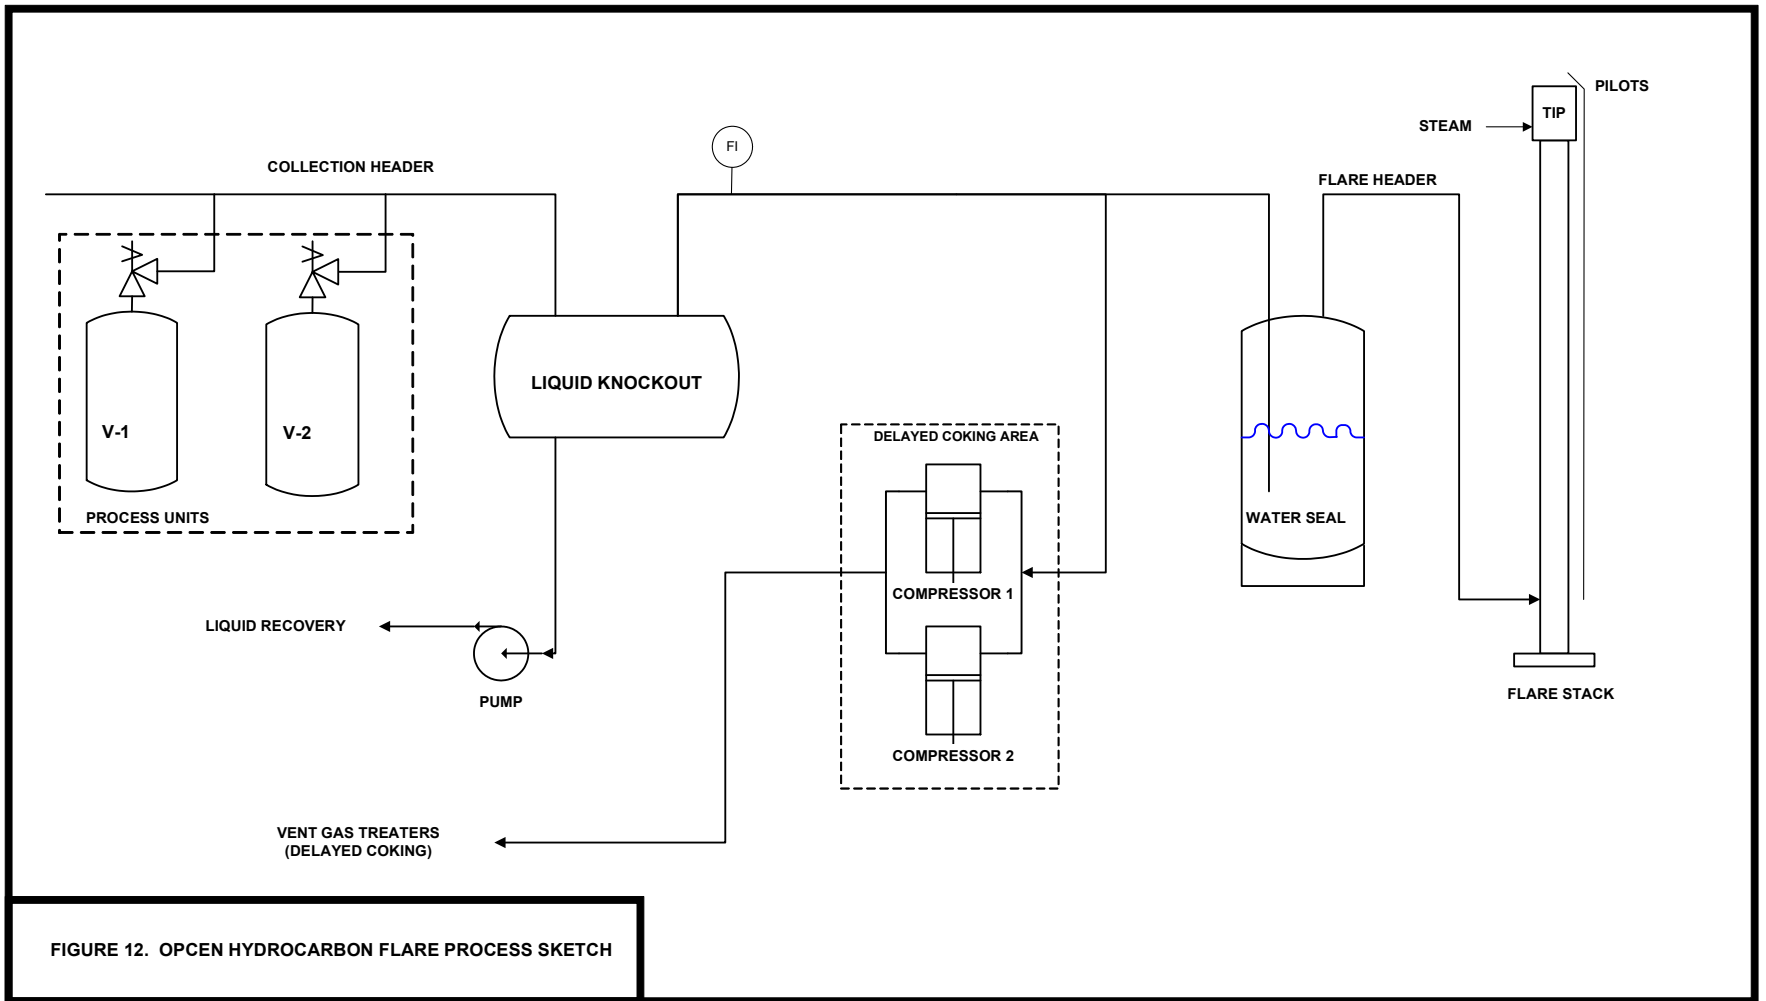
FIGURE 12. OPCEN HYDROCARBON FLARE PROCESS SKETCH

Process units in the OPCEN area are served by a dedicated flare system. This flare was modified by a project to provide flare vapor recovery. The vapor recovery project was operational in November 2006. A sketch of the flare system is provided in Figure 12. The OPCEN HC flare system is comprised of collection headers, a liquid knockout vessel, a water seal vessel, piping to flare gas recovery compressors and gas treating, the flare header proper, and the flare¹⁶. Additional details of the flare are provided in Appendix C.

Recovered gas from OPCEN is treated to remove H₂S and routed to fuel and hydrogen plant feed along with the recovered gas from Delayed Coking. The normal routing for Delayed Coker Area recovered flare gas is the Vent Gas Treater. Sufficient capacity is available for the incremental flow (up to the total recovery compressor capacity of about 8 MMSCFD).

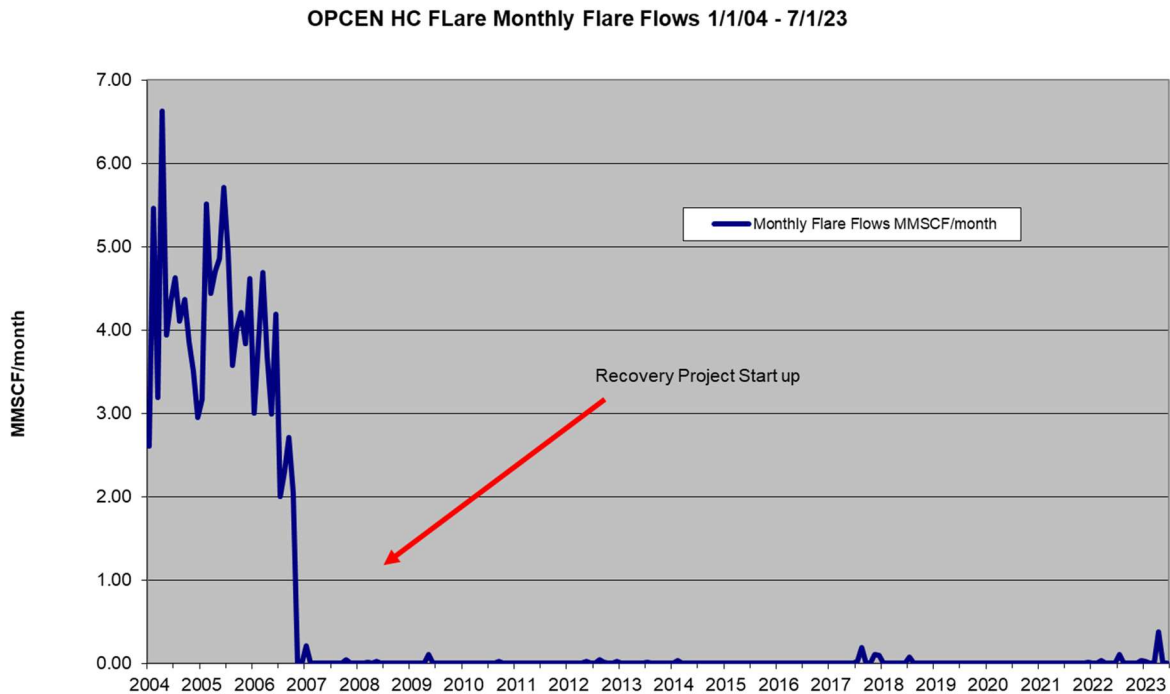
The figure below has been updated through 6/30/23 and shows the continued success of the implementation of the flare recovery project that occurred in 2006 for this flare.

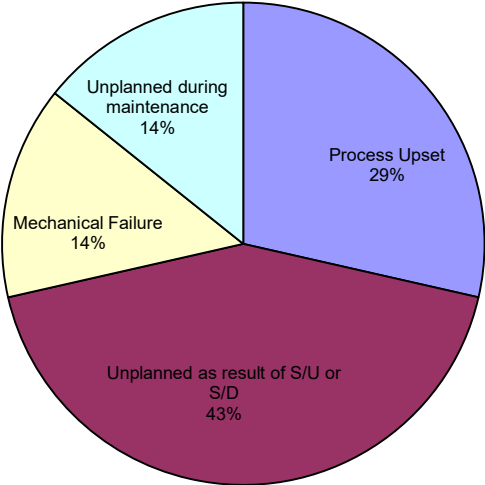
FIGURE 2008-4

The OPCEN HC flare events that occurred after the implementation of flare recovery from 11/1/06 – 6/1/08 were categorized by probable cause in Figure 2008-4. None of the flaring was planned. The cause of the events included process upset, mechanical failure or were unplanned during maintenance or startup and shutdown.

OPCEN HC Flare- Cause of Flaring 11/1/06 - 6/1/08
7 Events

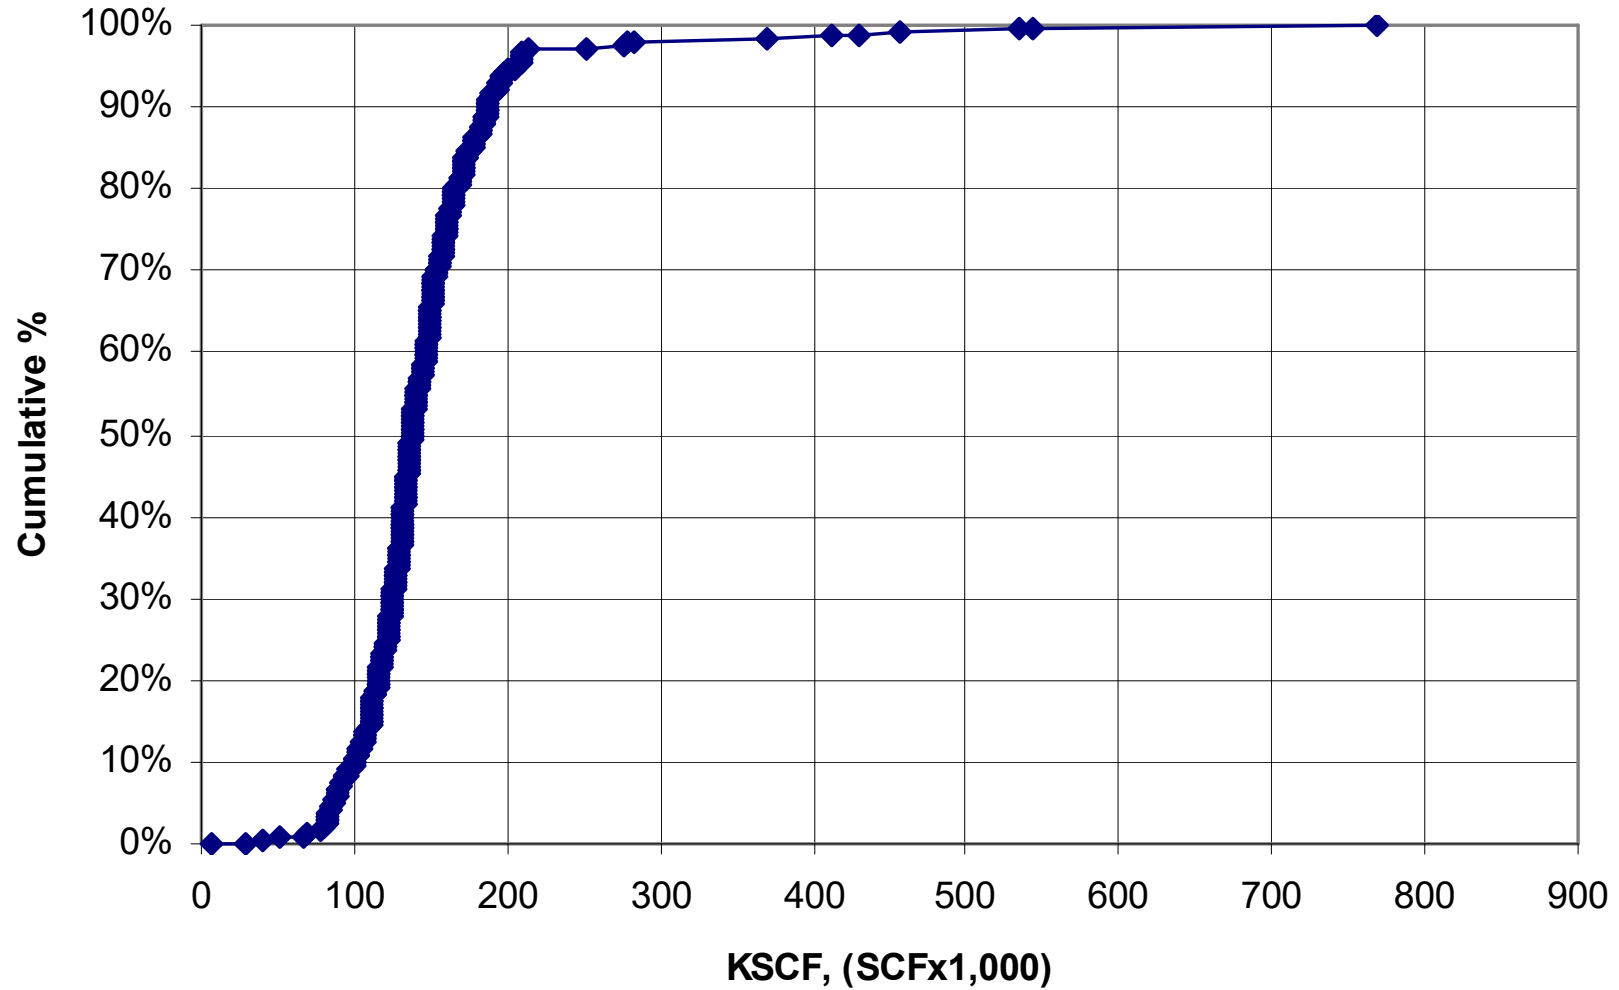
**Figure 13. OPCEN Hydrocarbon Flare Gas Volumes
(2005)**

With historical performance profoundly biased by absence of flare gas recovery, this review concentrated on calendar year 2005. Flare data are depicted in Figure 13. Total emissions of non-methane hydrocarbon during 2005 were approximately 30 tons. Emissions of SO₂ in 2005 were 0.3 tons.

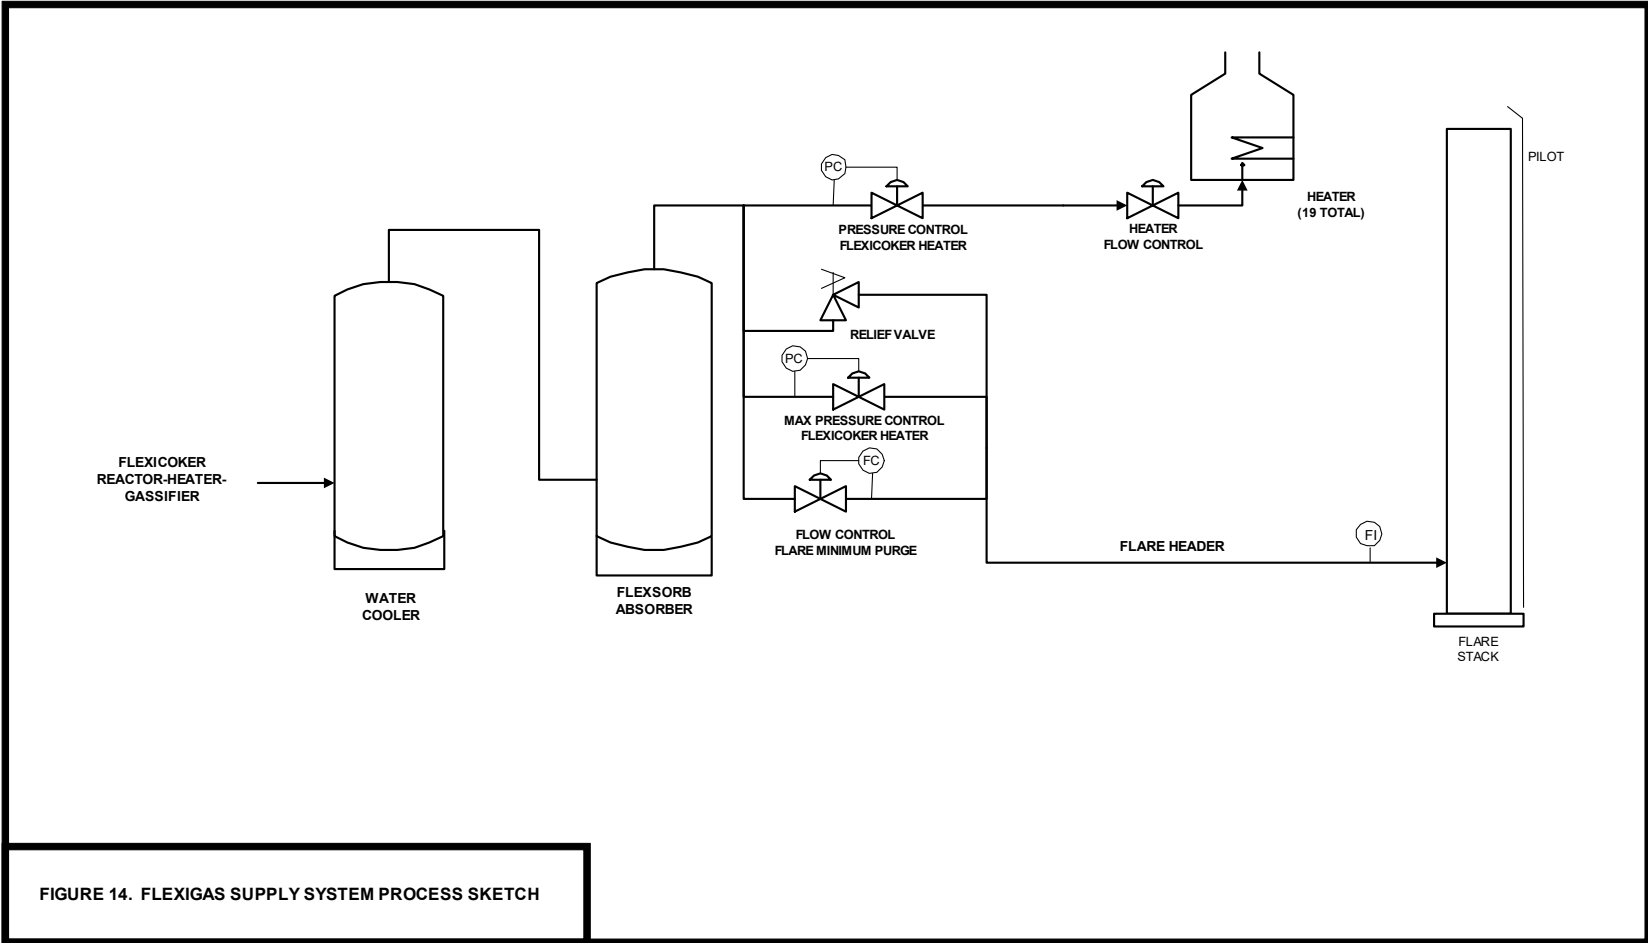
FIGURE 14. FLEXIGAS SUPPLY SYSTEM PROCESS SKETCH

The OPCEN Flexigas flare is a dedicated flare serving the Flexicoker Reactor/Heater/Gasifier. The Flexigas flare only combusts flexigas (FXG). This flare differs significantly from all other process flares serving Bay Area refineries for reasons described below. A simplified process sketch is provided in Figure 14. Details of the system are provided in Appendix D.
