Martinez Refining Company

Regulation 12 Rule 12

FLARE MINIMIZATION PLAN

Updated October 1, 2023

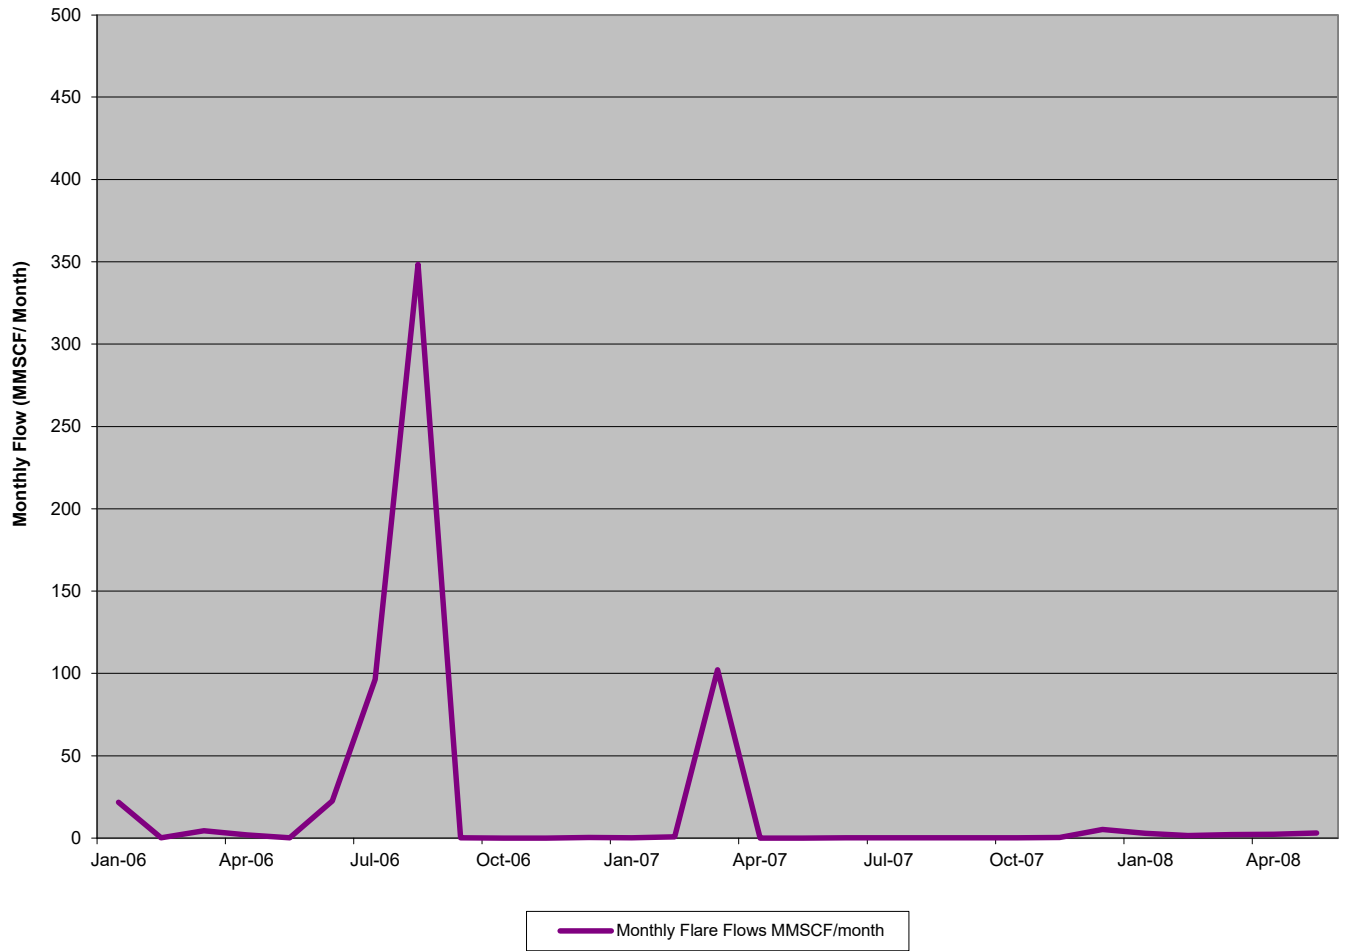
FIGURE 2008-5

Flexigas flare activity since 1/1/06 was reviewed for potential reduction opportunities. Figure 2008-5 shows the FXG flare flows over this time period. There were 11 events that required Causal Analysis. All of these flaring events were investigated and prevention measures identified and implemented (see Part 3 of this Section – Reductions Previously Realized). The results of the investigations into these events were reported to the District in Causal Analysis reports.

FXG Flare Flows 1/1/06 - 6/1/08

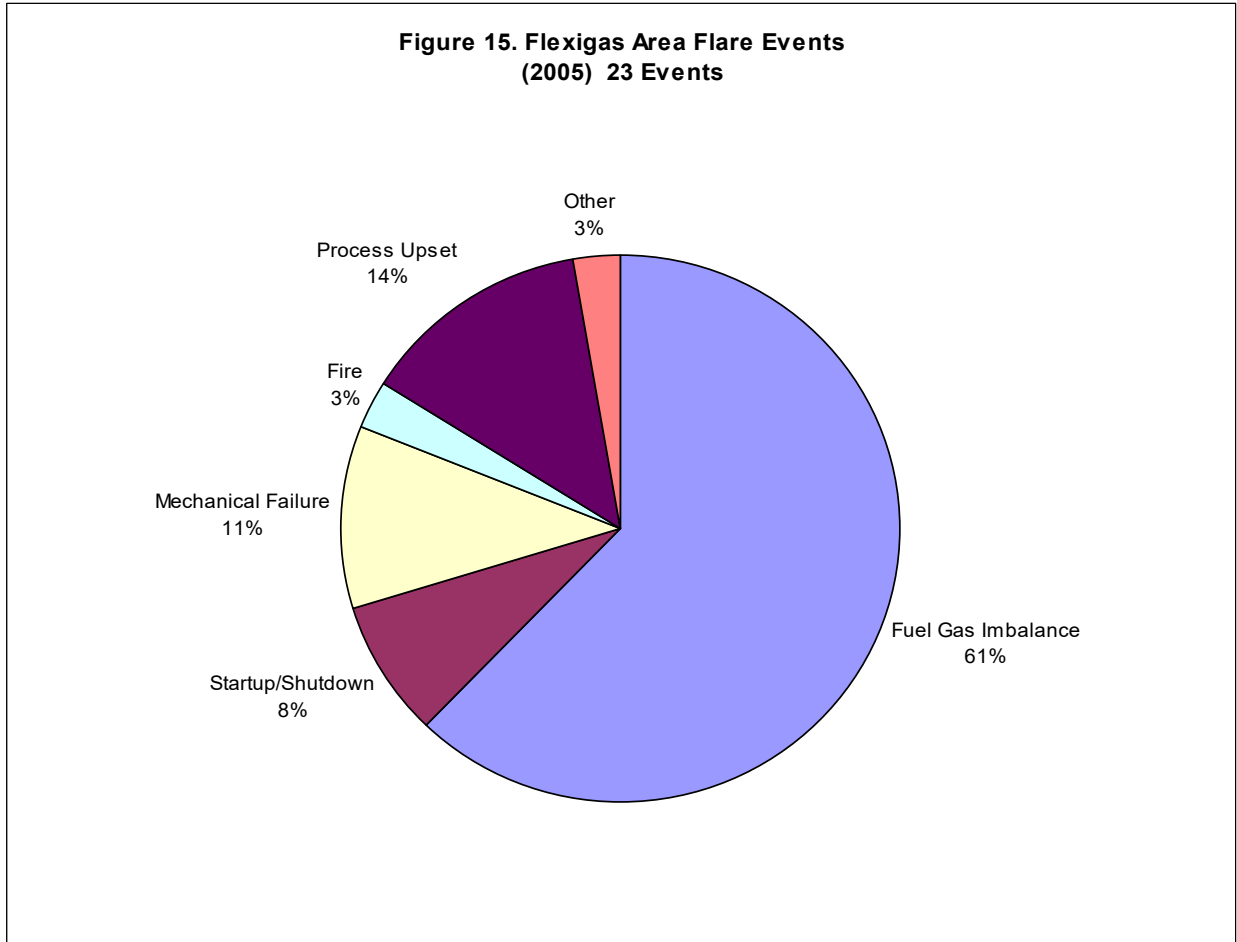
Historical flaring at the OPCEN Flexigas flare was reviewed to identify opportunities for potential mitigation. The highest quality data are available for the period from December 2003, to January 2006. This coincides with installation of the flare flow meter and BAAQMD flare reporting. Data for 2005 are plotted in Figure 15 and Figure 16.

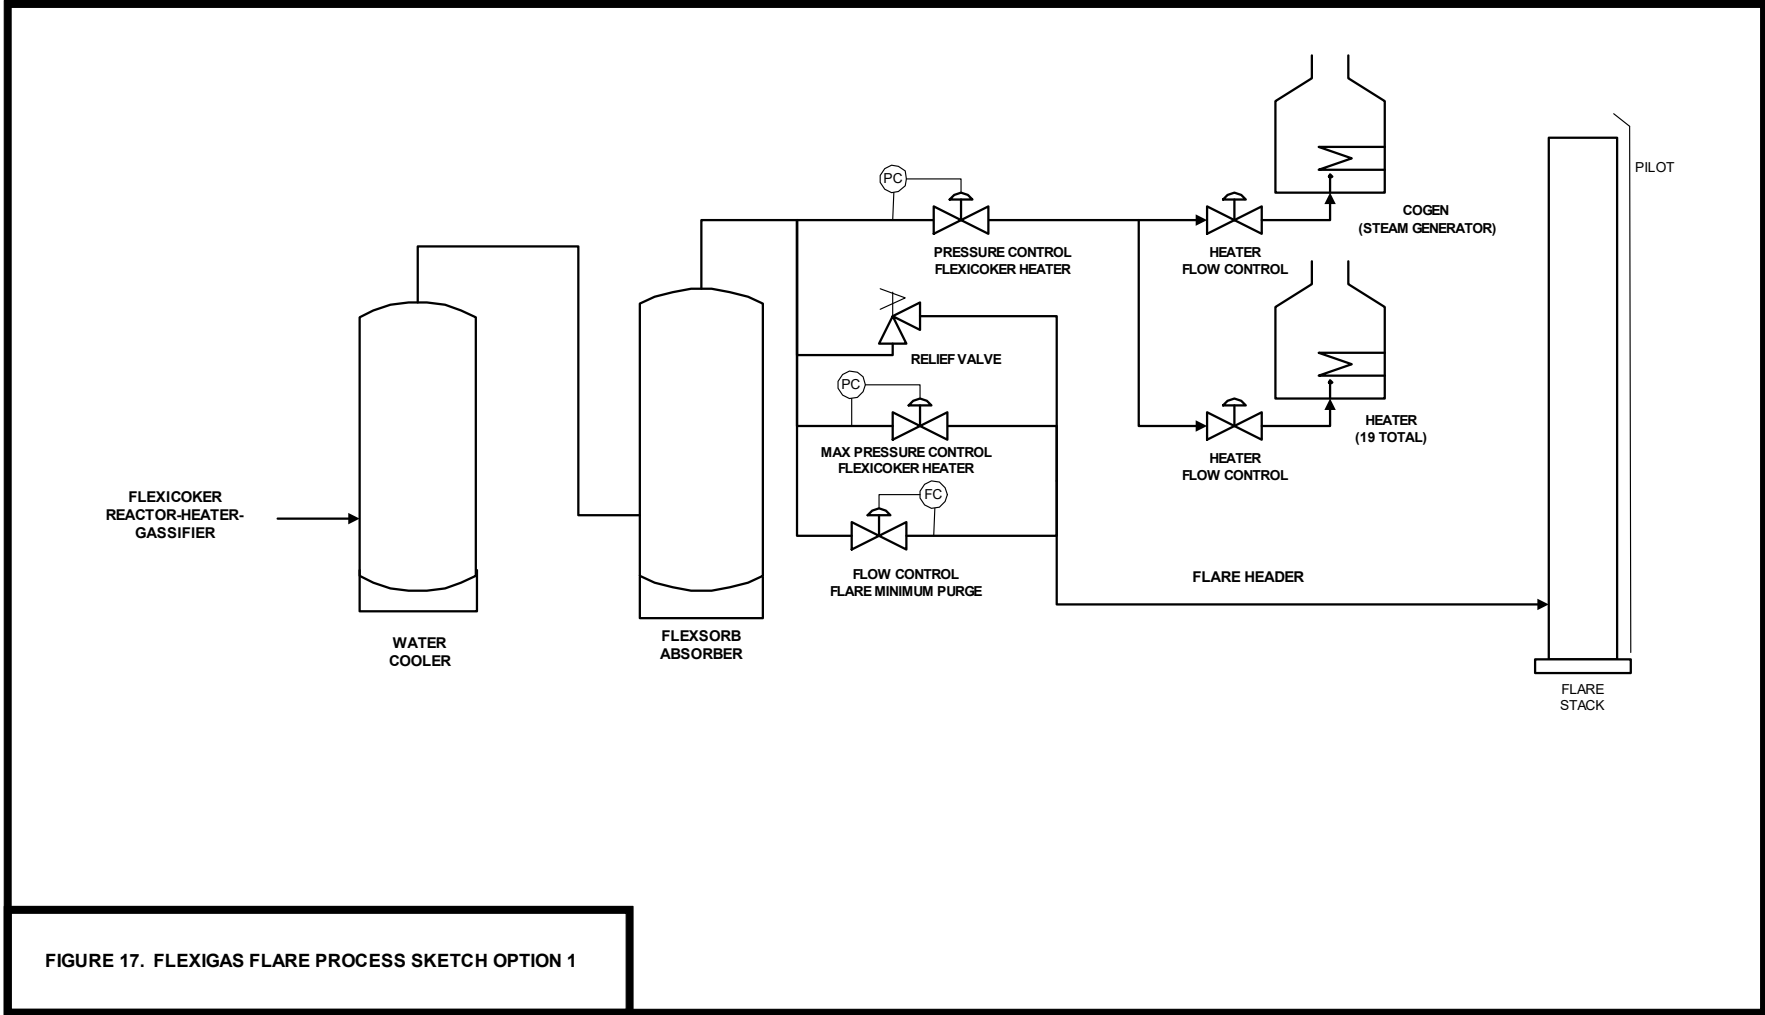
FIGURE 17. FLEXIGAS FLARE PROCESS SKETCH OPTION 1

OPTION 1: PROVIDE ADDITIONAL FLEXIGAS CONSUMERS (see Figure 17).

The objective of this project would be to provide an additional consumer that can rapidly pick up the Flexigas volumes made available by loss of another consumer (e.g., process heater) for any reason. Because excess Flexigas is available less than 10% of the time (based on the percent of days on which flaring occurred from Figure 16), and the current fuel system is roughly in balance, this consumer must essentially remain in hot standby until needed. This means it must be waiting to burn between 1 MMSCFD and 40 MMSCFD Flexigas when an existing consumer unexpectedly comes off line.

Assuming this eliminates all Flexigas flaring, it would reduce emissions of non-methane hydrocarbon by much less than one ton per year²¹. The cost effectiveness of this project using accepted BAAQMD methods is approximately \$19,000,000/ton for non-methane hydrocarbon and \$1,000,000 per ton of Sox. Table 3 summarizes the economic calculations for these and other criteria pollutants. Details of these calculations are provided in Appendix F of this report. If the refinery fuel and steam systems are in balance prior to the flare event, the actual value of produced steam is small. This more realistic assumption results in an even less cost-effective project. In either case, this project is not cost effective for reduction of flaring. However, as described above in the Prevention Measures section, MRC has implemented this project to minimize the impact of slowing the Flexicoker to balance the FXG system.

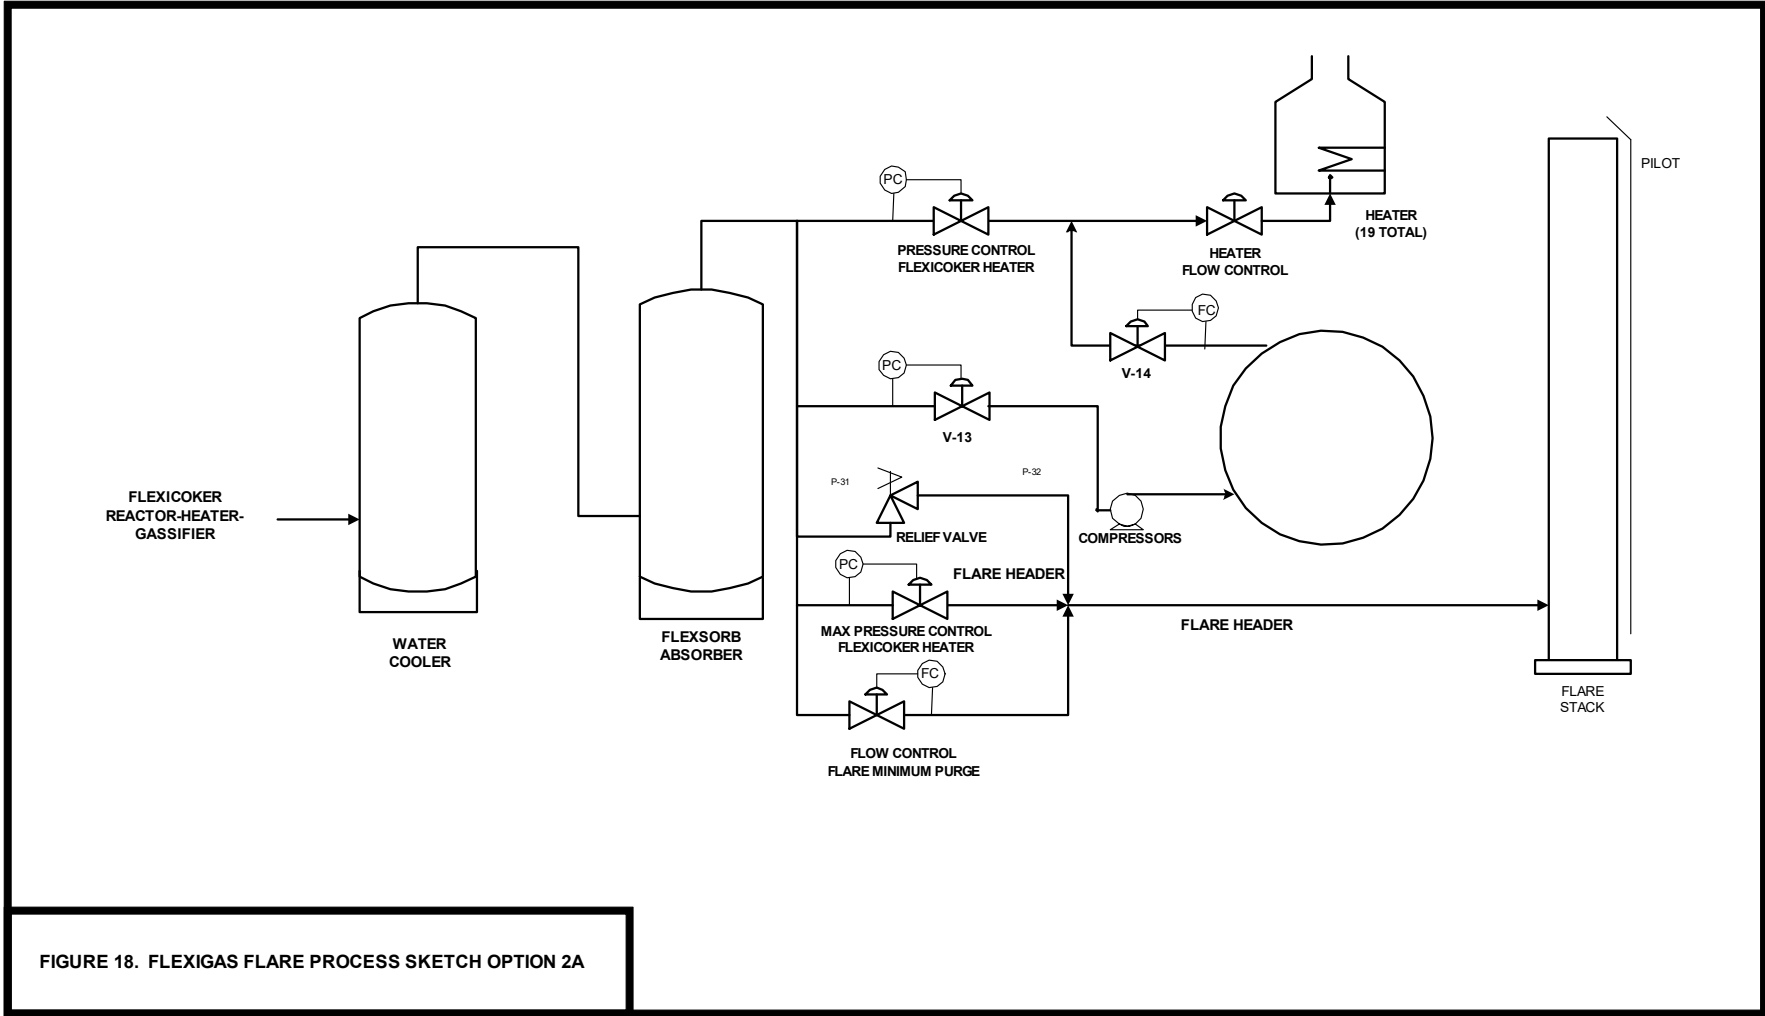
FIGURE 18. FLEXIGAS FLARE PROCESS SKETCH OPTION 2A

Option 2A consists of a pressurized vessel that would require a compressor with capacity ranging between 1 MMSCFD and 10 MMSCFD. This option is depicted in Figure 18. Flexigas in excess of consumer demand is routed to storage via compressor(s). A controlled flow is returned to the distribution system when enough consumers are available to avoid flaring. Due to the limited capacity of this storage, it has no real capability to accommodate prolonged fuel system imbalances. As a result, the expected best-case emission reductions are about the same as those available in 2005. A rough capital cost for the storage and large compressors is about \$27,000,000²². Annual electrical costs for the required compressors add another \$600,000. The annualized capital plus electrical costs to eliminate a ton of non-methane hydrocarbon result in a cost-effectiveness of approximately \$190 Million dollars per ton. Therefore, Option 2A is even less cost-effective for reducing flaring than Option 1.

²² Based on a nominal 1 MMSCF sphere (60' diameter) at 120 psig, and two 4 MMSCFD compressors. This system would handle only minor imbalances while the Flexicoker cuts rate.

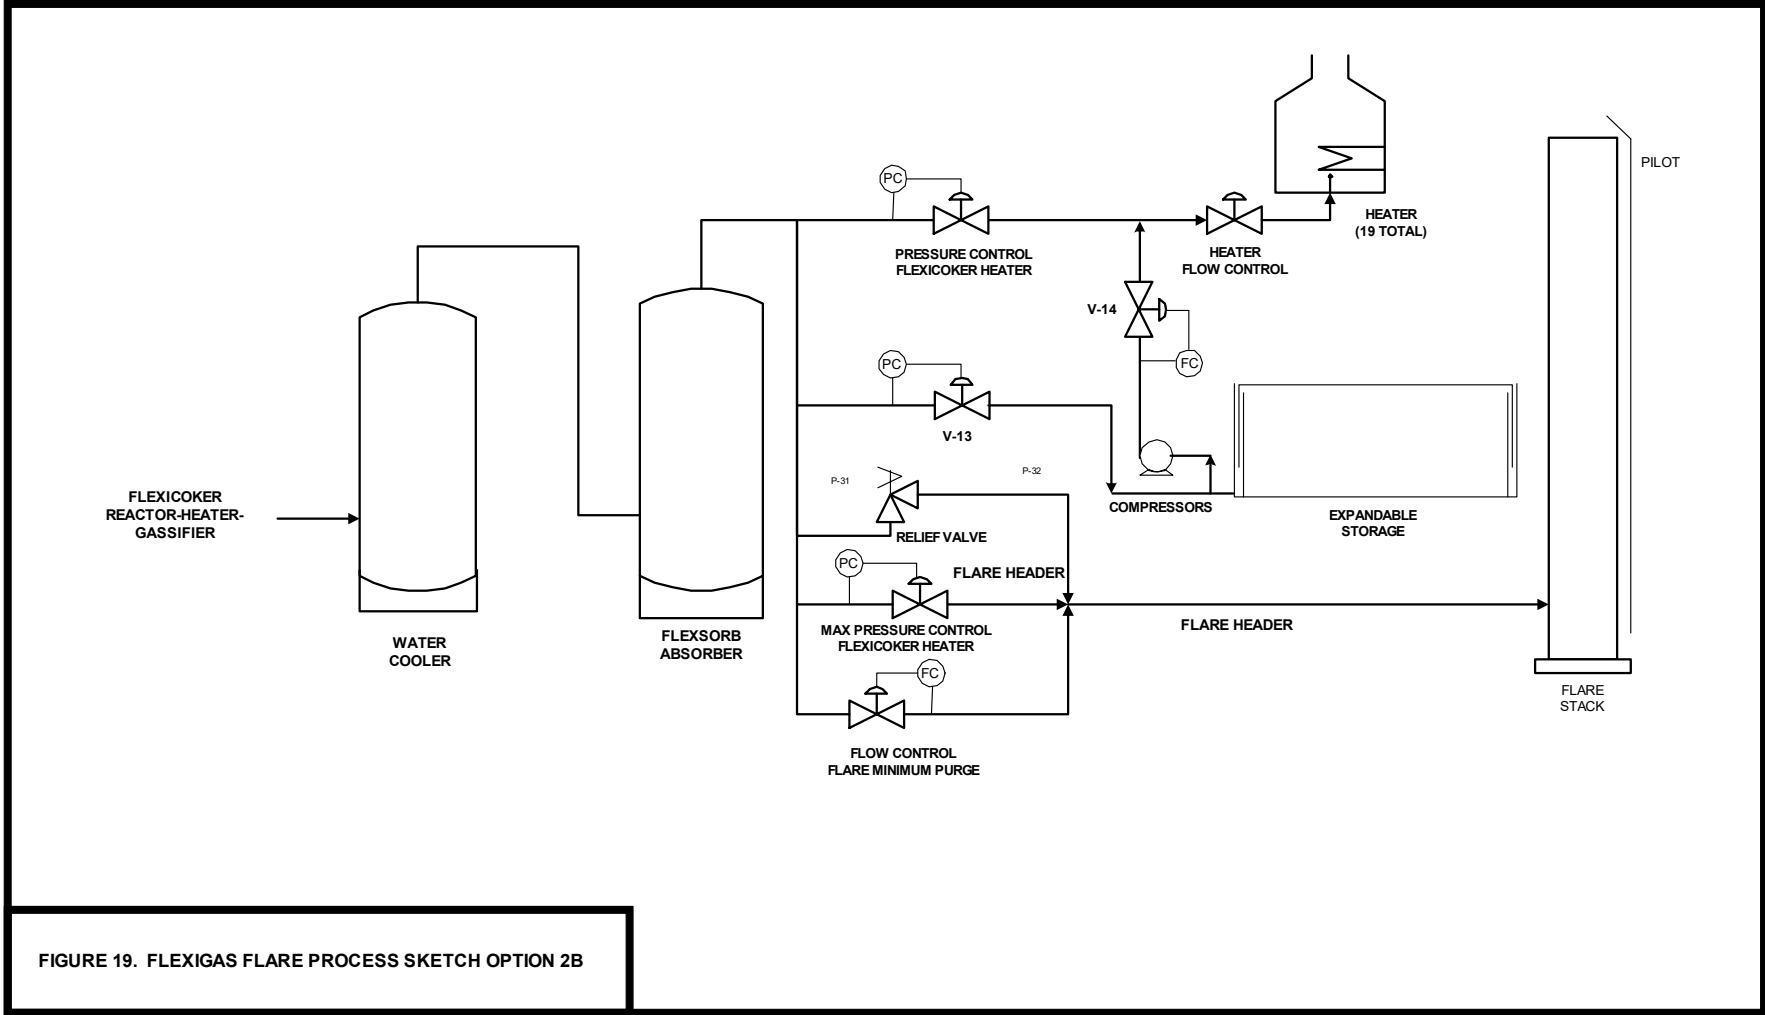
FIGURE 19. FLEXIGAS FLARE PROCESS SKETCH OPTION 2B

Option 2B uses low-pressure expandable gas storage. This option is depicted in Figure 19. This type of storage can be built significantly larger than the pressurized storage used in option 2A, and has the advantage of not requiring compressors in some cases. However, the concentration of carbon monoxide in the gas will likely require use of a water seal to limit leakage, restricting vessel height to a single lift. The requirement for a single lift, combined with low-pressure operation, significantly limits available storage volume²³. In any event, the installed cost is approximately \$21,000,000, providing cost-effectiveness of approximately \$276 Million dollars per ton of NMHC. As was the case for Option 2A, this option is even less cost-effective for reducing flaring than Option 1.
