Annual Update of Flare Minimization Plan - Public
Chevron Richmond Refinery

Flare Minimization Plan

Chevron Products Company - Richmond Refinery

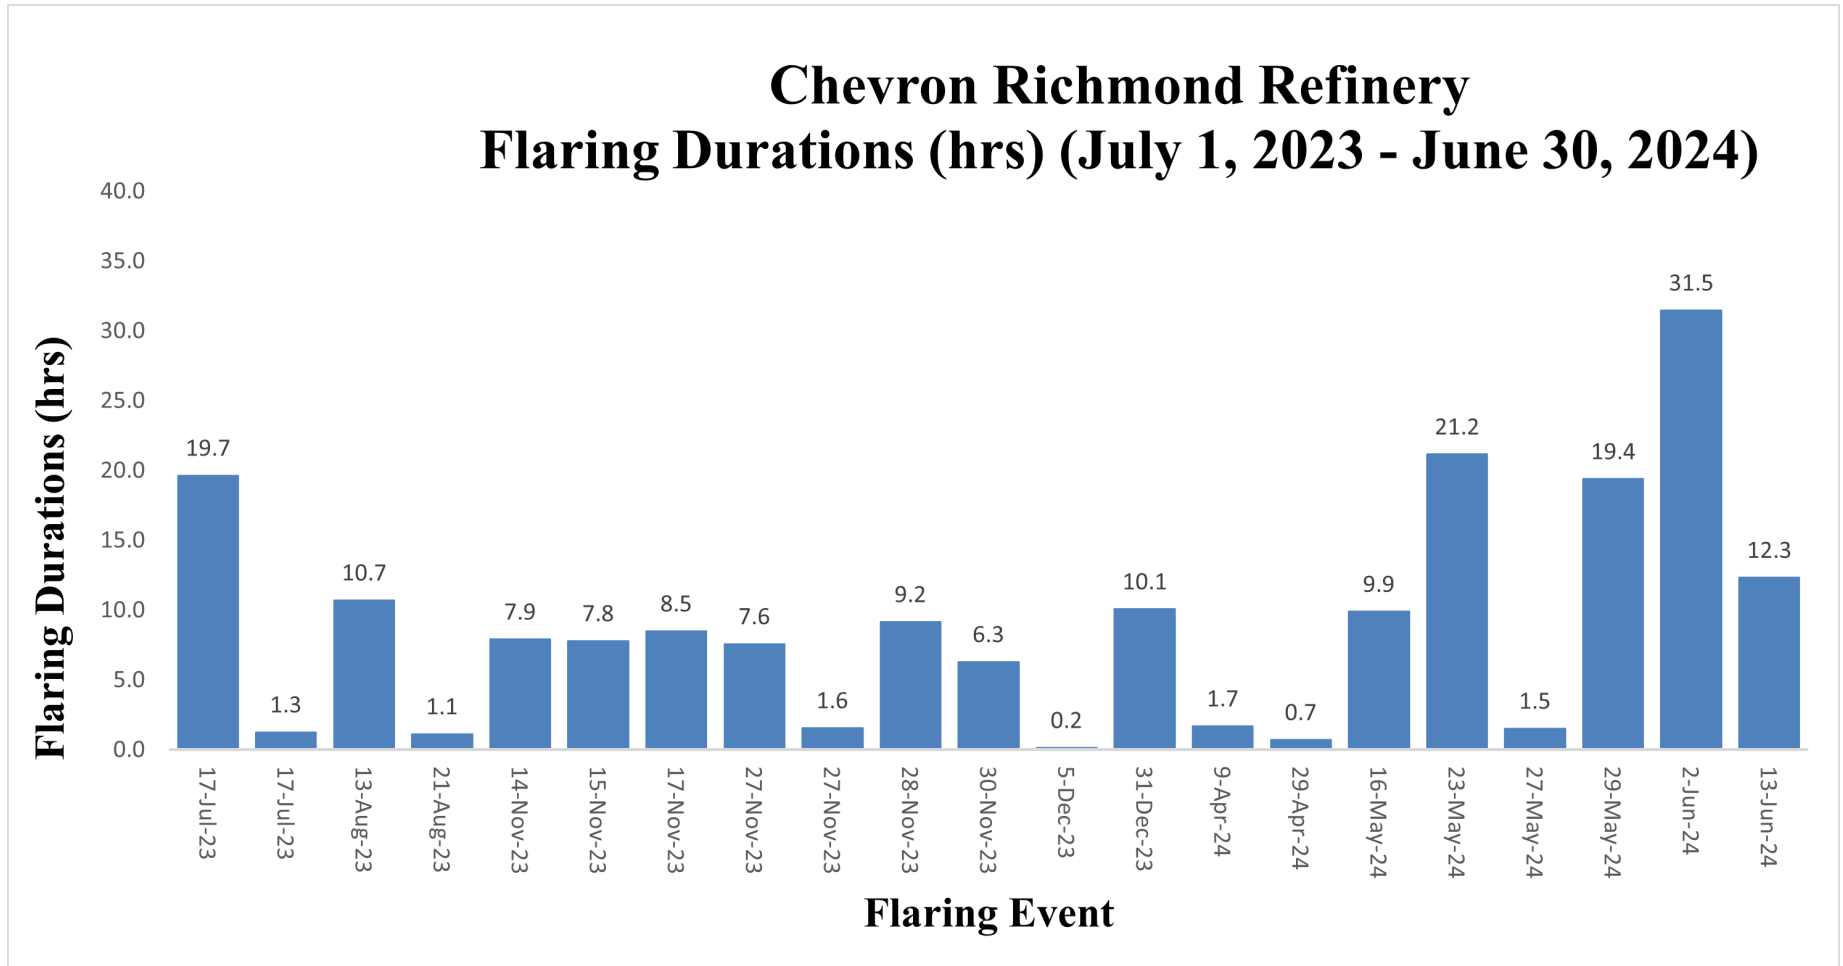
Chevron Richmond Refinery Flaring Vent Gas Flow (mmscf) (July 1, 2023 - June 30, 2024)

The first graph displays the number of reportable flaring events per Regulation 12-12 for the last 5 years. The second graph displays the flaring duration, in hours, of each reportable flaring event occurred from July 1, 2023 to June 30, 2024. The third graph displays the total flared vent gas volume of each reportable flaring event occurred from July 1, 2023 to June 30, 2024. The fourth graph displays the total methane, non-methane hydrocarbon (NMHC), and sulfur dioxide (SO₂) emissions for each reportable flaring event occurred from July 1, 2023 to June 30, 2024. The last graph displays the frequency of emergency versus non-emergency flaring events occurred during the last 5 years.

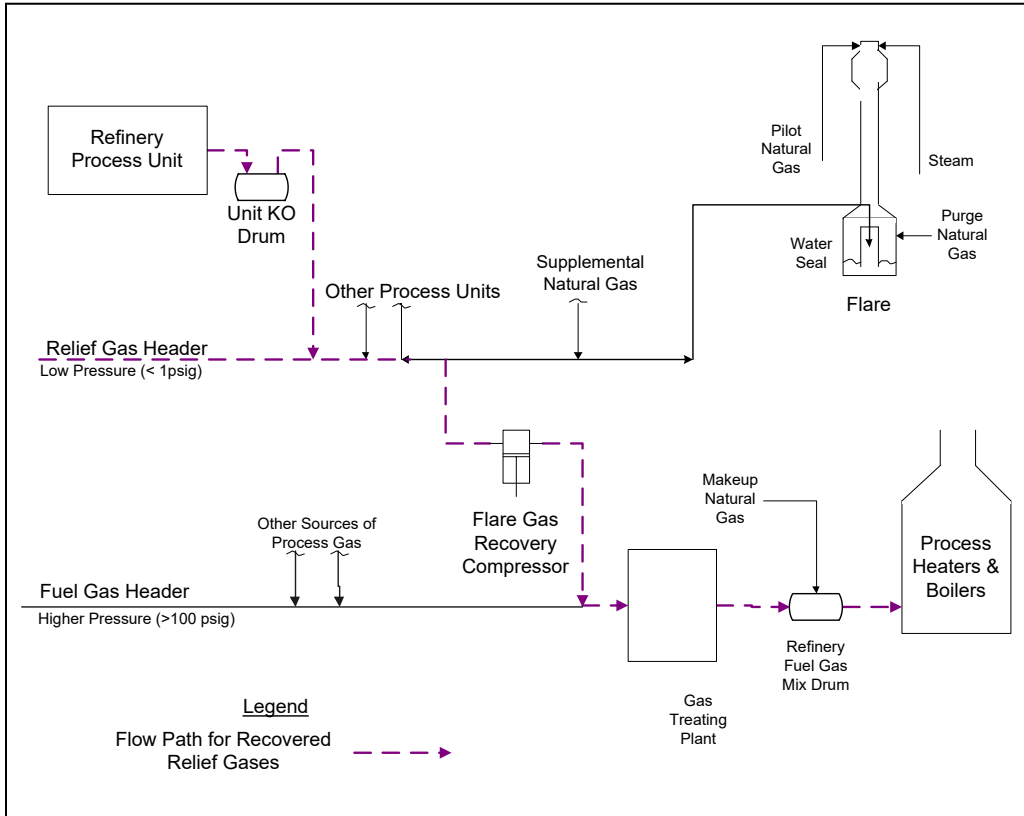
Figure 1-1, Simple Schematic - Flare System with Flare Gas Recovery

The following section describes how gases are generated and handled by refinery flare systems. A simplified schematic of a refinery flare system with flare gas recovery is shown in Figure 1-1.

A simplified diagram of the hypothetical design is shown in Figure 5-2. The diagram in Figure 5-2 highlights differences from the typical Flare Gas Recovery System shown previously in Figure 1-1. Results of this evaluation are provided for two system capacities for the North Yard

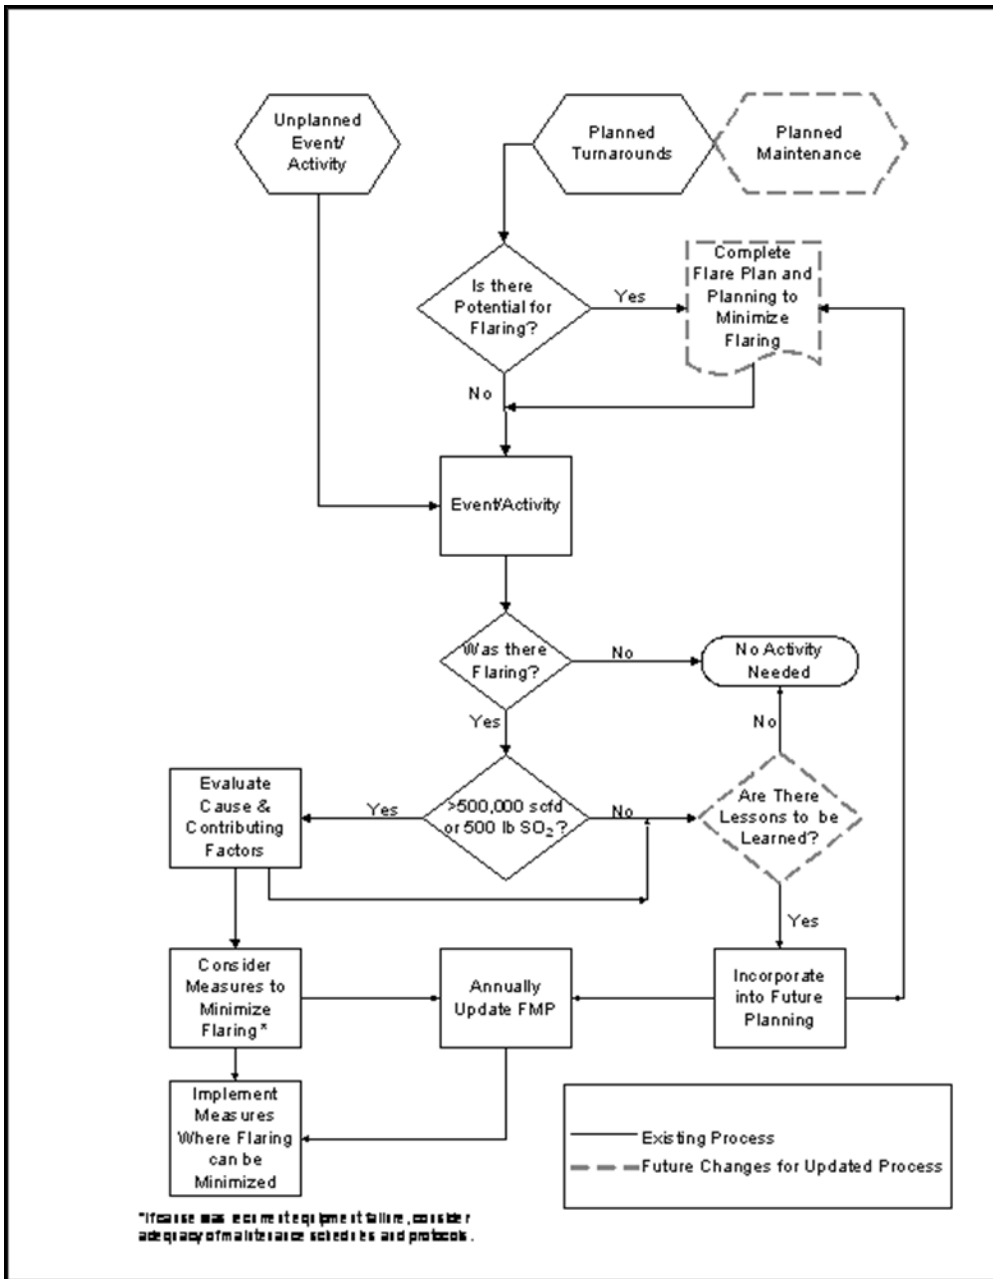
Figure 5-1, Flare Planning Process Flowchart

There are occasions, primarily as a result of equipment malfunction, where a relatively immediate decision is made to shutdown a block of the refinery, typically within a period of days, allowing little time for the kind of specific planning used for turnarounds and planned maintenance. In these cases, it is often not possible to make the same level of plant adjustments necessary to minimize flaring to the extent possible when a shutdown is planned far in advance. Despite this, there are actions that can be taken to minimize flaring even when there is very little advance notice. For these cases, the refinery utilizes general procedures to minimize flaring for unplanned events, as shown in Figure 5-1. Although there is less of an opportunity for scheduling shutdown procedures so as to ensure that there will be a home for all of the gas generated at each step of the process, many of the same general principles apply when the decision to bring the unit down is immediate. A flowchart of the Richmond Refinery's Flare Planning process is shown below, in Figure 5-1. This flowchart identifies aspects of the existing process, and highlights areas that will be updated.

Causal analyses of flaring events identified actions to maintain plant reliability that would reduce the likelihood of incidents which could cause potential flaring. These actions included the inspection and repair of equipment components that were either implemented as part of normal operations, or were scheduled for the next plant turnaround as described in Section 5.1.6 and Figure 5-1. Other actions are included in Table 4-1 below.

The development of flare plans under IMPACT SCS Task No. 27 is joint effort between the turnaround Operations Coordinator, Plant Process Engineer, and the IMPACT Planner. The improvements to this procedure are shown in figure 5-1 and listed in table 4-1.

The flowchart shown in Figure 5-1 covers the range of potential flaring events that the refinery might experience.

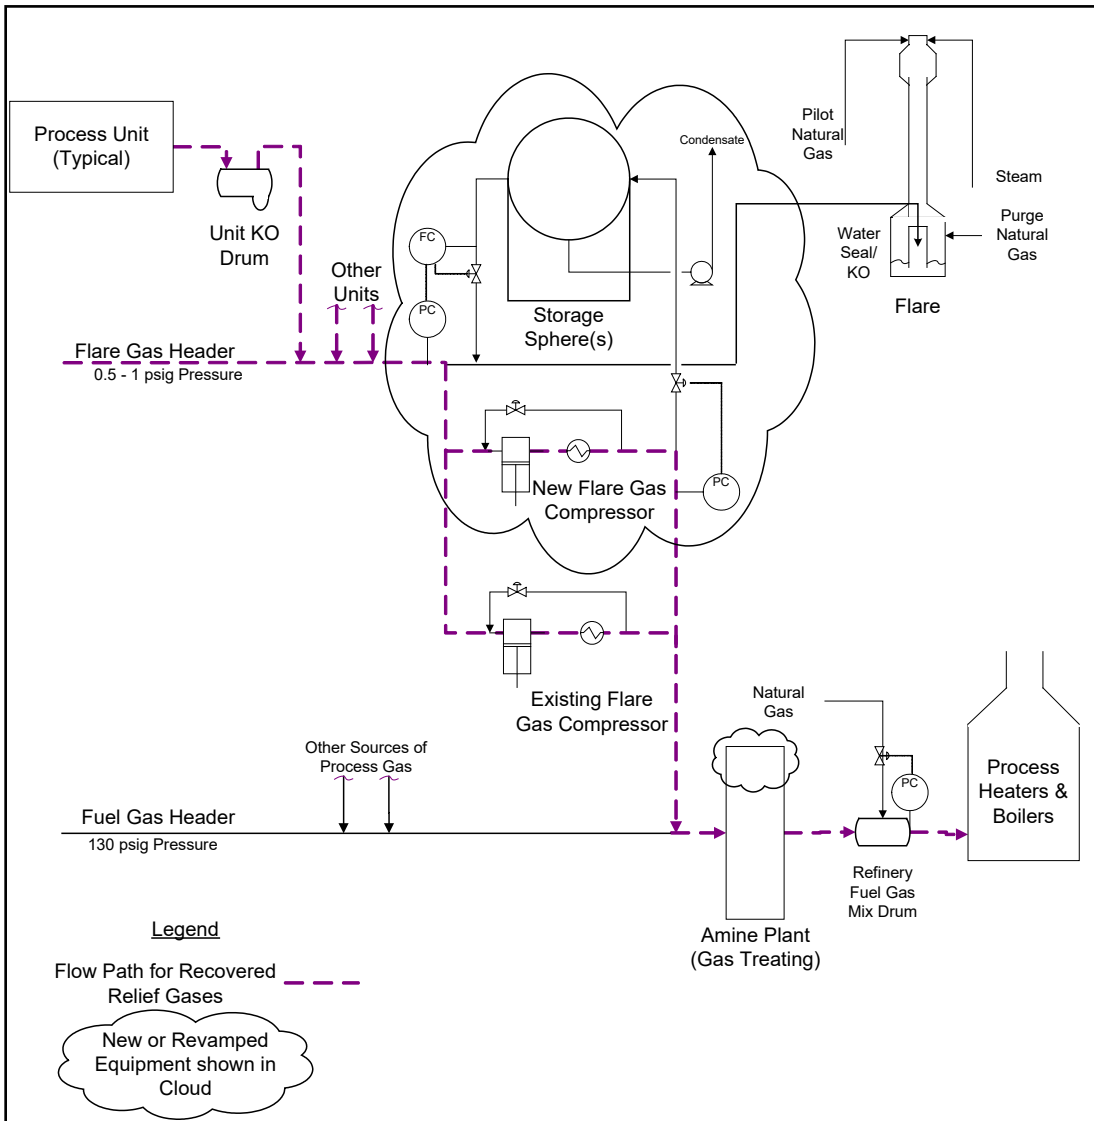
Figure 5-2, Flare Gas Recovery System with Additional Capacity

Flare Gas Recovery System, and two system capacities for the South Yard Flare Gas Recovery System.

A few specific cases for changes to the refinery's capacity to recover relief gases were evaluated. The cases evaluated correspond to several increments of additional capacity for recovering relief gases, the major equipment installations required to achieve that recovery, and the estimated total installed cost for the additional equipment. Budgetary level (order of magnitude) cost information for each of the cases evaluated is shown in Table 5-3.
