**Subject: MRC Flare Minimization Plan – Revised January 2025**

**FLARE MINIMIZATION PLAN**  
**MARTINEZ REFINING COMPANY**

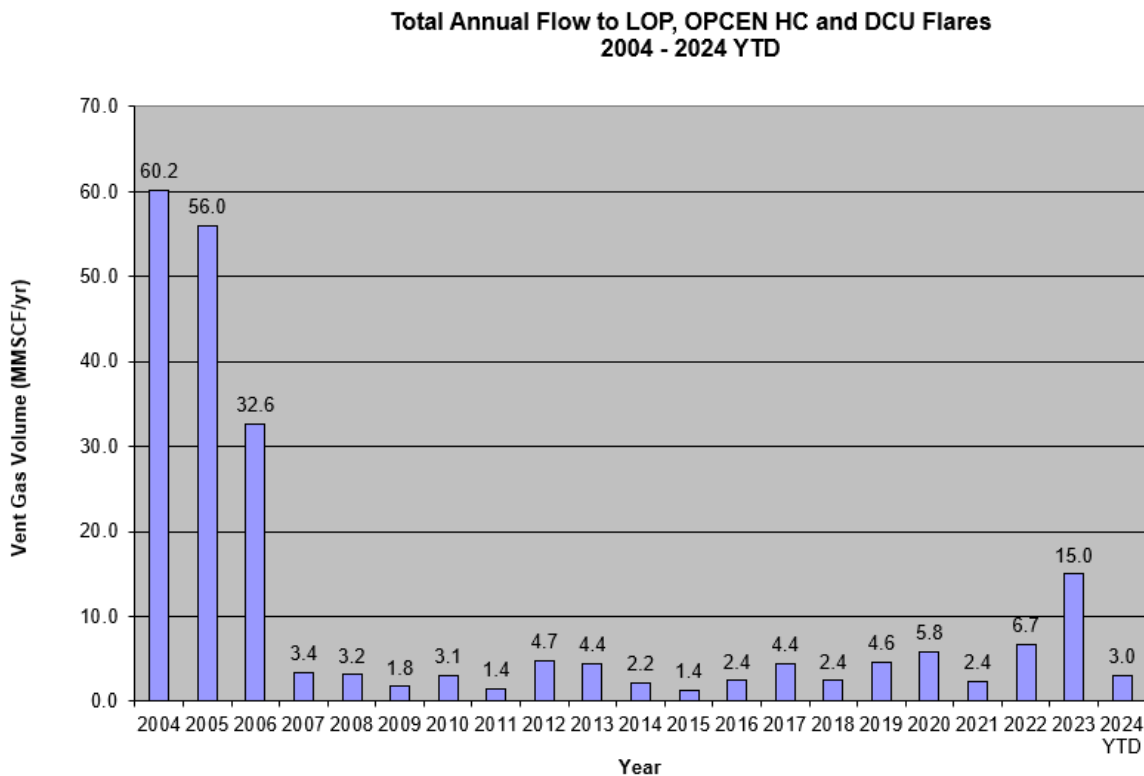
**FIGURE ES-1**

Figure ES-1 presents the total annual vent gas flow to the Light Oil Processing (LOP), Operations Central Hydrocarbon (OPCEN HC) and Delayed Coking Unit (DCU) Flares at the refinery from 2004 through June 30, 2024. Flare flow continues to be very low.

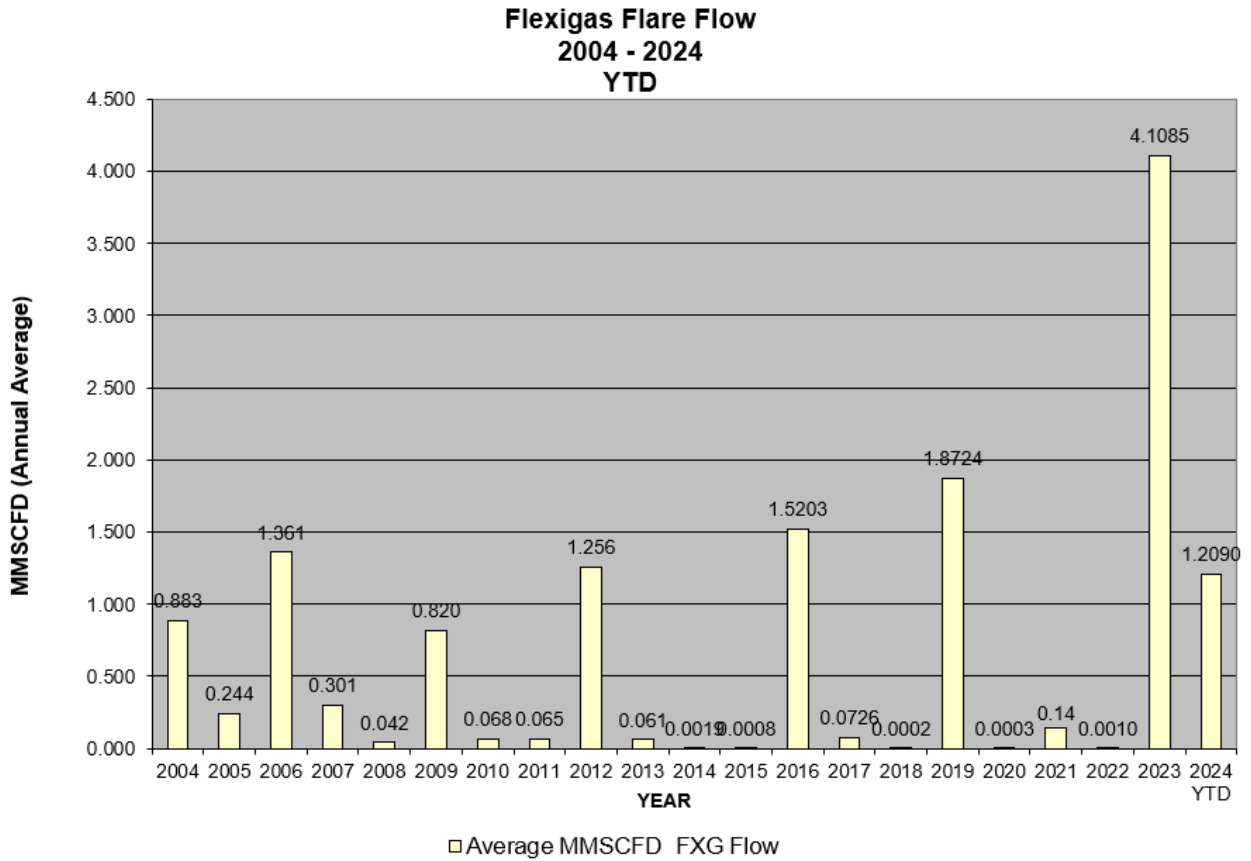
## **FIGURE ES-2**

Figure ES-2 shows the annualized vent gas flow from the Flexigas Flare. This figure shows a cyclic increase in Flexigas flaring which occurs during years with startup and shutdown of the Flexicoker due to the nature of the Flexicoking and Flexsorb processes. The flaring of treated flexigas during startups and shutdowns of the Flexicoker is allowed up to specified limits in MRC's Title V permit. Flexigas is a very low BTU gas used as a supplemental refinery fuel gas in refinery process heaters. Flexigas is treated for sulfur removal in the Flexsorb Unit before being combusted either in refinery process heaters or if necessary, in the Flexigas Flare. When FXG is flared, the volume of gas is typically large compared to the volume flared in the other refinery process flares, but emissions are significantly less because Flexigas contains very low concentrations of non-methane hydrocarbon and sulfur.

Flexigas flaring can also occur due to refinery fuel gas imbalance. MRC continues to fine-tune the Flexigas pressure control scheme to minimize flexigas flaring due to small imbalances in fuel gas. Improvements in this system, most notably addition of COGEN to the pressure control scheme, contribute to the very low flexigas flare flow rate seen in non-turnaround years including 2013, 2014, 2015, 2017, 2018, 2020, 2021, and 2022.

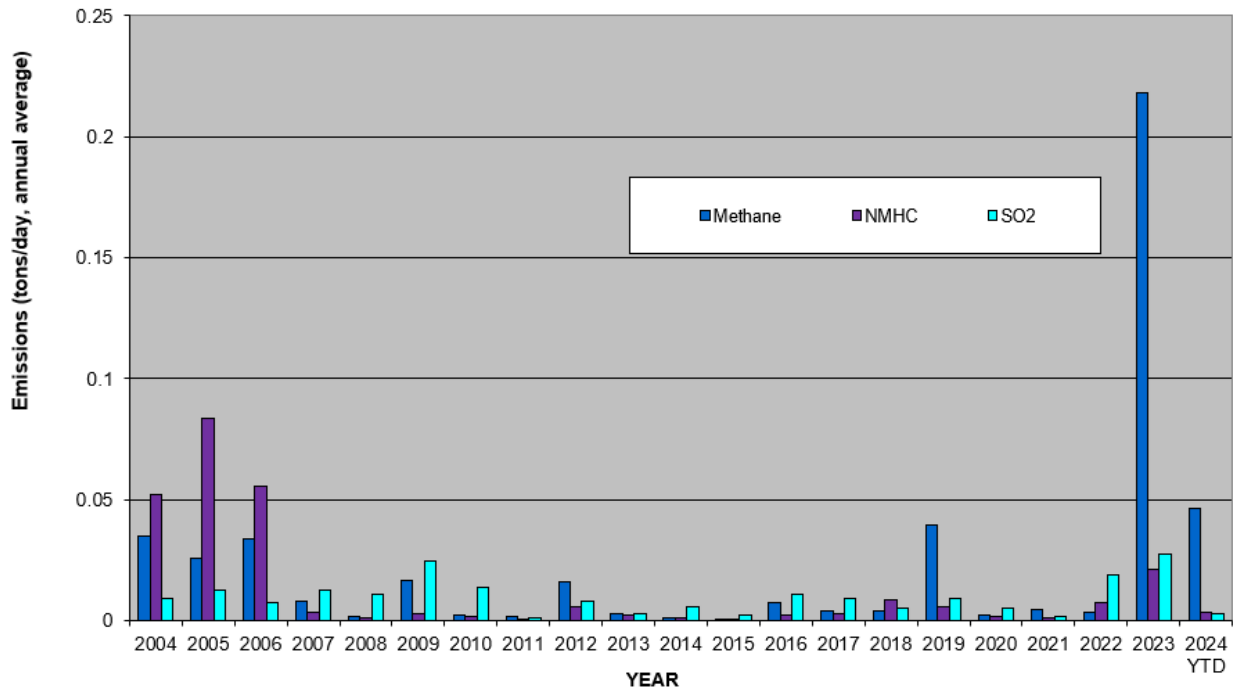
**FIGURE ES-3**

Figure ES-3 shows the methane, non-methane hydrocarbon, and sulfur dioxide emissions from all four refinery process flares from 2004 through June 30 of this year.

**MRC Flare Emissions - All Flares  
2004 - 2024 YTD**

Figure ES-3 shows the overall significant reduction in emissions that has occurred since the implementation of the Flare Minimization Plan in 2006 and highlights that even with large volumes of flexigas flaring during turnaround years, overall emissions from flaring are low.

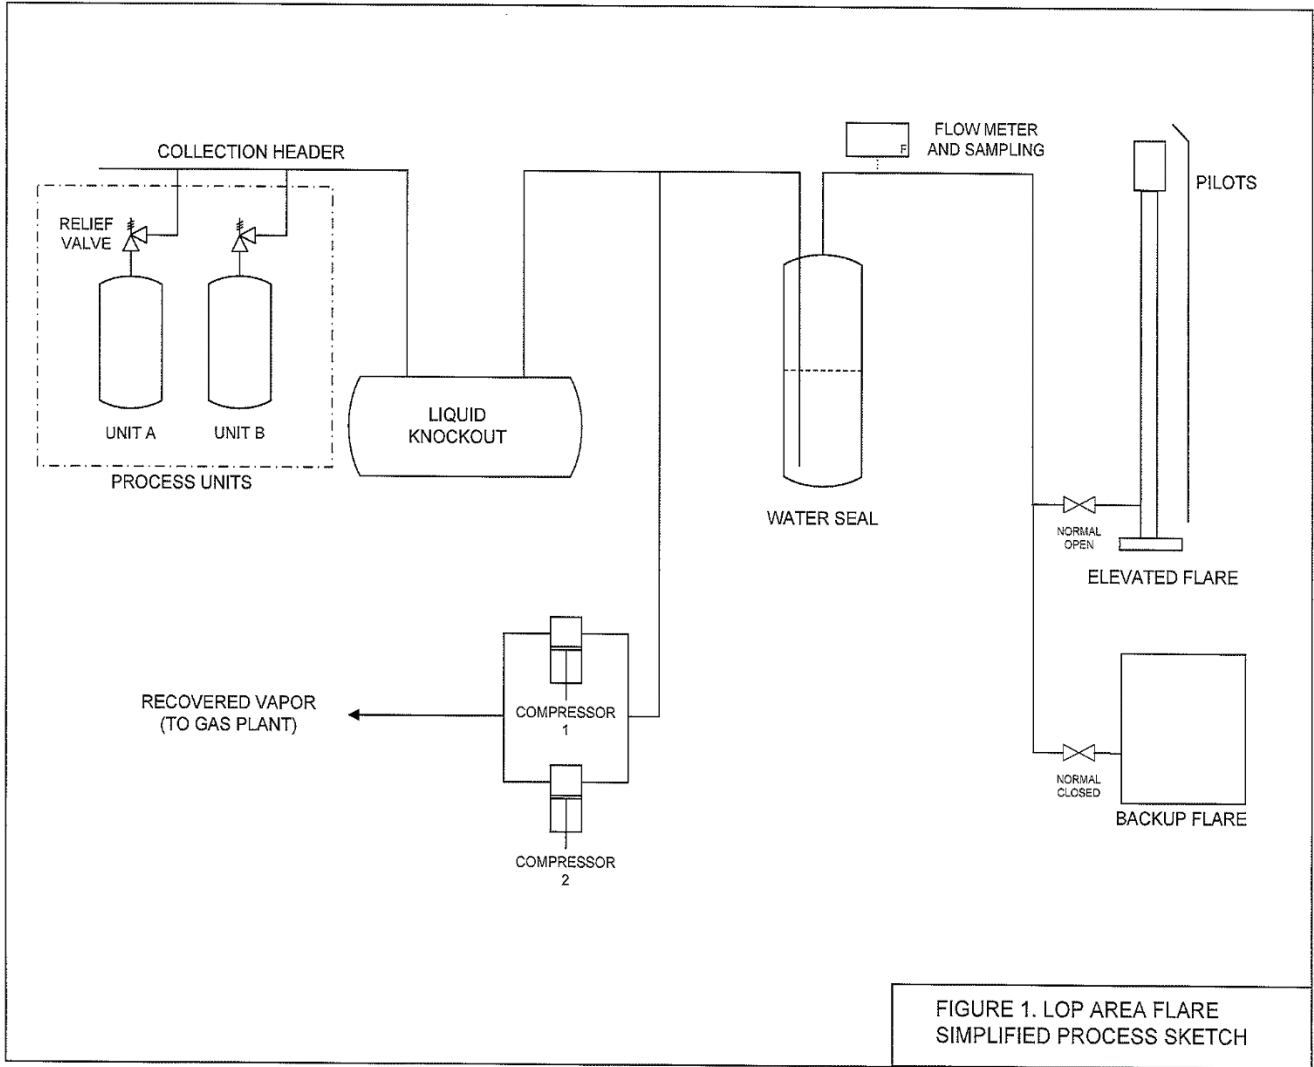
FIGURE 1. LOP AREA FLARE SIMPLIFIED PROCESS SKETCH

The LOP Flare system is comprised of collection headers, liquid knockout vessels, two flare vapor recovery compressors, piping to route recovered gas to fuel gas treaters, a water seal vessel, the flare header proper, and the flare stack. The LOP flare is an elevated, steam-assisted flare with nitrogen purge to prevent air intrusion. Piping and valves provide sufficient flexibility to operate in various configurations, allowing continuous and reliable operation during turnarounds, inspection and maintenance activities without flaring. Maintenance of the elevated flare (S#1471) is accomplished by putting an alternate flare in service. This alternate flare (Backup Can Flare, S#1472) is normally blinded and is only used when the elevated flare is out of service for inspection or repair. A sketch of the LOP Flare system is provided in Figure 1. Technical details of the system are provided in Appendix A<sup>2</sup>.

LOP FLARE Monitors		
Stream	Monitor Parameter	Measurement Location
Flare Gas	Volumetric Flow	Downstream of water seal vessel on 36" line
Flare Gas	Pressure	Downstream of water seal vessel on 36" line
Flare Gas	Temperature	Downstream of water seal vessel on 36" line
Flare Gas	BTU	Downstream of water seal vessel on 24" line
Steam	Volumetric Flow (high)	Upstream of entry into elevated flare S-1471 at bottom steam ring
Steam	Volumetric Flow (low)	Upstream of entry into elevated flare S-1471 at bottom steam ring
Steam	Volumetric Flow	Upstream of entry into elevated flare S-1471 at upper steam ring
Steam	Volumetric Flow	Flow orifice in center pipe at entry to elevated flare S-1471.
Nitrogen	Volumetric Flow	Upstream of entry into flare vent gas line to elevated flare S-1471
Nitrogen	Volumetric Flow	Upstream of entry into flare vent gas line to can flare S-1470
Natural Gas	Volumetric Flow	Upstream of the vent gas analyzers on the NG line

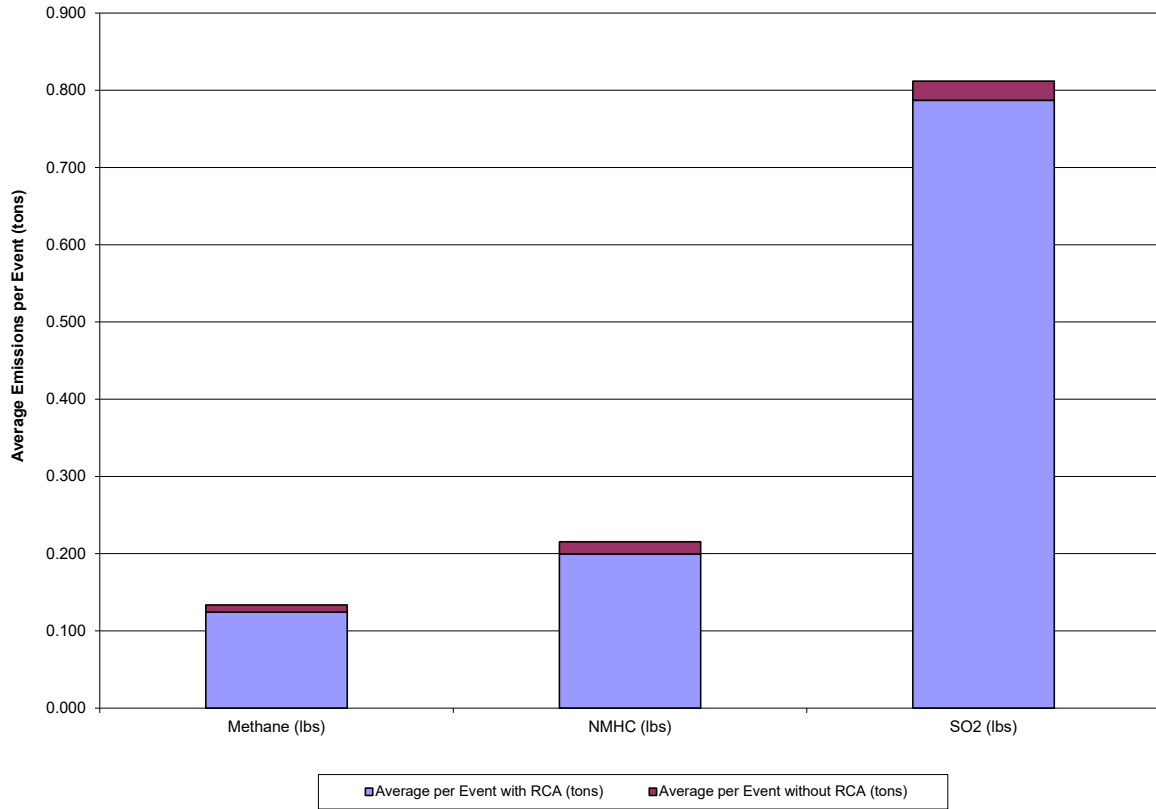
FIGURE 2008 -1

LOP Flare Events w/ Causal Analysis vs. Small Events  
1/1/06 - 6/1/08

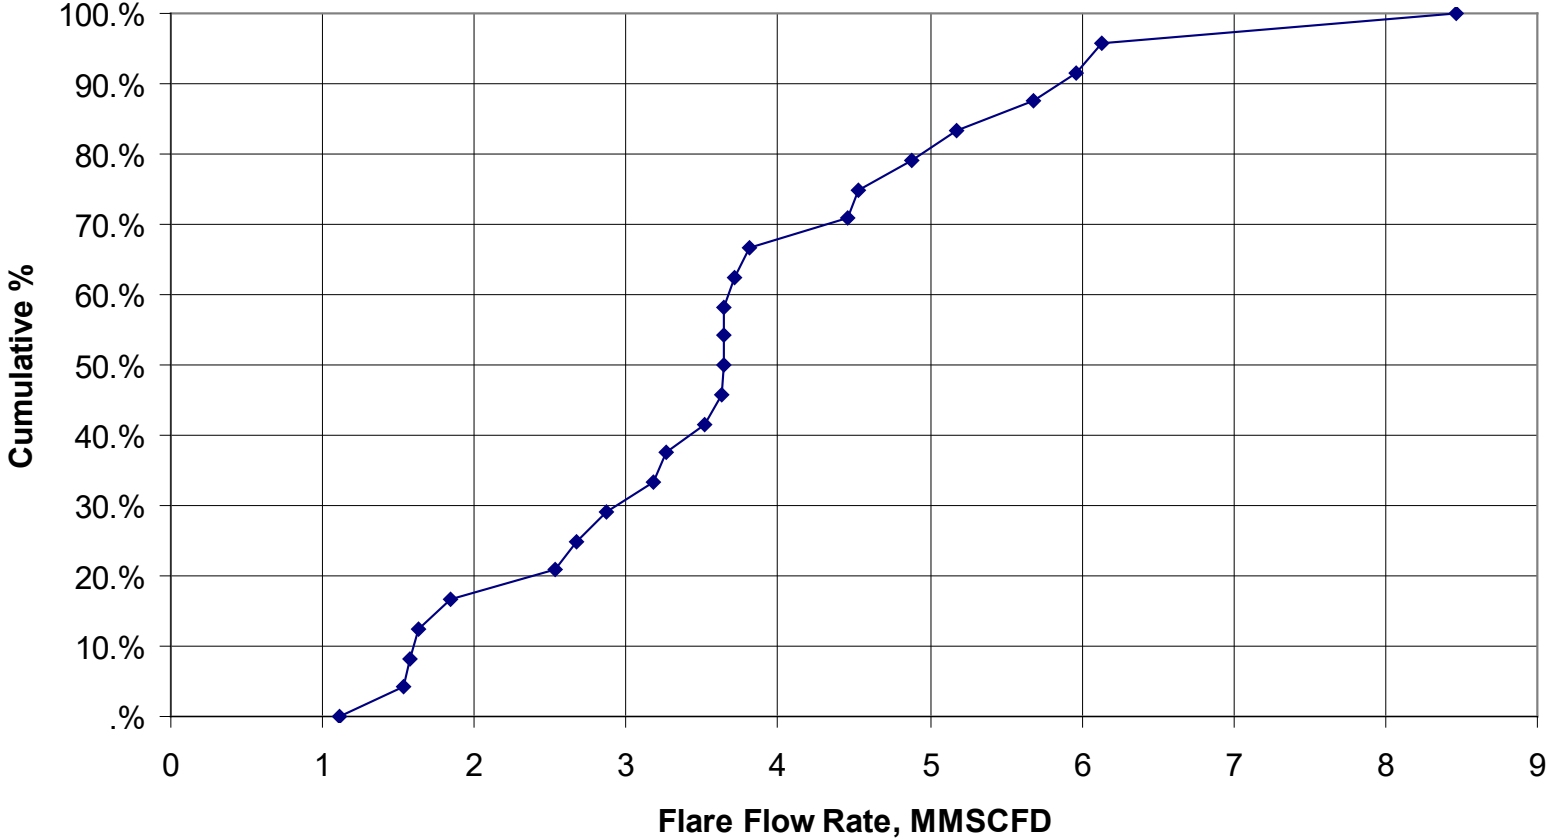
Figure 4 depicts the average rates of flow to the flare for events occurring in 2005. These data indicate that approximately 30% of the flare events had event-average flow rates of less than 3 million standard cubic feet per day. Actual instantaneous rates are generally higher – often significantly – than these average rates. This difference between the average rate for an event and instantaneous flare gas rate during an event is important because once the instantaneous rate exceeds the available compressor capacity the water seal is typically broken and flaring occurs. Once flaring begins, backpressure in the flare header provided by the water seal is significantly reduced. Due to the lower header pressure, flare gas recovery rates are typically significantly reduced from their rated capacity.

Data from Figure 4 were used to evaluate the leverage provided by additional flare gas recovery in LOP. As each increment of compressor capacity was added, the corresponding events with average flows within the newly revised total capacity were considered to be recovered rather than flared. Similarly, the reported emissions for these events were presumed not to occur. This provided the basis for emissions reductions as a function of compressor capacity.

**Figure 4. LOP Flare Gas Flow Rates  
(2005)**

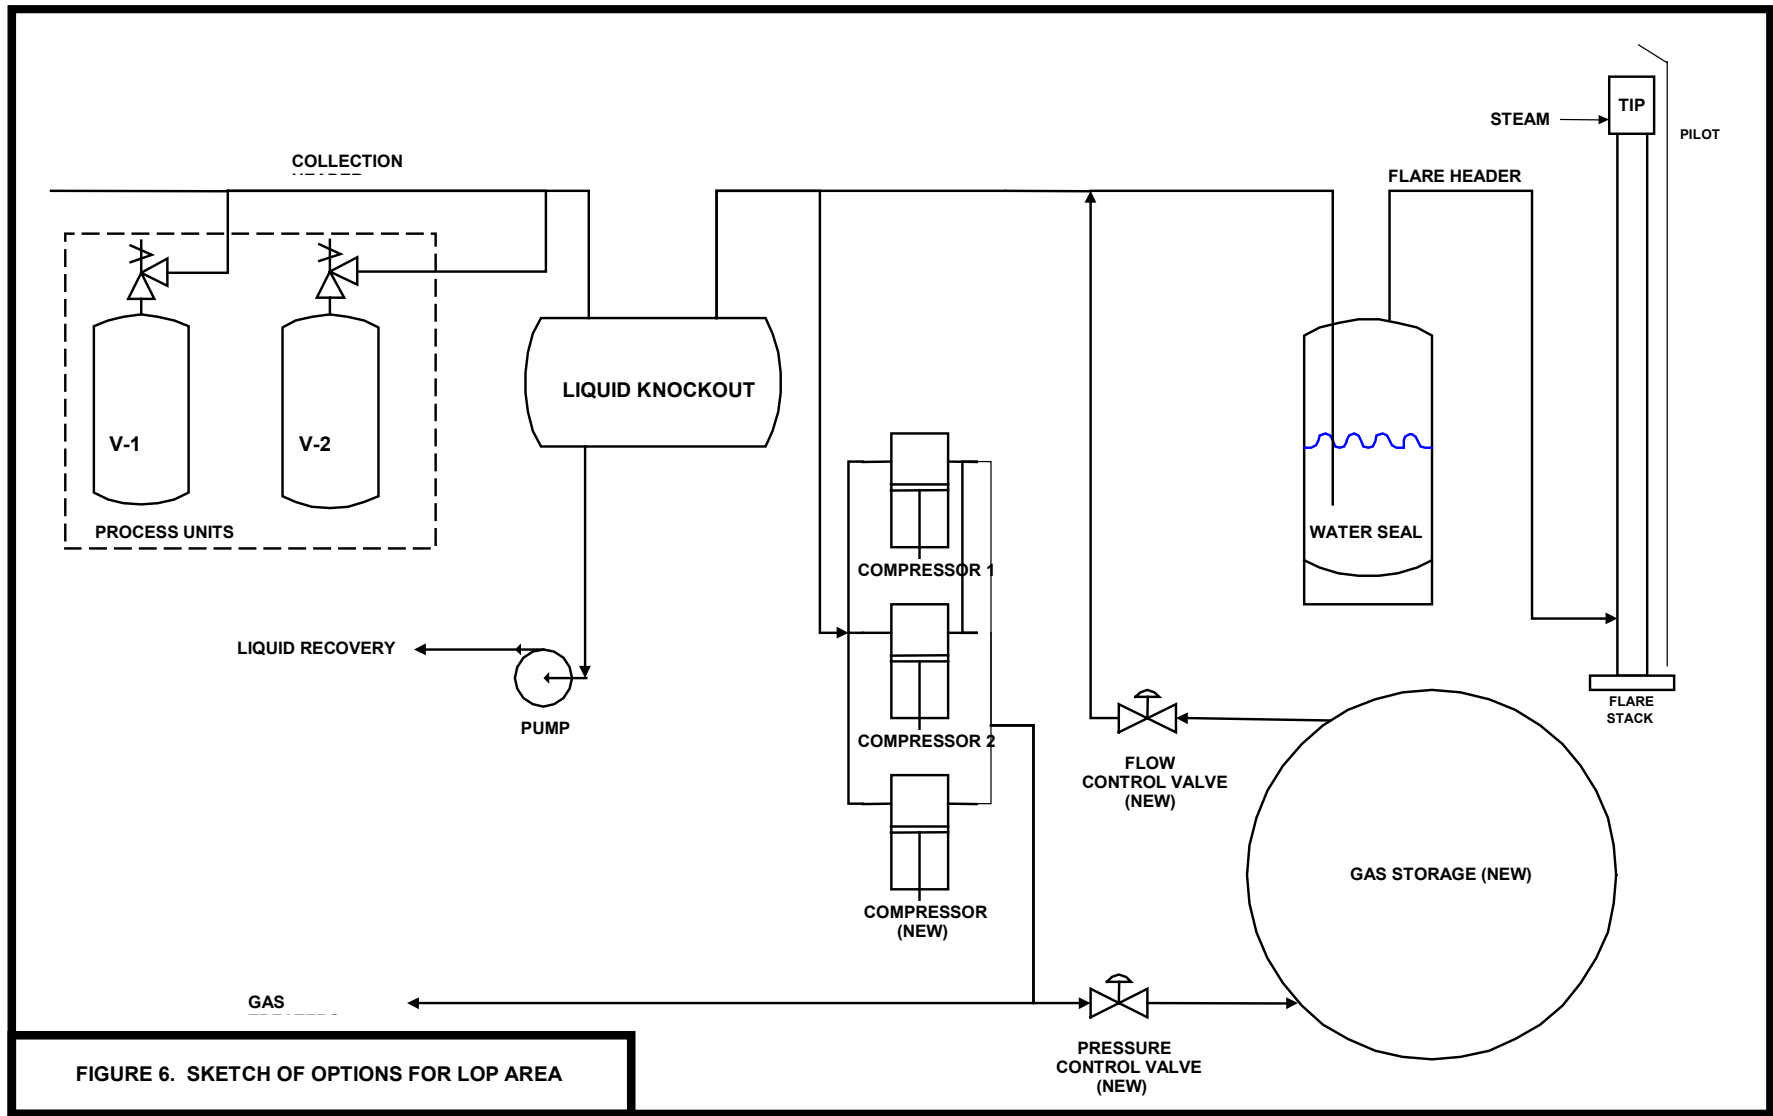
FIGURE 6. SKETCH OF OPTIONS FOR LOP AREA

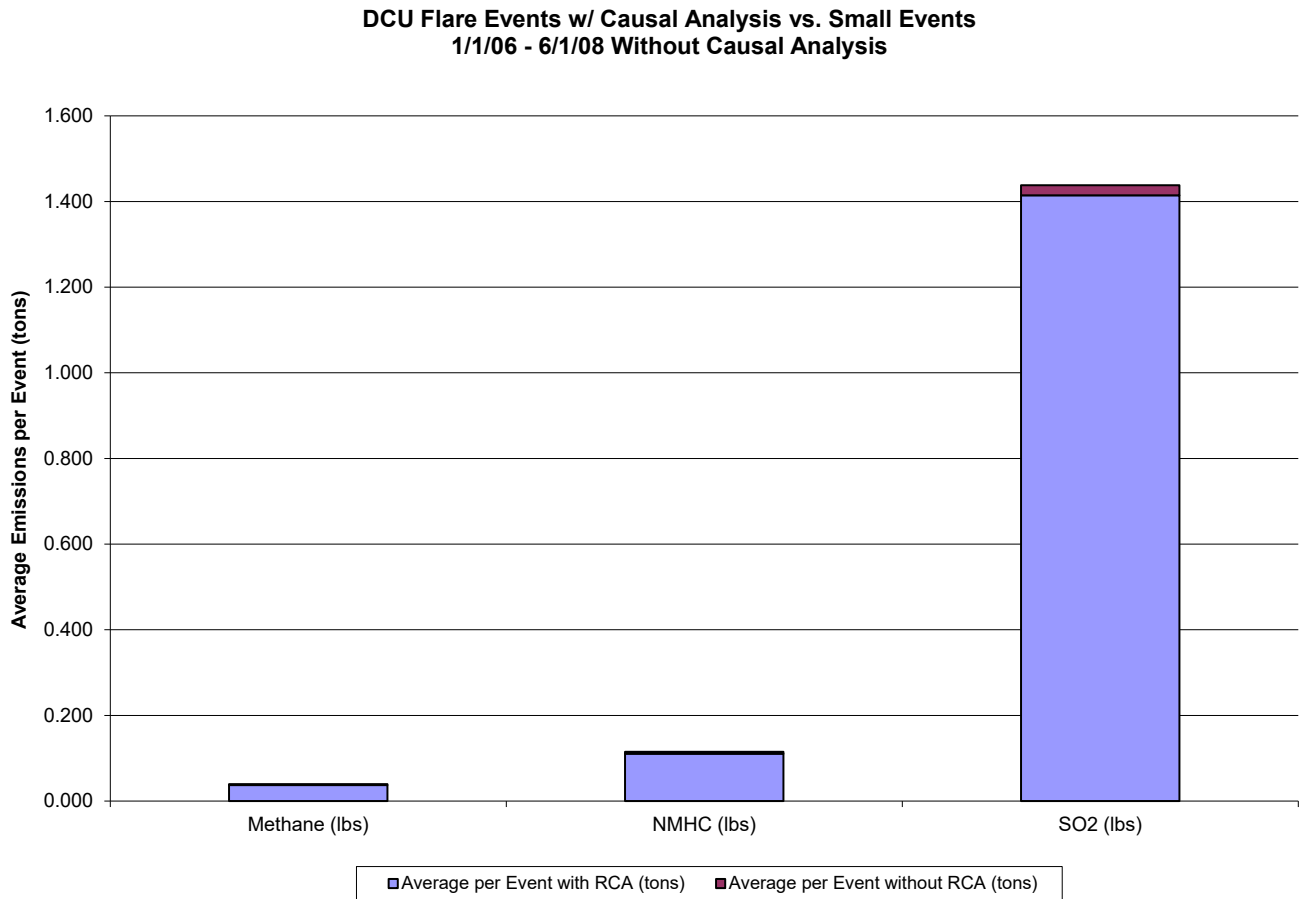
**FIGURE 2008-2**

Beginning in November 2006 with the adoption of the Flare Procedures described in the Common Measures Section, pertinent information, when available, was captured immediately after a flaring event to determine the cause of any flaring and what could be done to prevent it from happening again. Total emissions from all flaring during this 30-month period were: 0.17 tons of methane, 0.45 tons of non-methane hydrocarbon and 4.19 tons of SO<sub>2</sub>. Figure 2008-2 presents a comparison of the average emissions per large reportable events over this time period vs. the average emissions per small event for the DCU Flare. This figure shows that small events contributed < 6% of the emissions of a large event. Figure 2008-2 reinforces the appropriateness of the causal analysis trigger of 0.5 MMSCF/ 500 lbs SO<sub>2</sub> to ensure the resources to conduct a Causal Analysis are most effectively applied to address high emission events.

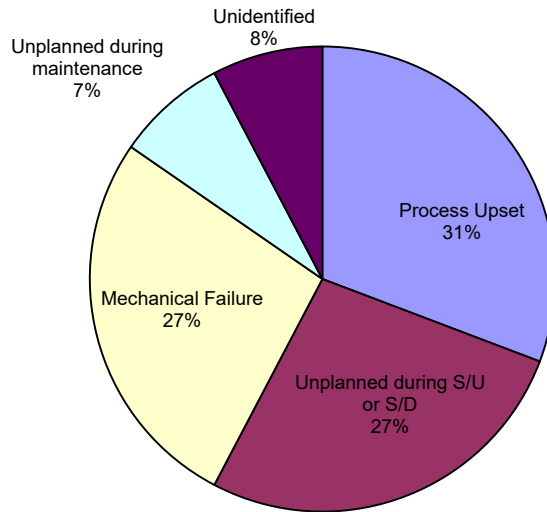
**FIGURE 2008 - 3**

The DCU flare events that occurred from 1/1/06 – 6/1/08 were categorized by probable cause in Figure 2008-3. None of the flaring was planned. Most of the events were < 10 minutes long. The majority of the events were caused by process upset, mechanical failure or were unplanned during startup and shutdowns.

**Probable Cause of Flaring on DCU Flare 1/1/06-6/1/08  
26 Events**

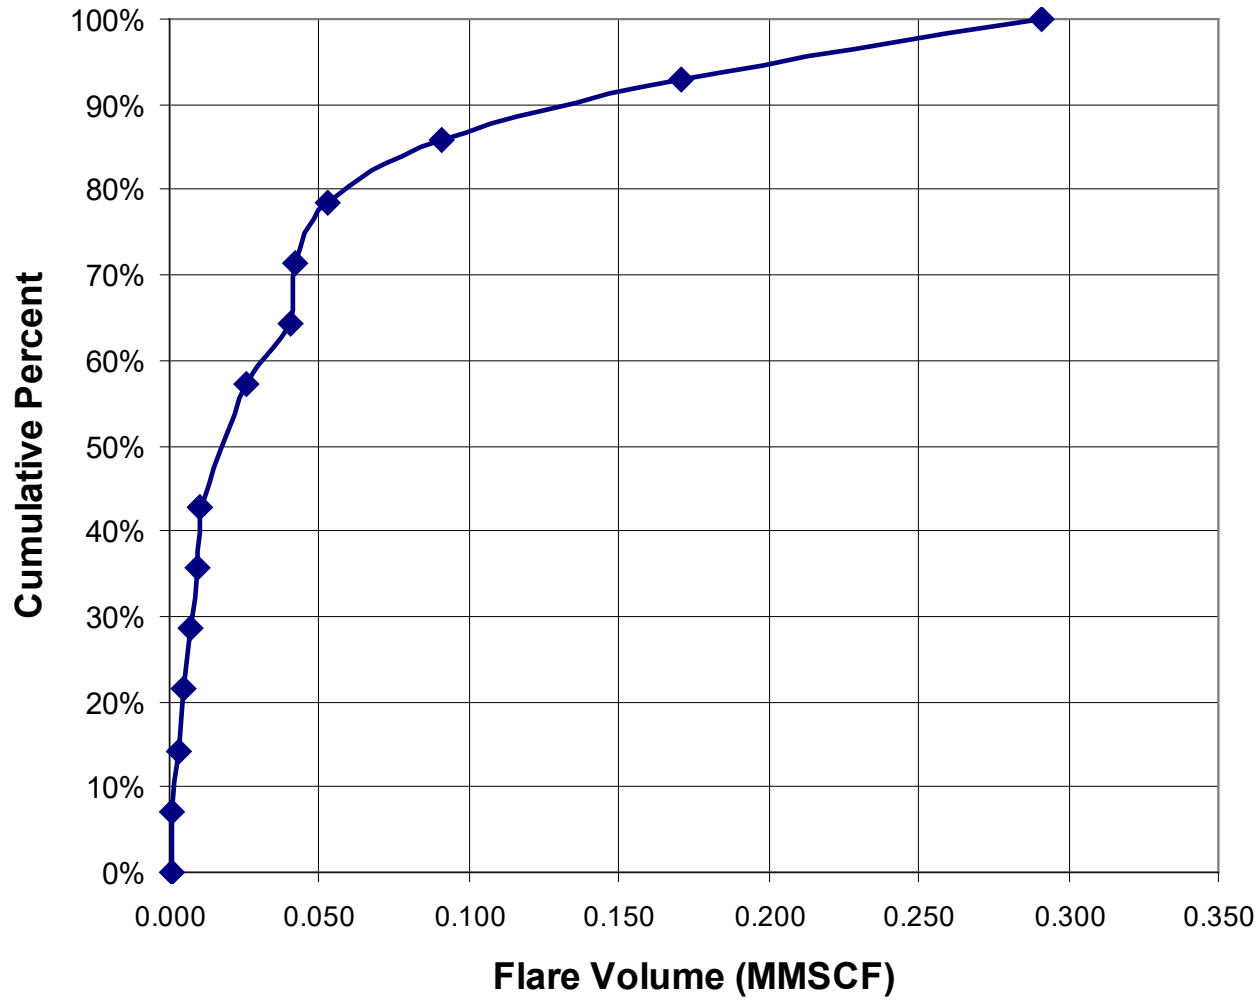
Figure 9 depicts the amount of material flared during the reported incidents of flare activity in 2005. All flaring was below 500,000 scf. Approximately 70% of the incidents of reported flaring involved volumes of gas of 50,000 SCF or less. All were below 300,000 standard cubic feet.

**Figure 9. Delayed Coking Area Flare Gas Volumes  
(2005)**

is provided in figures 9 through 11. These data, together with knowledge of the various process units and hardware served by the flare, provide no new alternative mitigations beyond those already presented for the LOP Area flare.<sup>14</sup>

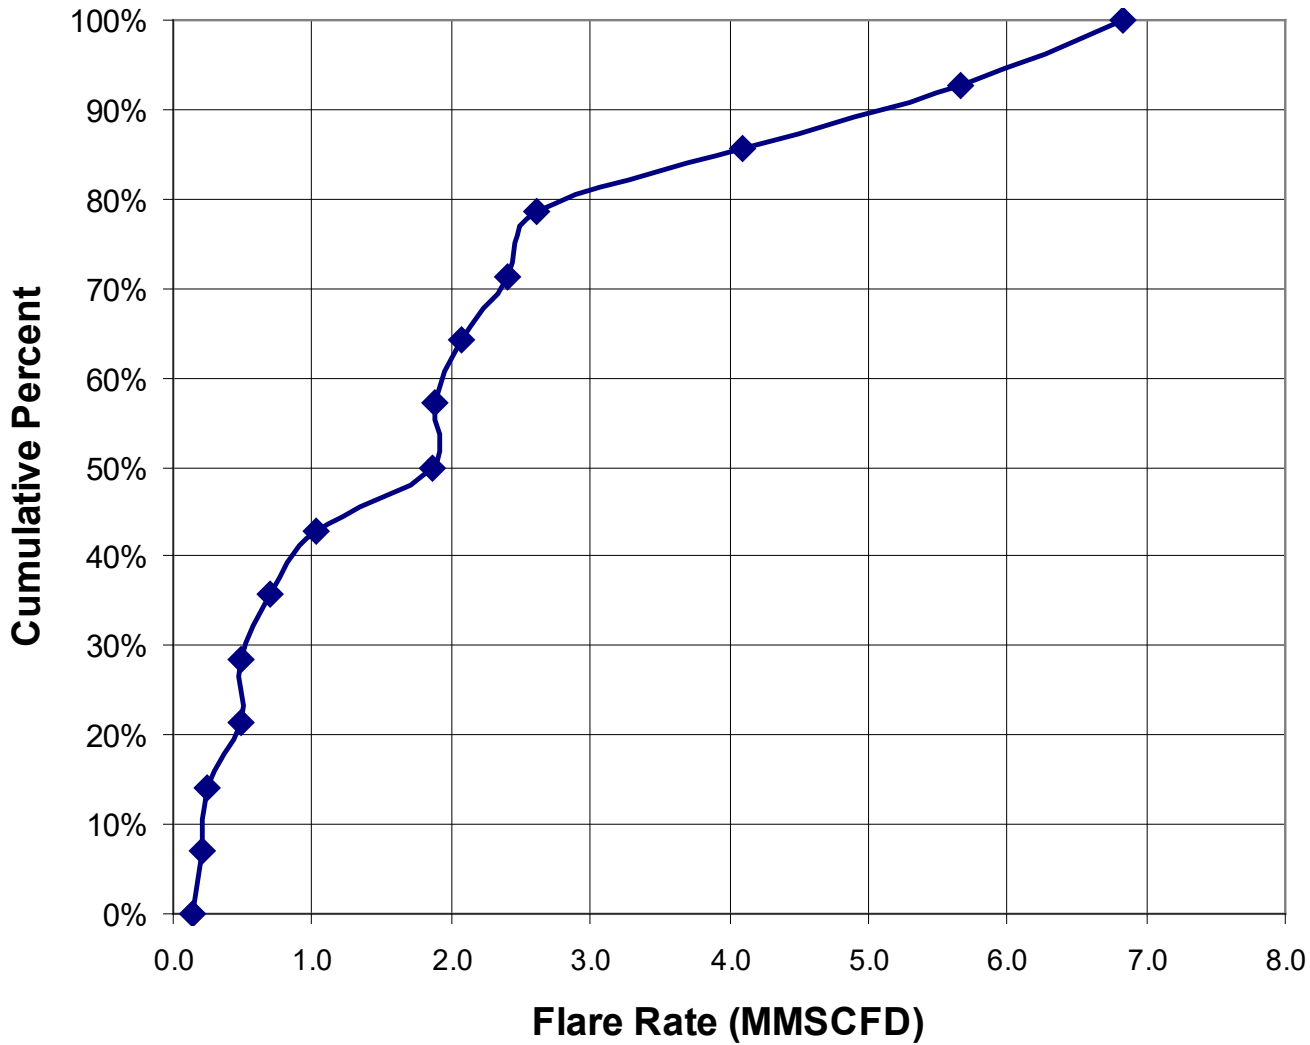
Figure 10 depicts the average rates of flow to the flare for events occurring in 2005. These data indicate that approximately 80% of the flare events had event-average flow rates less than 3 million standard cubic feet per day. Actual instantaneous rates comprising the average are generally higher – often significantly – than these average rates.

**Figure 10. Delayed Coking Area Flare Gas Flow Rates  
(2005)**

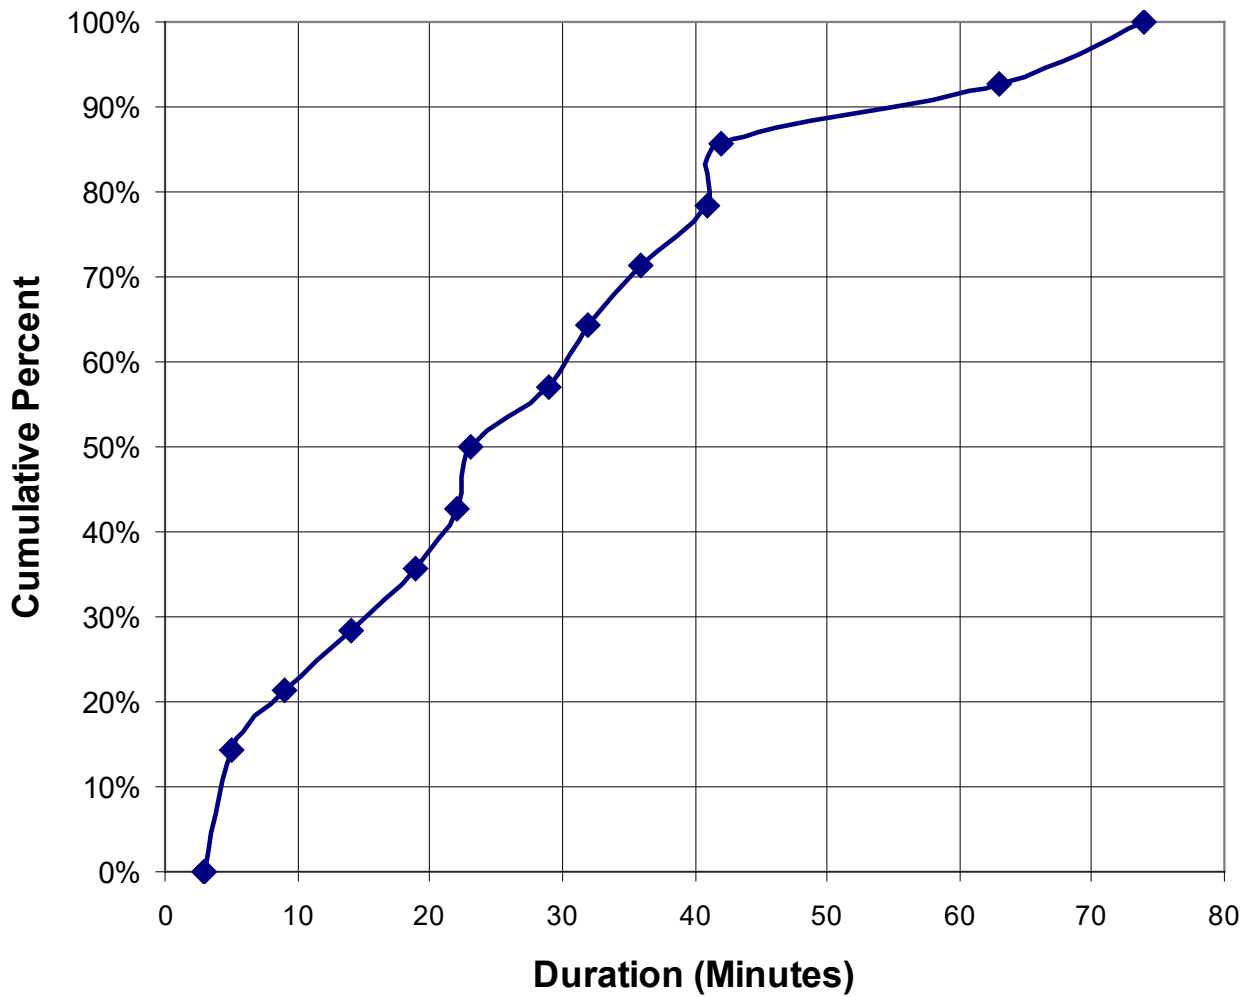
Figure 11 depicts the distribution of flare event durations for 2005 where these data are available. 50% of the events lasted less than 30 minutes. This is consistent with other data characterizing the bulk of flare events being very brief.

**Figure 11. Delayed Coking Area Flare Event Durations  
(2005)**

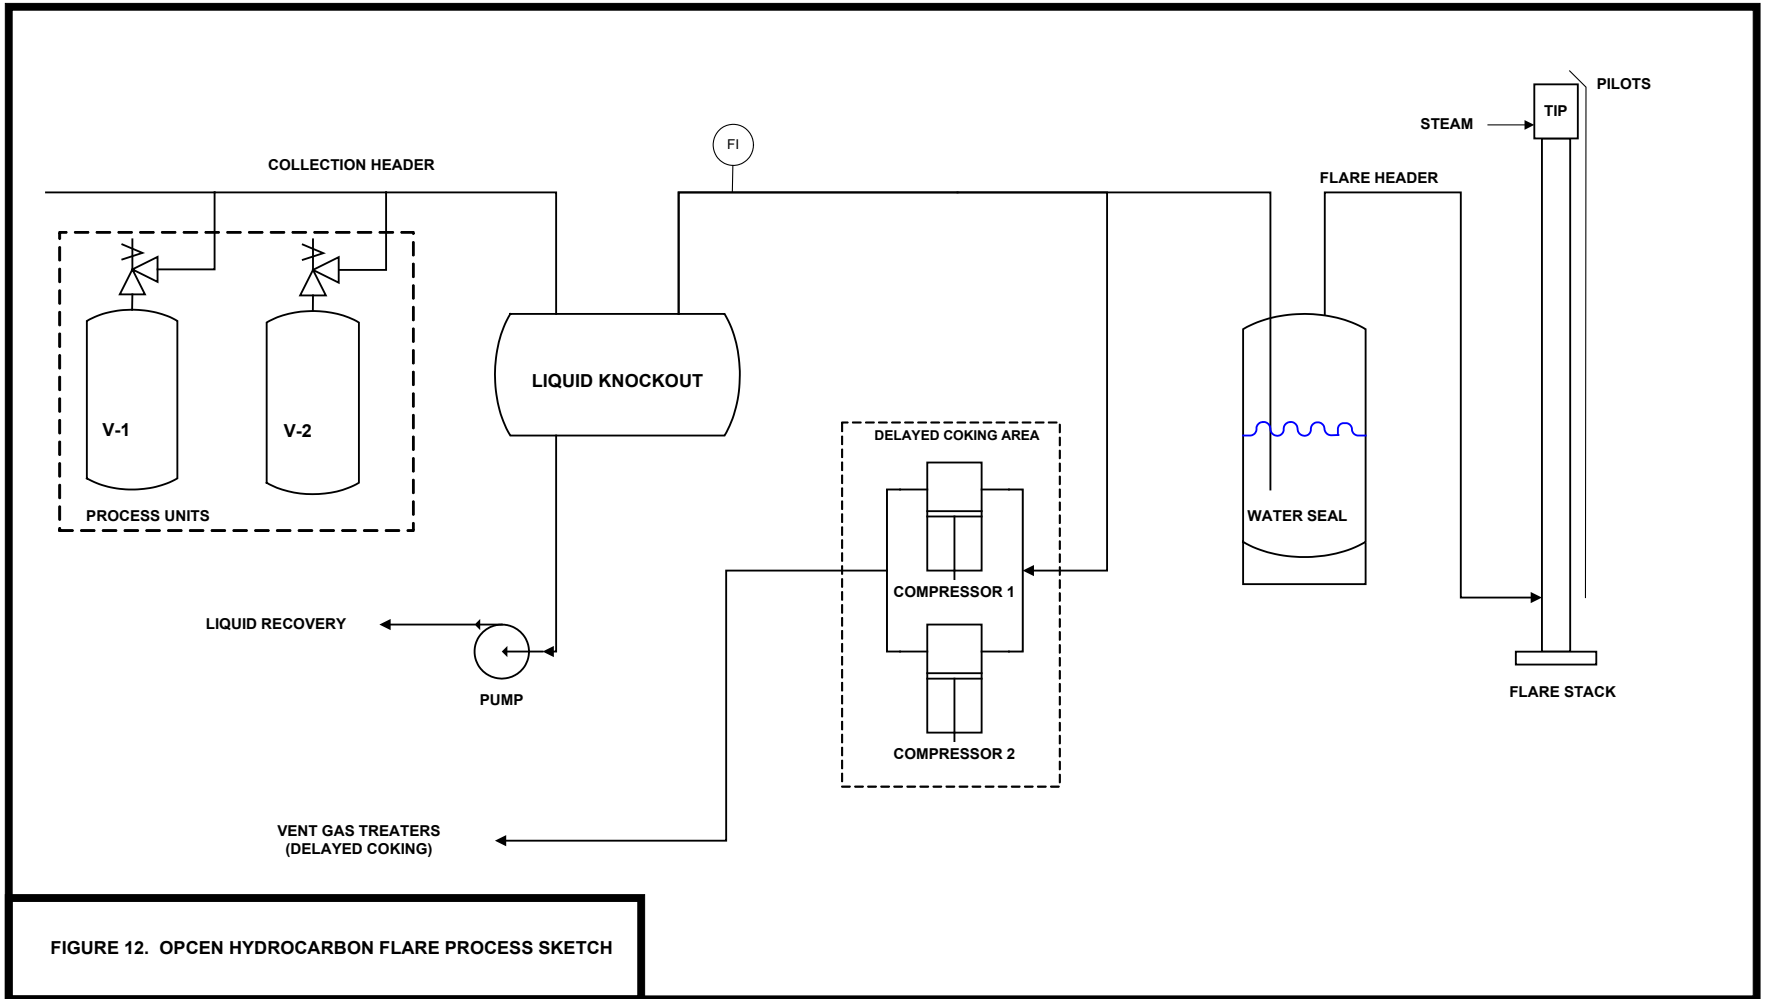
Process units in the OPCEN area are served by a dedicated flare system. This flare was modified by a project to provide flare vapor recovery. The vapor recovery project was operational in November 2006. A sketch of the flare system is provided in Figure 12. The OPCEN HC flare system is comprised of collection headers, a liquid knockout vessel, a water seal vessel, piping to flare gas recovery compressors and gas treating, the flare header proper, and the flare<sup>16</sup>. Additional details of the flare are provided in Appendix C.

This flare is equipped with a water seal tank that is maintained with a level of approximately 75%. Water seal break through is occurring when water seal level drops below 65%, seal pot pressure exceeds 3.4 PSIG, and flare flow exceeds 0.475 MMSCFD (2 out of these 3 conditions must be met). The compliance monitors for this flare are shown in the table below. More detailed information on the monitoring systems for this flare can be found in the Appendices in Section 5.

FIGURE 12. OPCEN HYDROCARBON FLARE PROCESS SKETCH

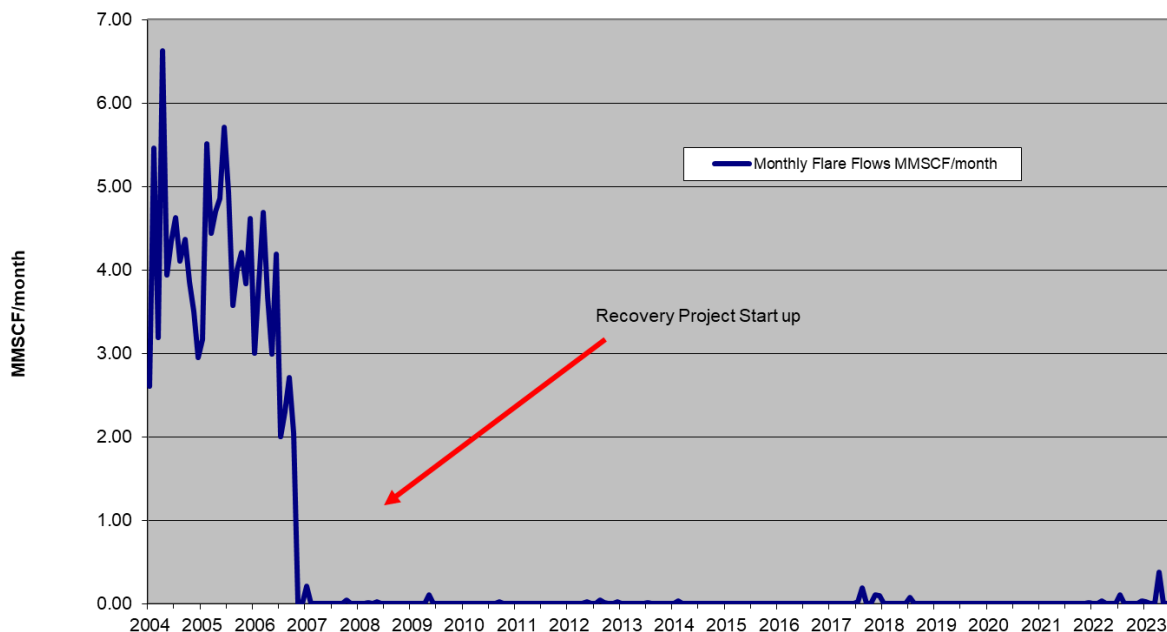
The figure below has been updated through 6/30/23 and shows the continued success of the implementation of the flare recovery project that occurred in 2006 for this flare.

OPCEN HC FLare Monthly Flare Flows 1/1/04 - 7/1/23

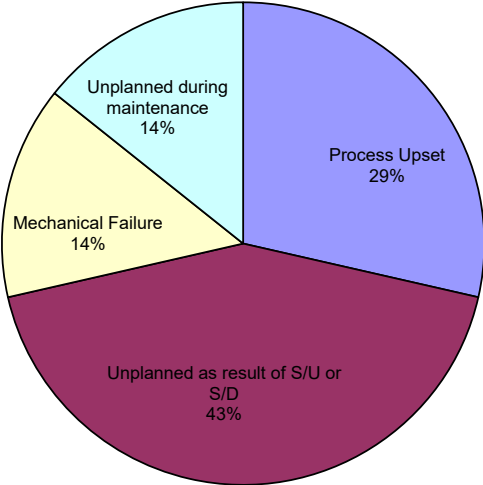
FIGURE 2008-4

OPCEN HC Flare- Cause of Flaring 11/1/06 - 6/1/08  
7 Events

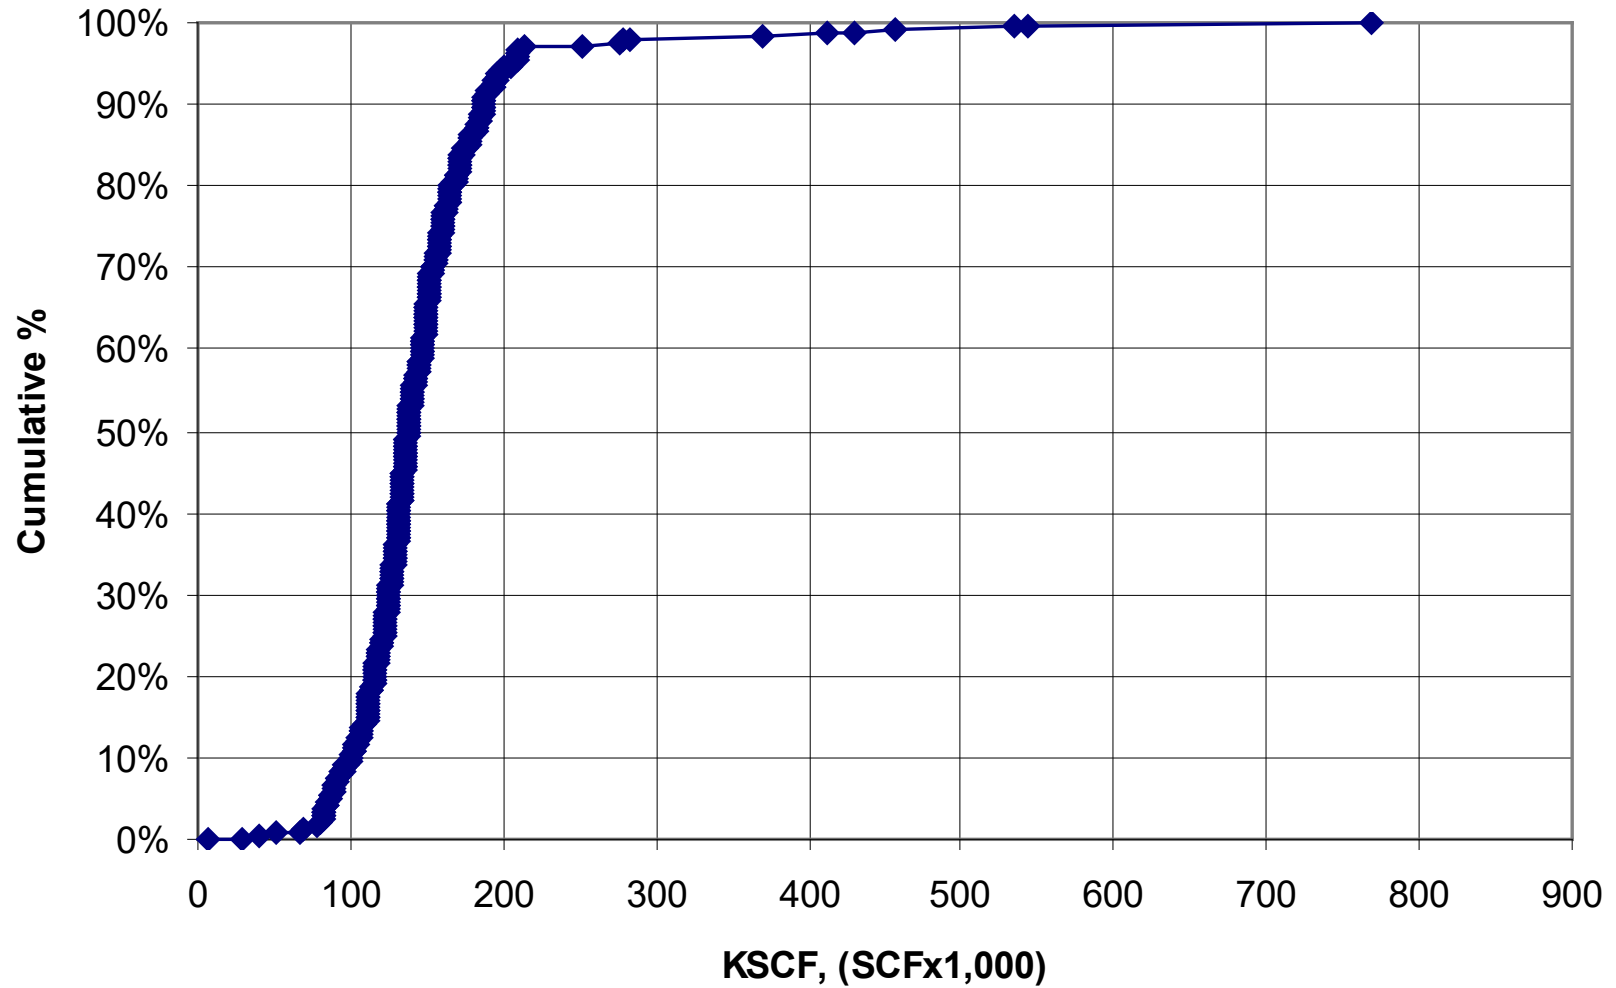
**Figure 13. OPCEN Hydrocarbon Flare Gas Volumes  
(2005)**

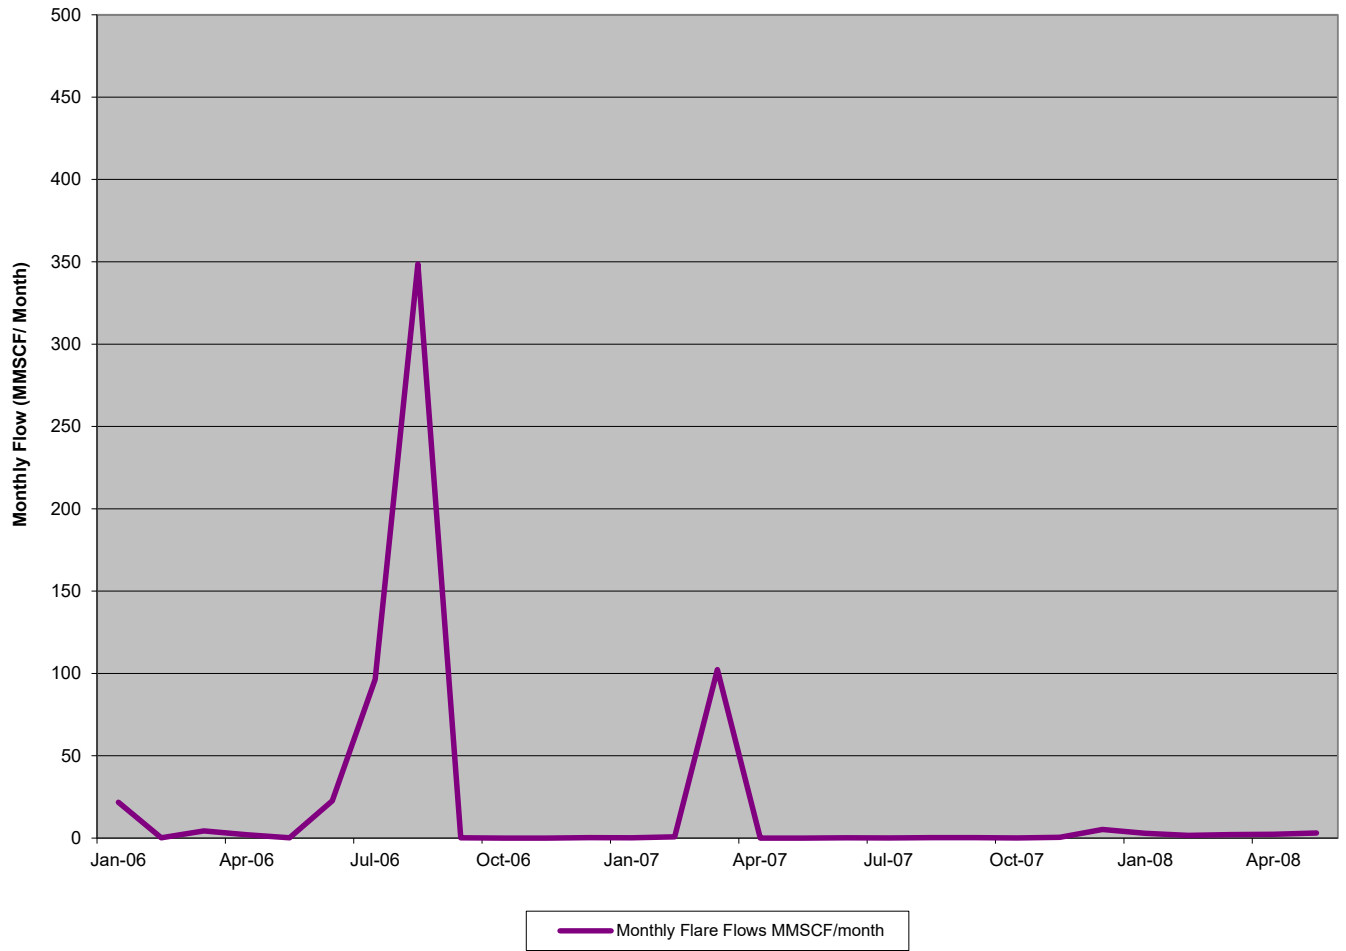
FIGURE 2008-5

FXG Flare Flows 1/1/06 - 6/1/08

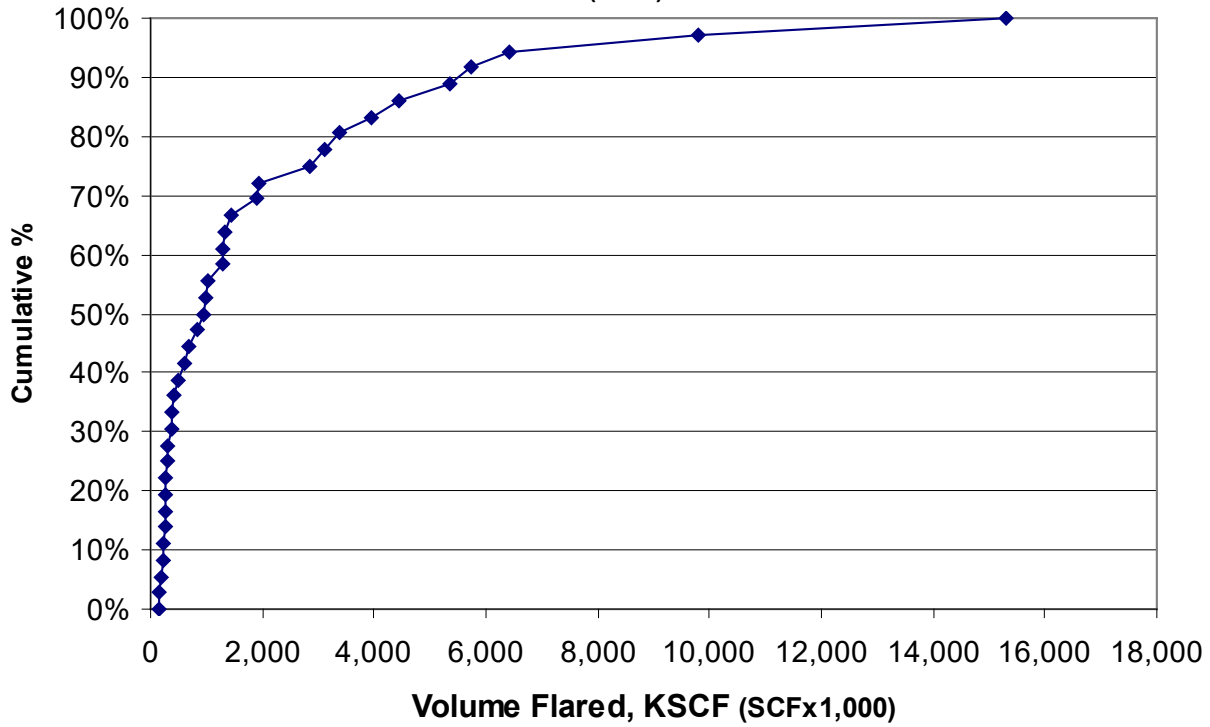
**Figure 16. Flexigas Flare Gas Volumes  
(2005)**

Historical flaring at the OPCEN Flexigas flare was reviewed to identify opportunities for potential mitigation. The highest quality data are available for the period from December 2003, to January 2006. This coincides with installation of the flare flow meter and BAAQMD flare reporting. Data for 2005 are plotted in Figure 15 and Figure 16.
