**Subject: MRC Flare Minimization Plan – Revised January 2025**

**FLARE MINIMIZATION PLAN**  
**MARTINEZ REFINING COMPANY**

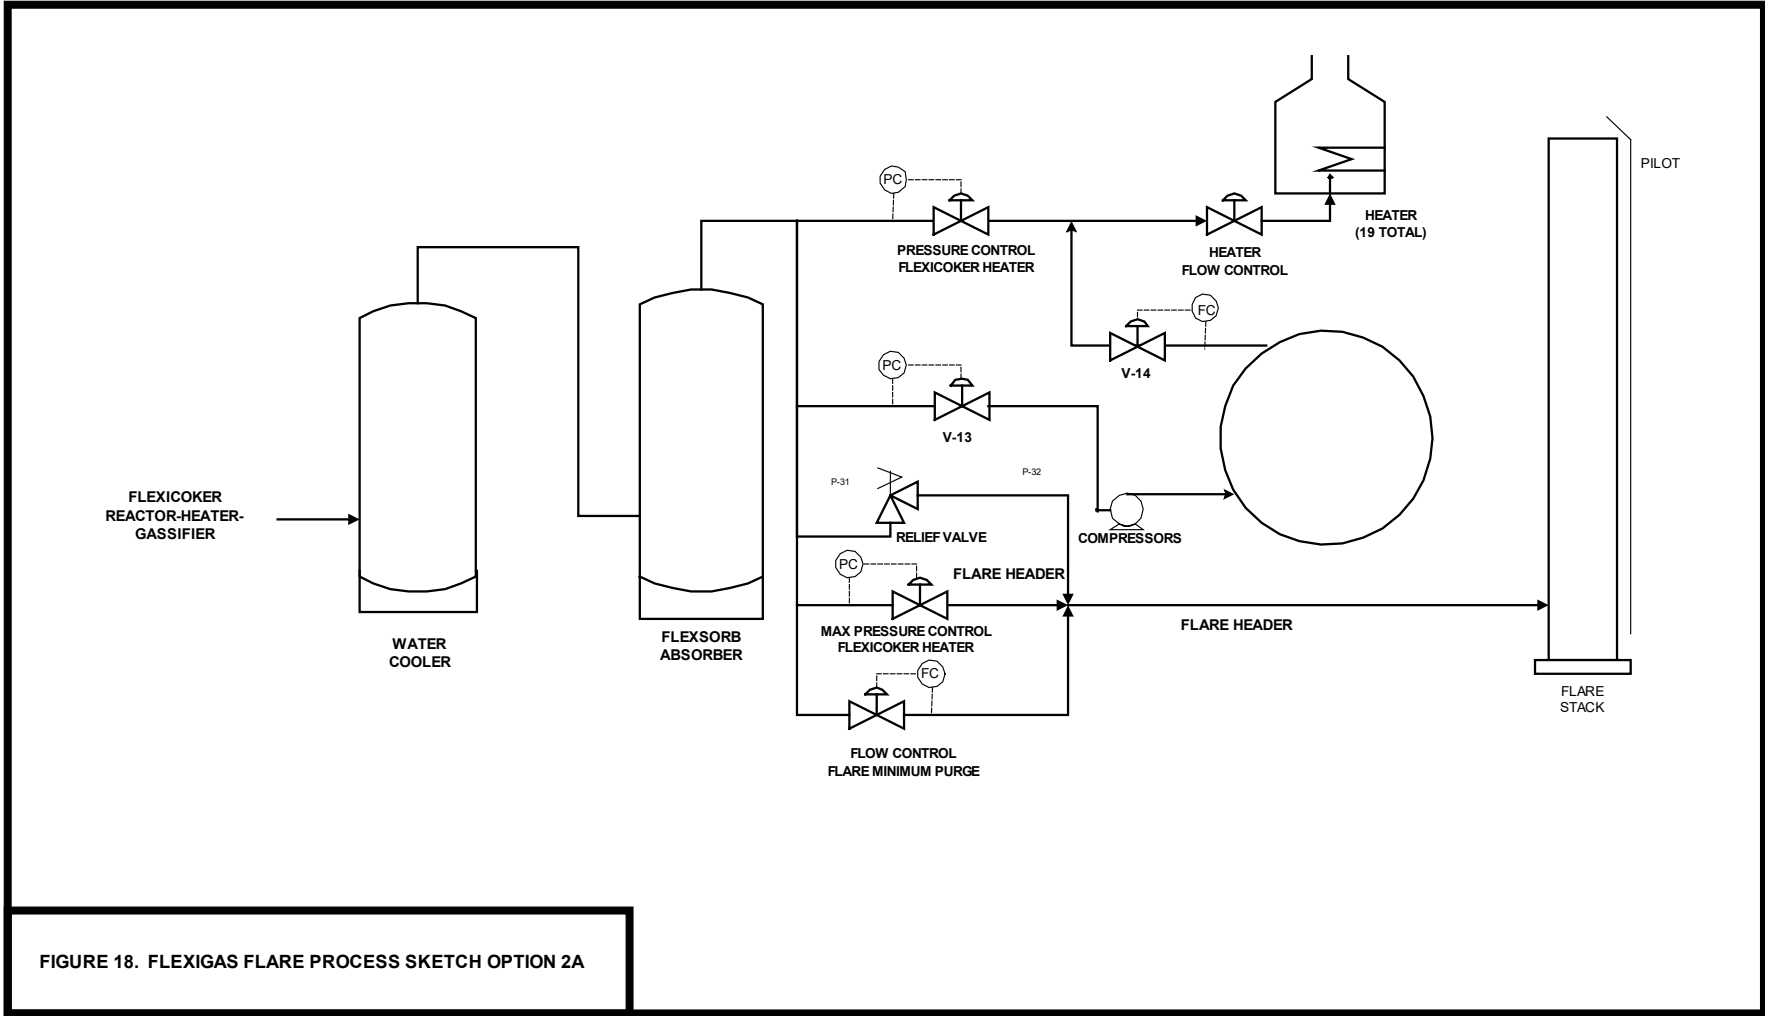
FIGURE 18. FLEXIGAS FLARE PROCESS SKETCH OPTION 2A

**Option 2A** consists of a pressurized vessel that would require a compressor with capacity ranging between 1 MMSCFD and 10 MMSCFD. This option is depicted in Figure 18. Flexigas in excess of consumer demand is routed to storage via compressor(s). A controlled flow is returned to the distribution system when enough consumers are available to avoid flaring. Due to the limited capacity of this storage, it has no real capability to accommodate prolonged fuel system imbalances. As a result, the expected best-case emission reductions are about the same as those available in 2005. A rough capital cost for the storage and large compressors is about \$27,000,000<sup>22</sup>. Annual electrical costs for the required compressors add another \$600,000. The annualized capital plus electrical costs to eliminate a ton of non-methane hydrocarbon result in a cost-effectiveness of approximately \$190 Million dollars per ton. Therefore, Option 2A is even less cost-effective for reducing flaring than Option 1.

<sup>22</sup> Based on a nominal 1 MMSCF sphere (60' diameter) at 120 psig, and two 4 MMSCFD compressors. This system would handle only minor imbalances while the Flexicoker cuts rate.

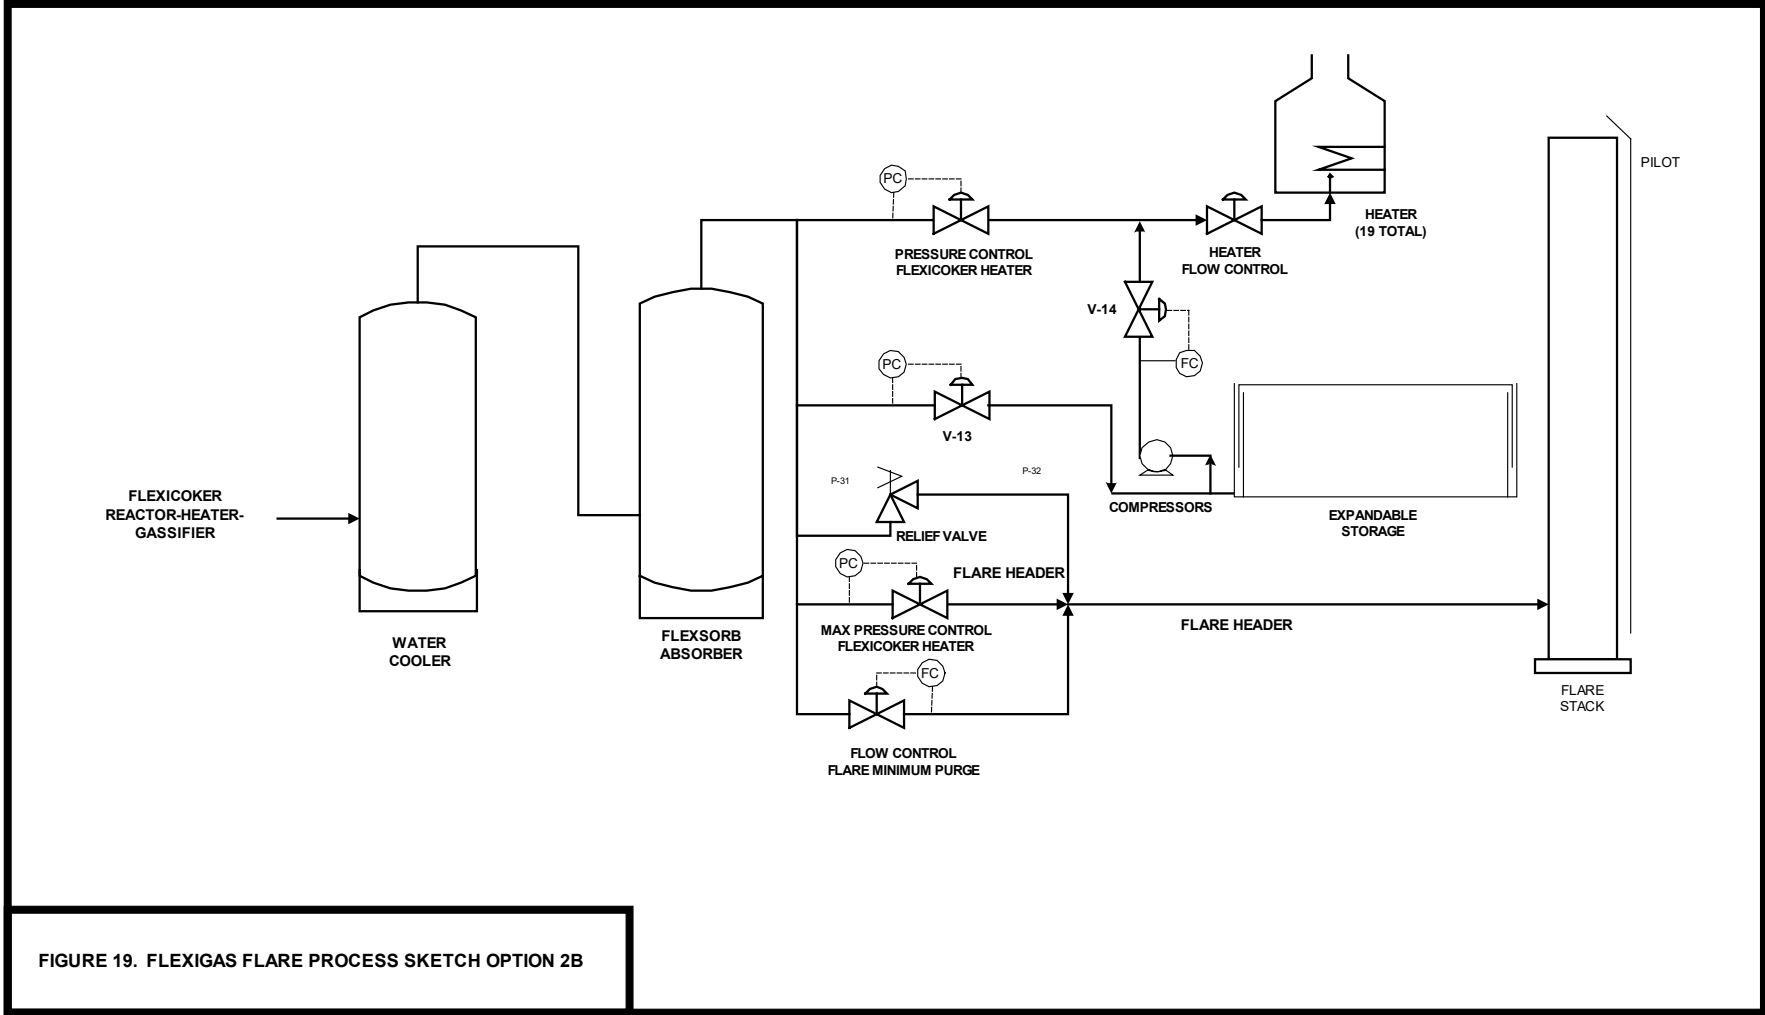
FIGURE 19. FLEXIGAS FLARE PROCESS SKETCH OPTION 2B

**Option 2B** uses low-pressure expandable gas storage. This option is depicted in Figure 19. This type of storage can be built significantly larger than the pressurized storage used in option 2A, and has the advantage of not requiring compressors in some cases. However, the concentration of carbon monoxide in the gas will likely require use of a water seal to limit leakage, restricting vessel height to a single lift. The requirement for a single lift, combined with low-pressure operation, significantly limits available storage volume<sup>23</sup>. In any event, the installed cost is approximately \$21,000,000, providing cost-effectiveness of approximately \$276 Million dollars per ton of NMHC. As was the case for Option 2A, this option is even less cost-effective for reducing flaring than Option 1.
