Subject: MRC Flare Minimization Plan – Annual Update October 2024

I certify that based on the information available to me, the 2024 Annual Update of Martinez Refining Company's Flare Minimization Plan dated September 26, 2024 is accurate, true and complete.

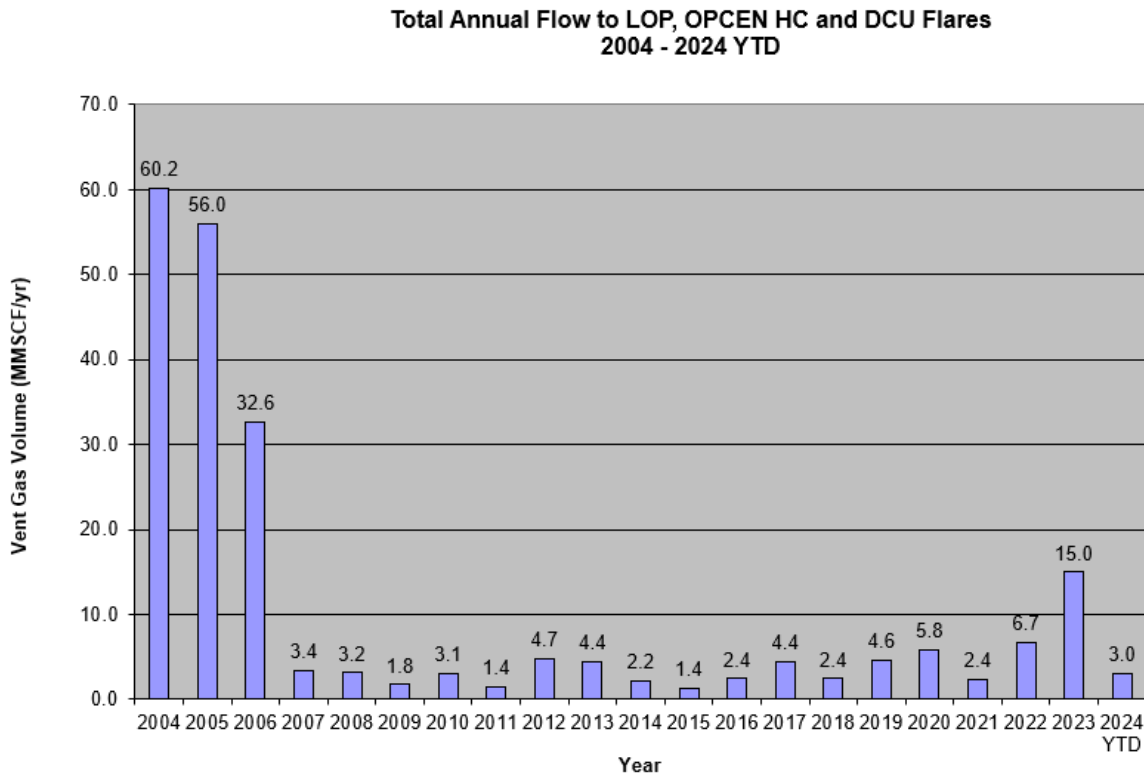
FIGURE ES-1

Figure ES-1 presents the total annual vent gas flow to the Light Oil Processing (LOP), Operations Central Hydrocarbon (OPCEN HC) and Delayed Coking Unit (DCU) Flares at the refinery from 2004 through June 30, 2024. Flare flow continues to be very low.

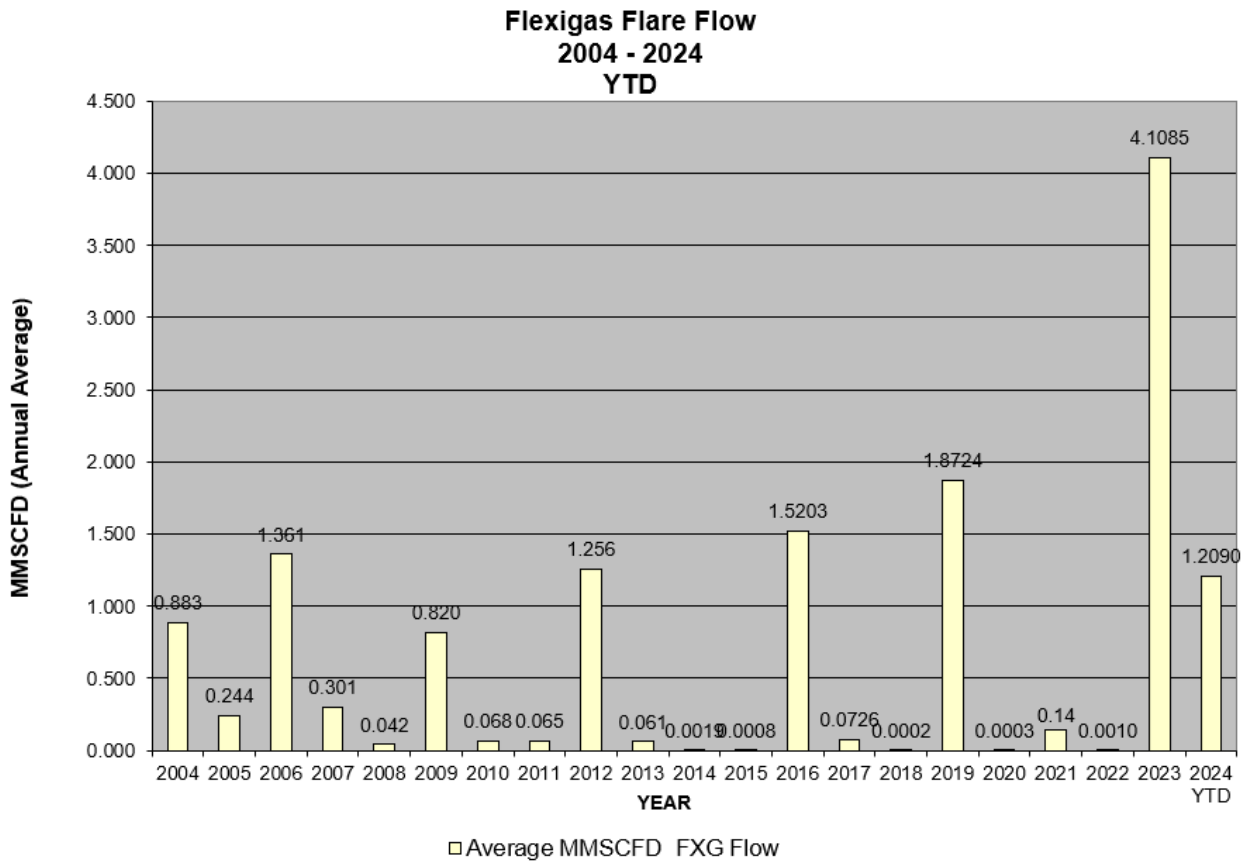
FIGURE ES-2

Figure ES-2 shows the annualized vent gas flow from the Flexigas Flare. This figure shows a cyclic increase in Flexigas flaring which occurs during years with startup and shutdown of the Flexicoker due to the nature of the Flexicoking and Flexsorb processes. The flaring of treated flexigas during startups and shutdowns of the Flexicoker is allowed up to specified limits in MRC's Title V permit. Flexigas is a very low BTU gas used as a supplemental refinery fuel gas in refinery process heaters. Flexigas is treated for sulfur removal in the Flexsorb Unit before being combusted either in refinery process heaters or if necessary, in the Flexigas Flare. When FXG is flared, the volume of gas is typically large compared to the volume flared in the other refinery process flares, but emissions are significantly less because Flexigas contains very low concentrations of non-methane hydrocarbon and sulfur.

Flexigas flaring can also occur due to refinery fuel gas imbalance. MRC continues to fine-tune the Flexigas pressure control scheme to minimize flexigas flaring due to small imbalances in fuel gas. Improvements in this system, most notably addition of COGEN to the pressure control scheme, contribute to the very low flexigas flare flow rate seen in non-turnaround years including 2013, 2014, 2015, 2017, 2018, 2020, 2021, and 2022.

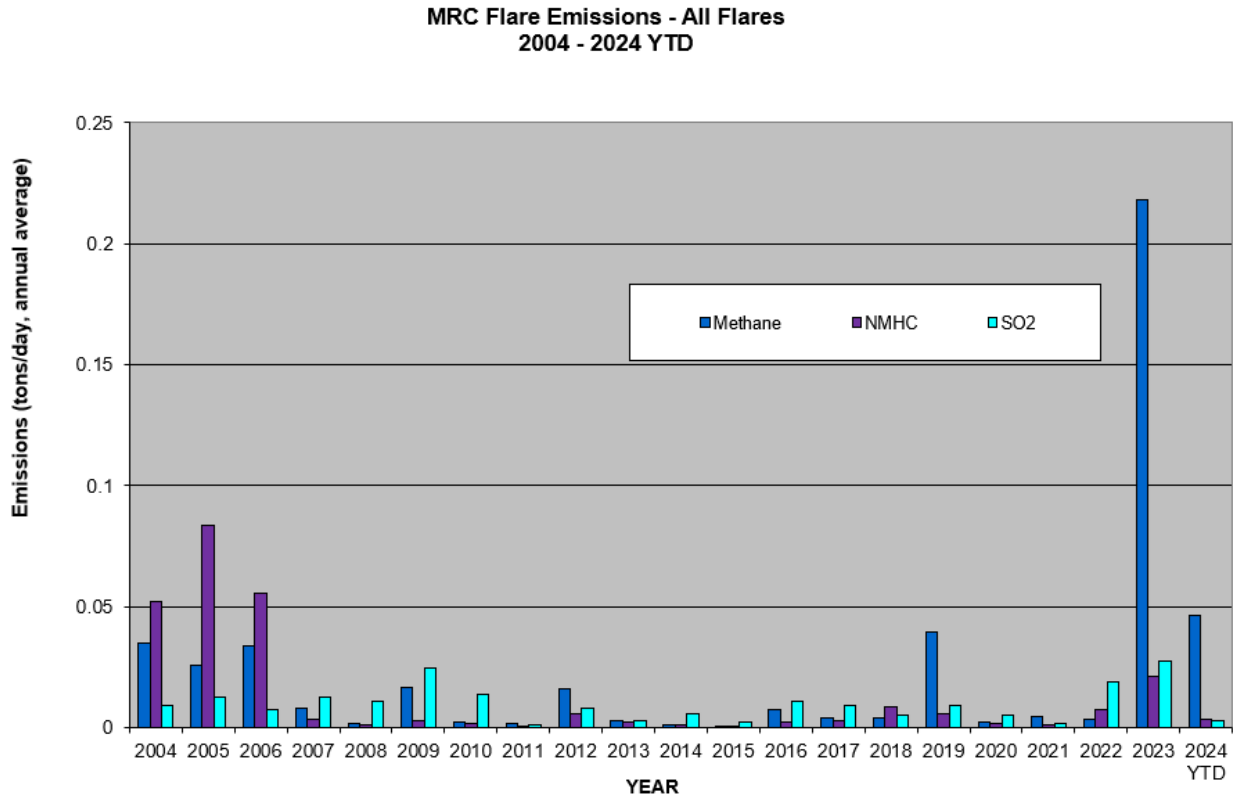
FIGURE ES-3

Figure ES-3 shows the methane, non-methane hydrocarbon, and sulfur dioxide emissions from all four refinery process flares from 2004 through June 30 of this year.

Figure ES-3 shows the overall significant reduction in emissions that has occurred since the implementation of the Flare Minimization Plan in 2006 and highlights that even with large volumes of flexigas flaring during turnaround years, overall emissions from flaring are low.

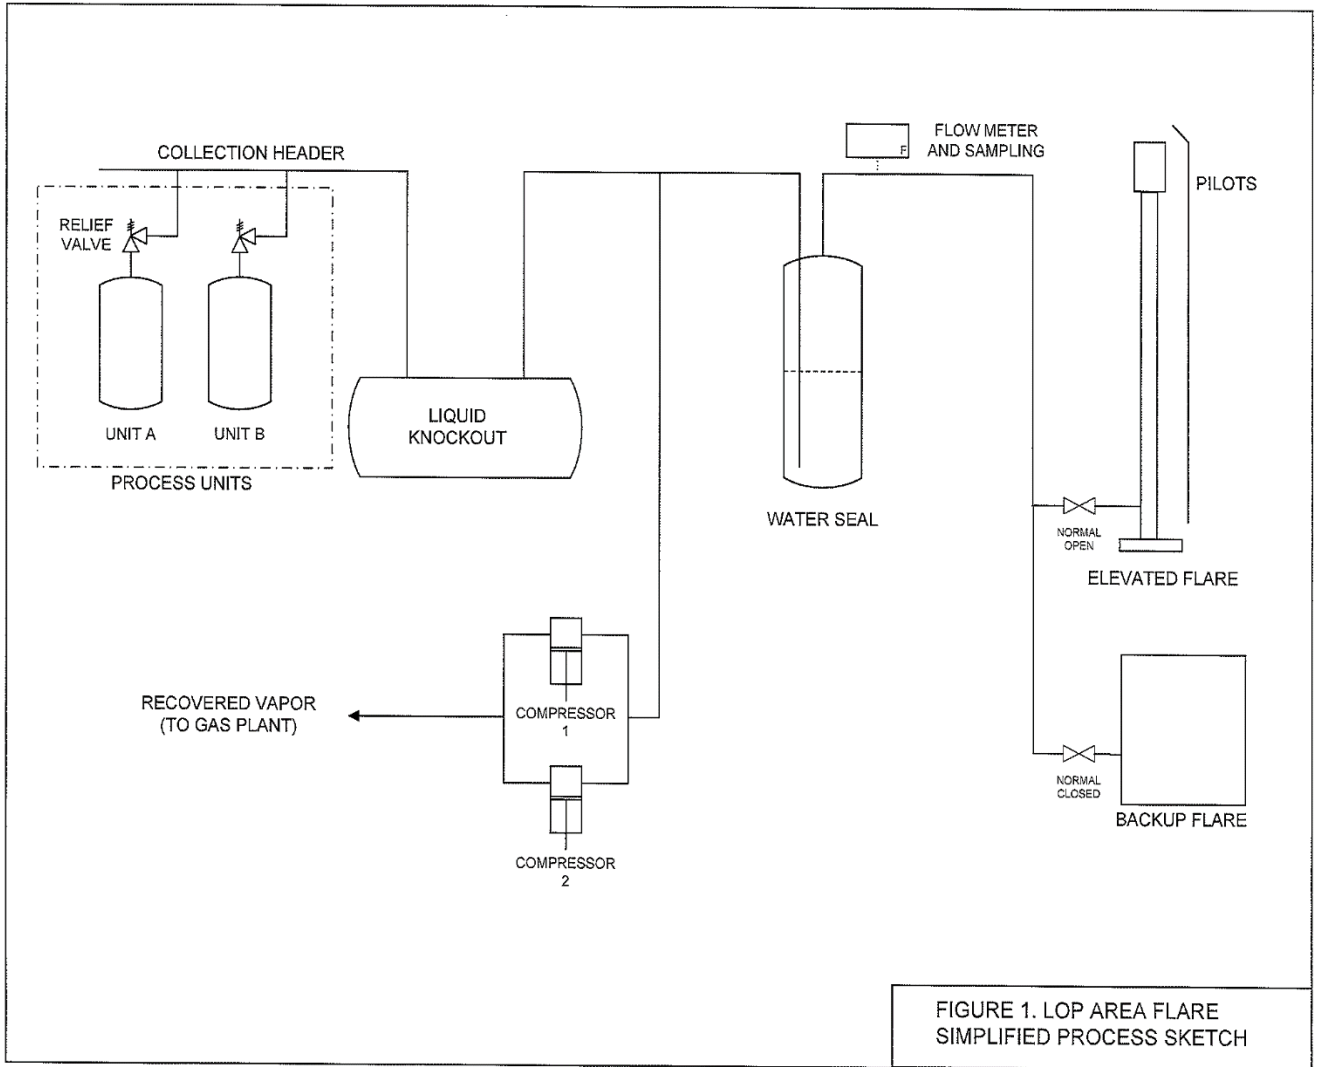
FIGURE 1. LOP AREA FLARE SIMPLIFIED PROCESS SKETCH

The LOP Flare system is comprised of collection headers, liquid knockout vessels, two flare vapor recovery compressors, piping to route recovered gas to fuel gas treaters, a water seal vessel, the flare header proper, and the flare stack. The LOP flare is an elevated, steam-assisted flare with nitrogen purge to prevent air intrusion. Piping and valves provide sufficient flexibility to operate in various configurations, allowing continuous and reliable operation during turnarounds, inspection and maintenance activities without flaring. Maintenance of the elevated flare (S#1471) is accomplished by putting an alternate flare in service. This alternate flare (Backup Can Flare, S#1472) is normally blinded and is only used when the elevated flare is out of service for inspection or repair. A sketch of the LOP Flare system is provided in Figure 1. Technical details of the system are provided in Appendix A².

Recovered flare gas is treated to remove hydrogen sulfide and condensable liquids. Treated gas is routed to the fuel gas system. The fuel gas treaters typically used for LOP recovered flare gas are located in the Catalytic Cracker Gas Plant (CGP). When this unit is unavailable for any reason, recovered gas may be routed to the Saturates Gas Plant (SGP). Sufficient capacity can be made available in both sets of treaters for the incremental flow up to the total capacity of both compressors of about 6.4 MMSCFD.

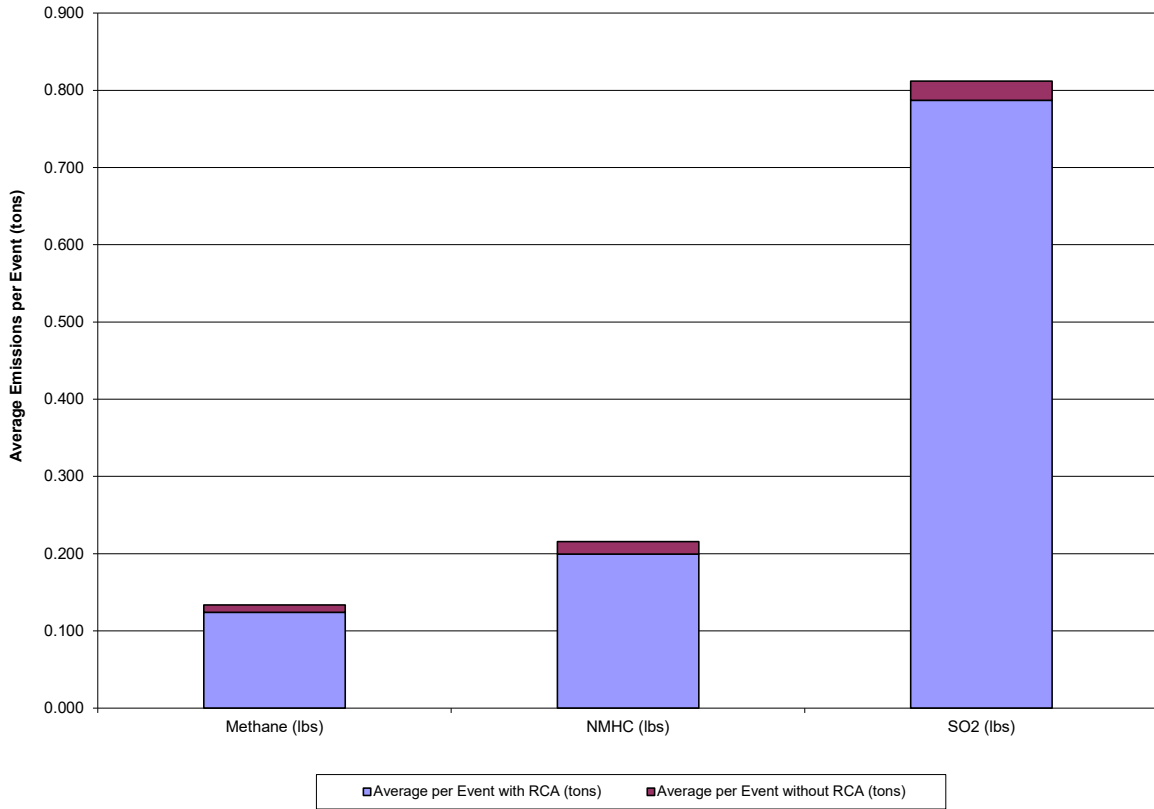
FIGURE 2008 -1

LOP Flare Events w/ Causal Analysis vs. Small Events
1/1/06 - 6/1/08

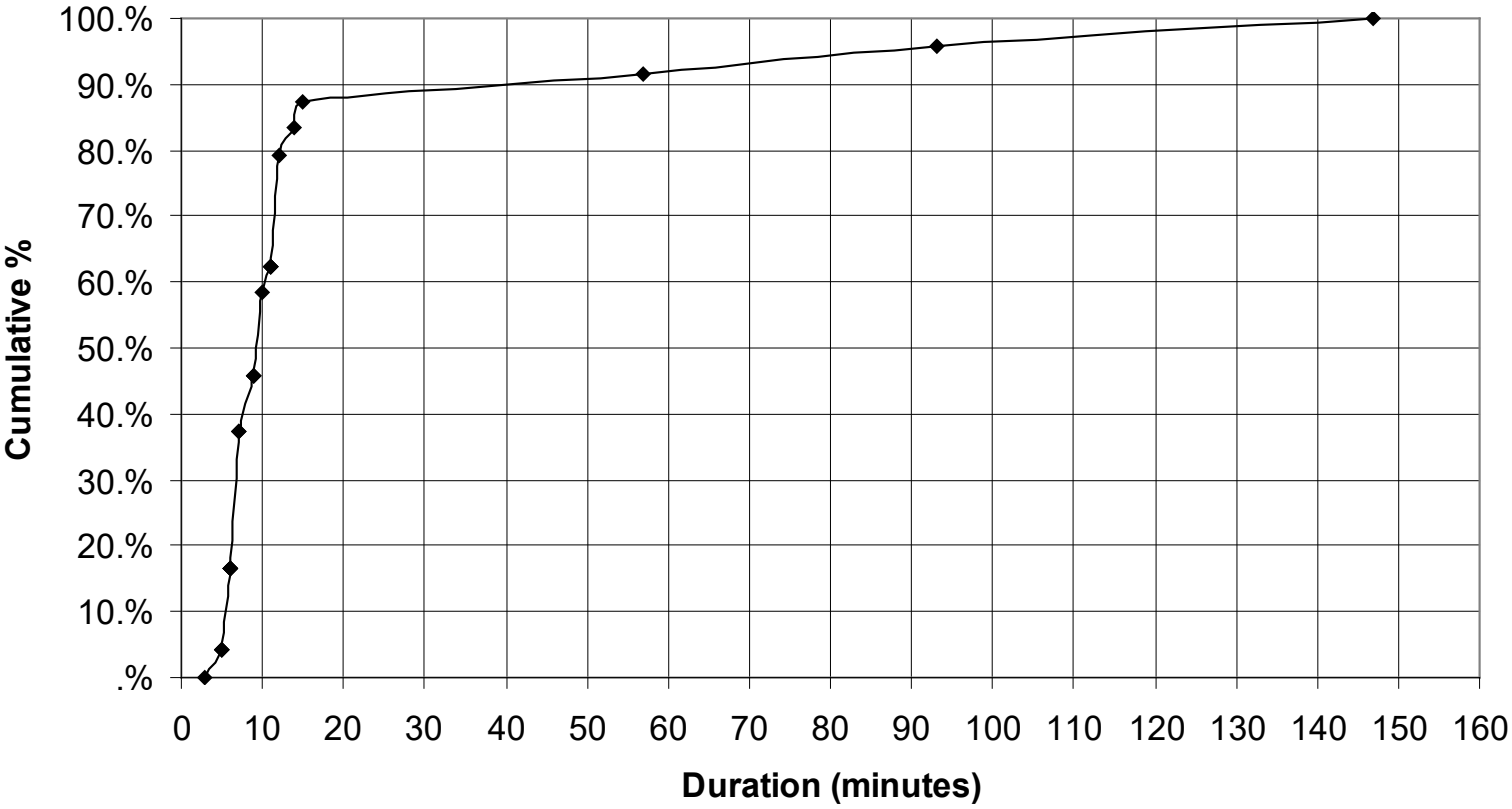
Figure 5. LOP Flare Durations
(2005 - 25 Events)

Figure 5 depicts the distribution of flare event durations for 2005, the year for which these data are available. Most flare events have very short durations with small volumes of gas flared. From

Figure 5 it can be seen that half of the flare events had durations of less than 10 minutes. By combining event durations with additional data on the volume flared during each event, it can be shown that the 50% of events with durations less than 10 minutes contributed less than 10% to the total volume of gas flared. The 85% of events which lasted 15 minutes or less contributed less than 40% to the total volume flared. Only three of the flare events during this period lasted longer than one hour. All of the event durations were less than three hours.

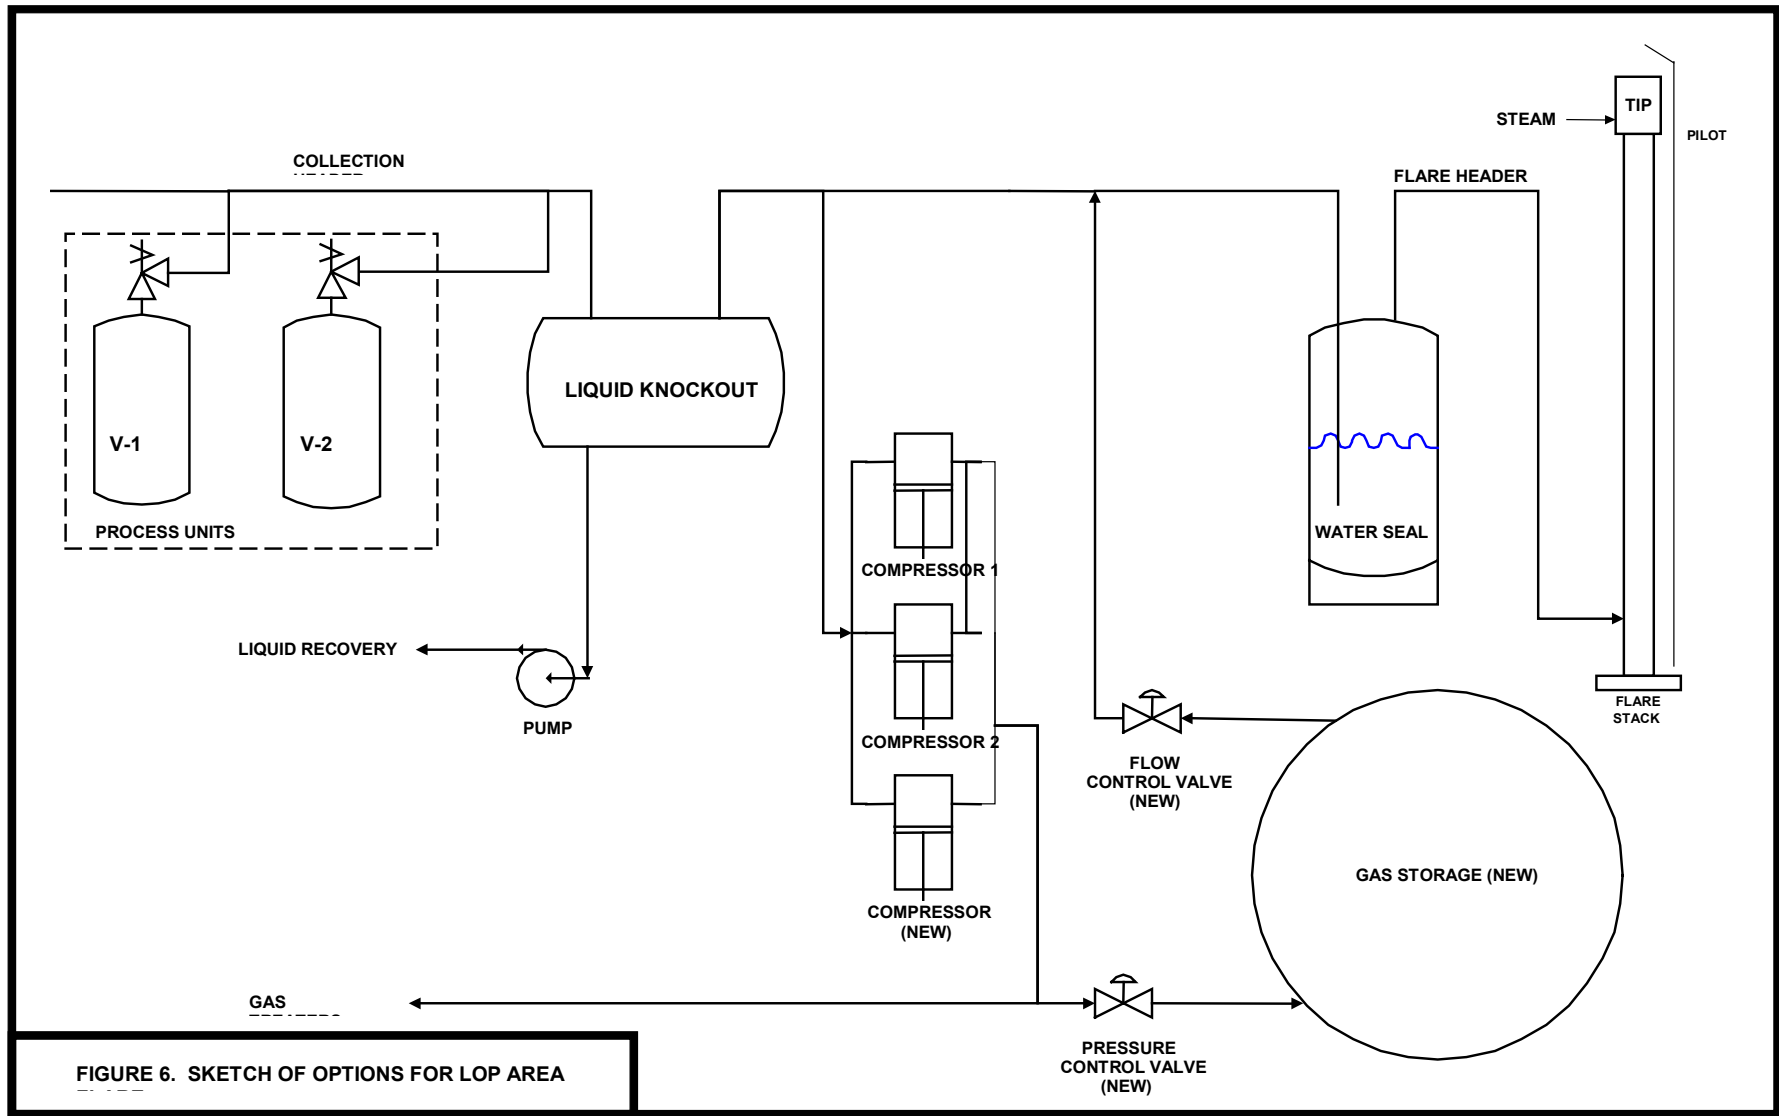
FIGURE 6. SKETCH OF OPTIONS FOR LOP AREA

Tables 1A and B depict the increased flare gas recovery and annual costs and benefits for the revised facilities considered. The evaluation makes use of data from actual flare events for calculation of potential benefits and conservatively assumes that all emissions can be eliminated, including those resulting from emergencies. Excluding the emergency emissions would result in even a higher cost per ton reduction. The evaluation below is calculated on the basis of emission reductions using the reported emissions from 2005. Even with the very conservative assumptions used in the calculations, the most cost-effective measure is still not feasible.

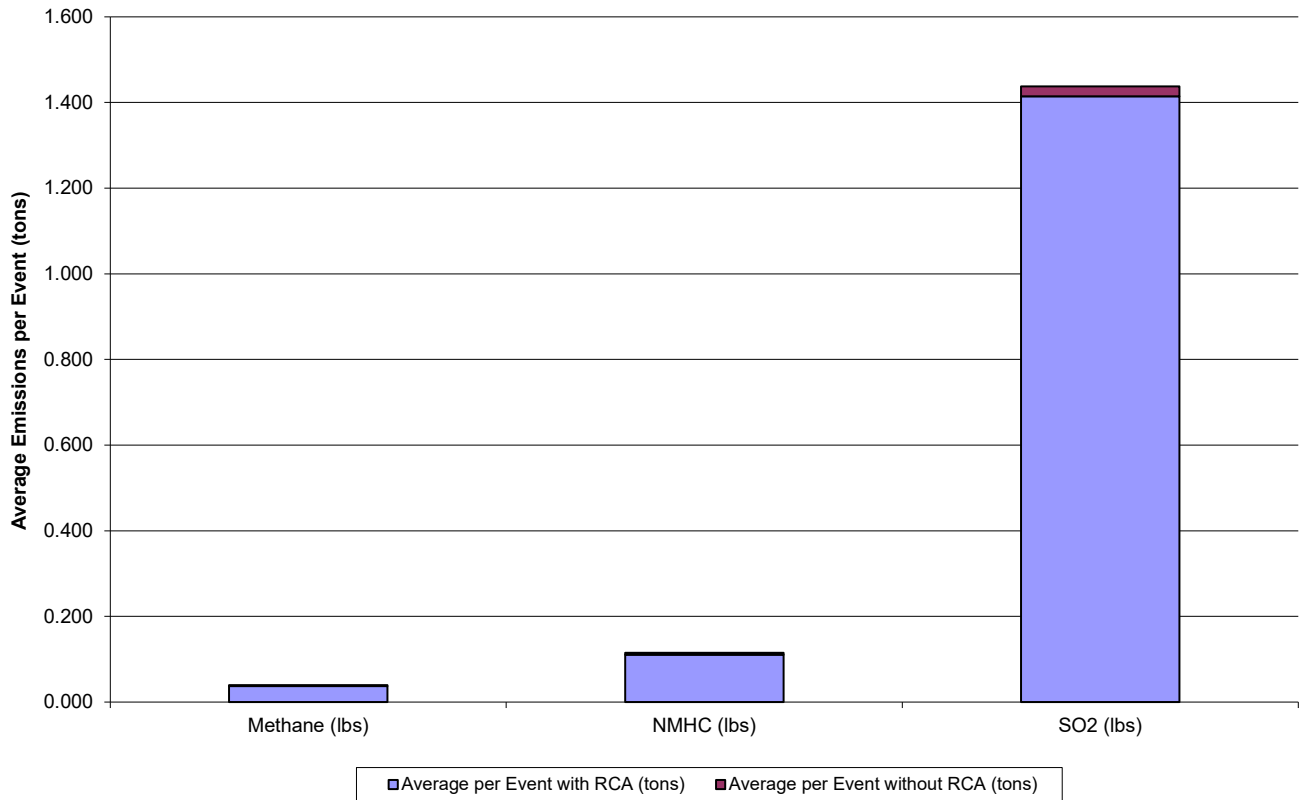
FIGURE 2008-2

Beginning in November 2006 with the adoption of the Flare Procedures described in the Common Measures Section, pertinent information, when available, was captured immediately after a flaring event to determine the cause of any flaring and what could be done to prevent it from happening again. Total emissions from all flaring during this 30-month period were: 0.17 tons of methane, 0.45 tons of non-methane hydrocarbon and 4.19 tons of SO₂. Figure 2008-2 presents a comparison of the average emissions per large reportable events over this time period vs. the average emissions per small event for the DCU Flare. This figure shows that small events contributed < 6% of the emissions of a large event. Figure 2008-2 reinforces the appropriateness of the causal analysis trigger of 0.5 MMSCF/ 500 lbs SO₂ to ensure the resources to conduct a Causal Analysis are most effectively applied to address high emission events.

**DCU Flare Events w/ Causal Analysis vs. Small Events
1/1/06 - 6/1/08 Without Causal Analysis**

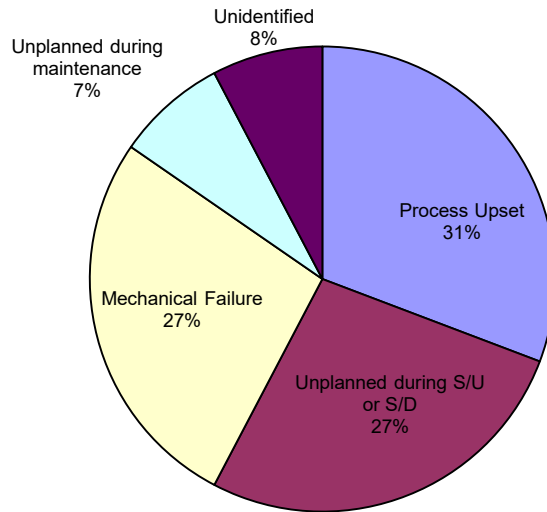
FIGURE 2008 - 3

The DCU flare events that occurred from 1/1/06 – 6/1/08 were categorized by probable cause in Figure 2008-3. None of the flaring was planned. Most of the events were < 10 minutes long. The majority of the events were caused by process upset, mechanical failure or were unplanned during startup and shutdowns.

**Probable Cause of Flaring on DCU Flare 1/1/06-6/1/08
26 Events**

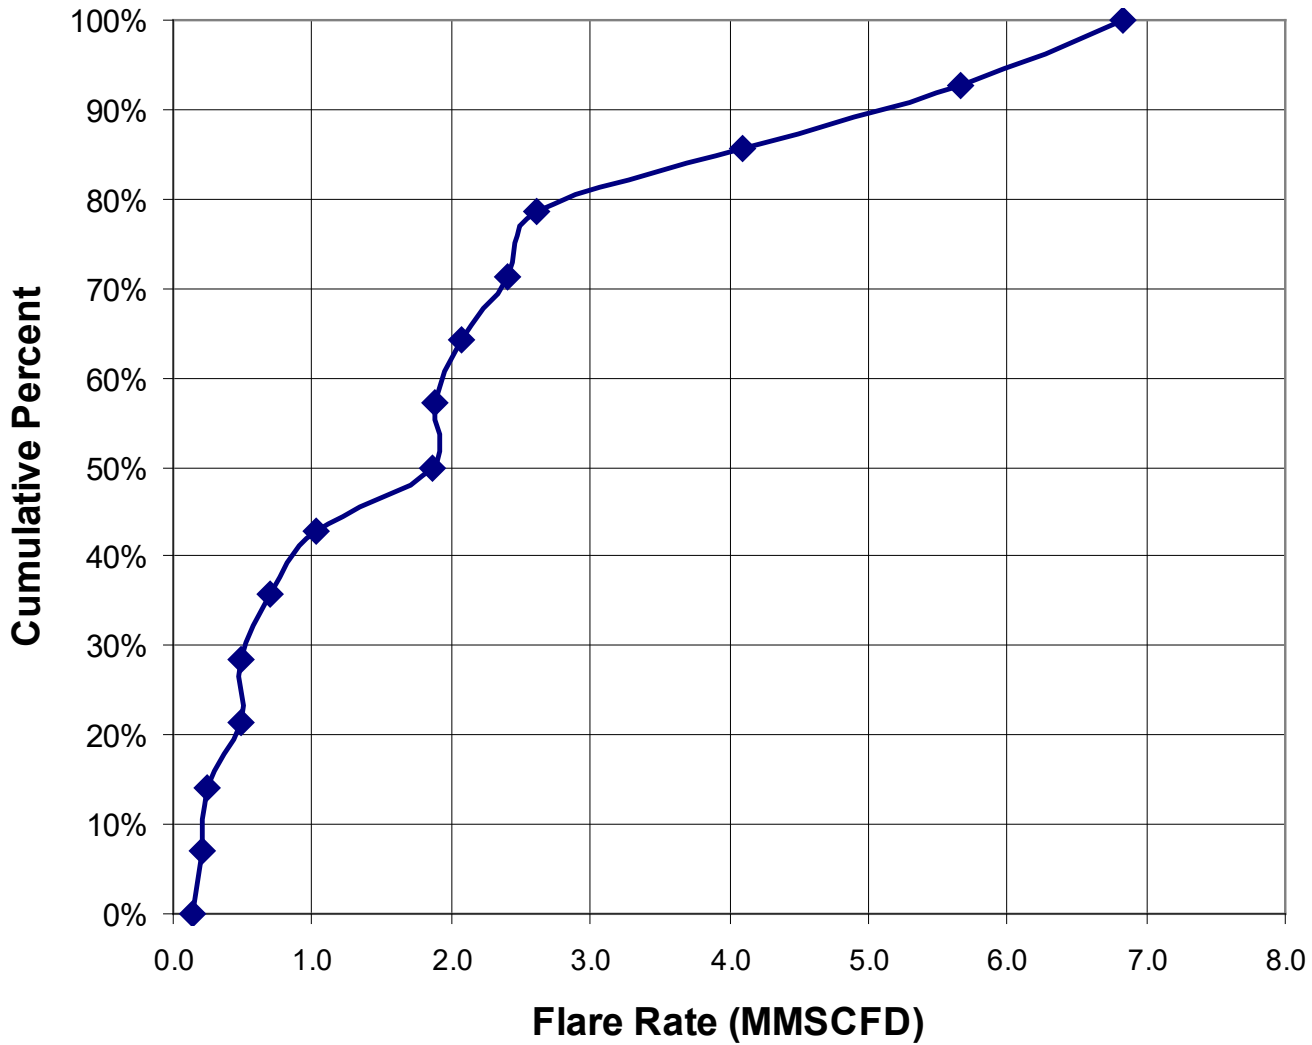
**Figure 10. Delayed Coking Area Flare Gas Flow Rates
(2005)**

Figure 10 depicts the average rates of flow to the flare for events occurring in 2005. These data indicate that approximately 80% of the flare events had event-average flow rates less than 3 million standard cubic feet per day. Actual instantaneous rates comprising the average are generally higher – often significantly – than these average rates.

Flaring during 2005. The highest quality data are available for the period from January 2005 to January 2006. Data is available during this period from flare flow meters and monthly BAAQMD flare reporting. Available data for flare event volumes and durations are provided in Figures 9 through 11 below.

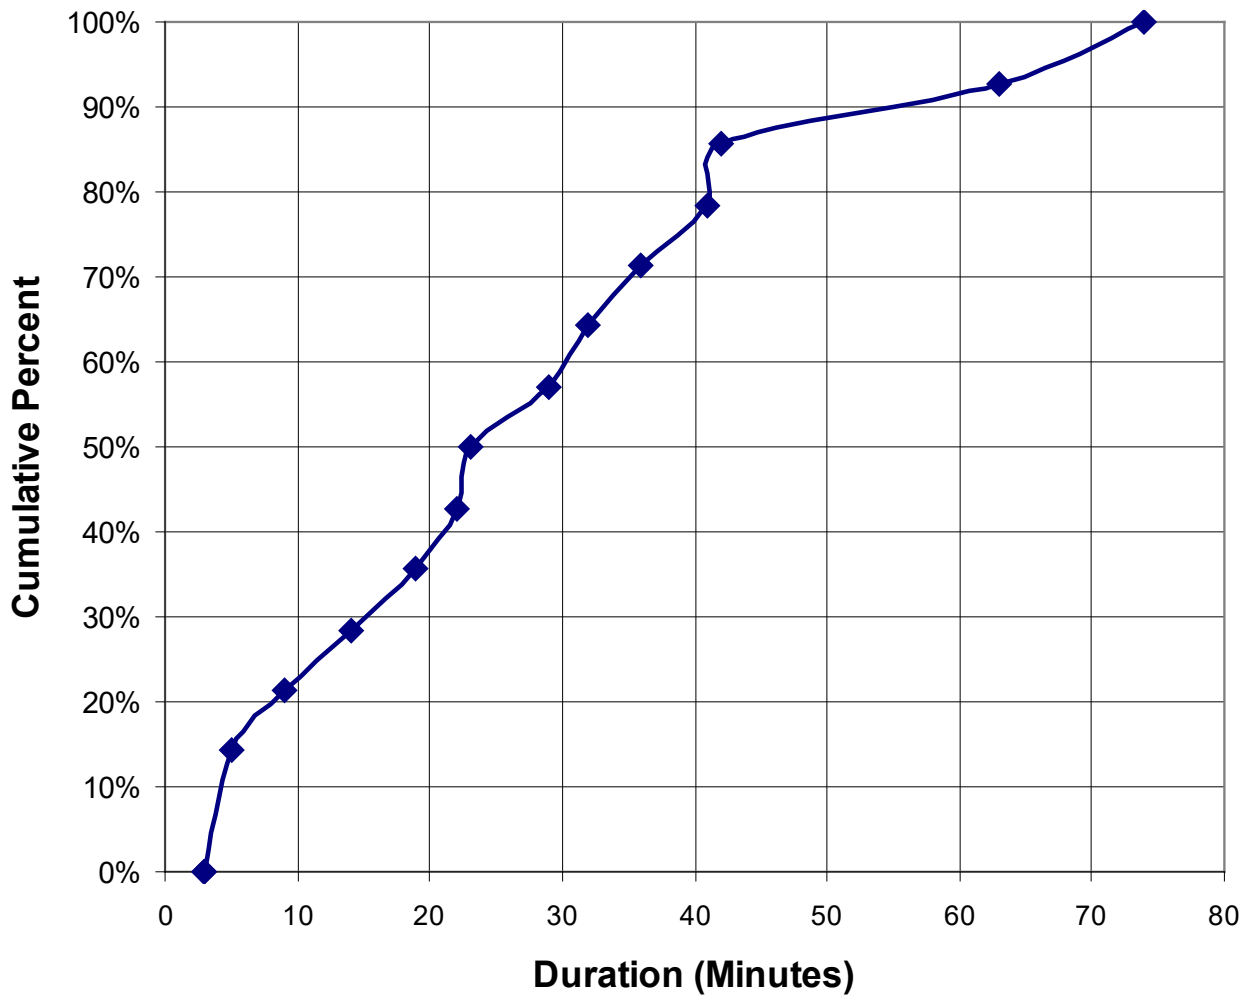
**Figure 11. Delayed Coking Area Flare Event Durations
(2005)**

Figure 11 depicts the distribution of flare event durations for 2005 where these data are available. 50% of the events lasted less than 30 minutes. This is consistent with other data characterizing the bulk of flare events being very brief.

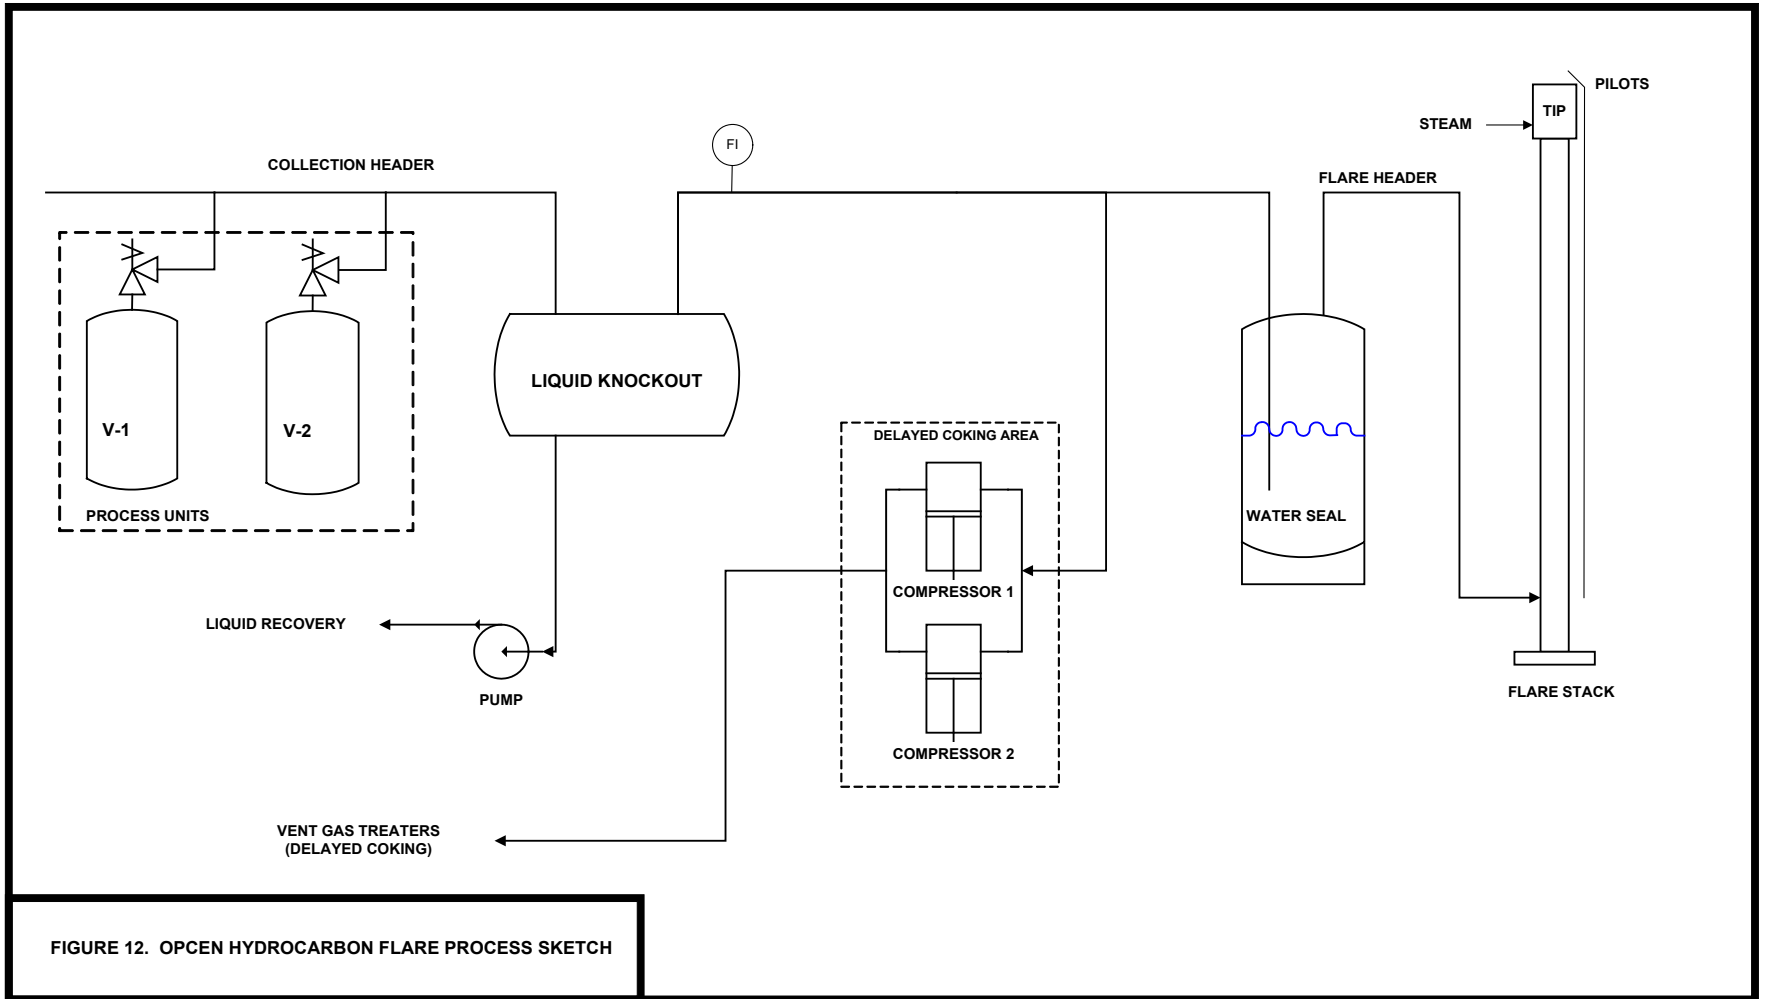
FIGURE 12. OPCEN HYDROCARBON FLARE PROCESS SKETCH

Process units in the OPCEN area are served by a dedicated flare system. This flare was modified by a project to provide flare vapor recovery. The vapor recovery project was operational in November 2006. A sketch of the flare system is provided in Figure 12. The OPCEN HC flare system is comprised of collection headers, a liquid knockout vessel, a water seal vessel, piping to flare gas recovery compressors and gas treating, the flare header proper, and the flare¹⁶. Additional details of the flare are provided in Appendix C.

Recovered gas from OPCEN is treated to remove H₂S and routed to fuel and hydrogen plant feed along with the recovered gas from Delayed Coking. The normal routing for Delayed Coker Area recovered flare gas is the Vent Gas Treater. Sufficient capacity is available for the incremental flow (up to the total recovery compressor capacity of about 8 MMSCFD).

¹⁶ This figure includes the flare gas recovery system with the modification. Due to the need for a general shutdown of process units in the OPCEN area, the system was not operable in time for the August 1, 2006 original submittal of this plan. Post-project facilities are used as the basis for system description. However, the historical performance of this flare obviously provides little basis for evaluating mitigation options beyond the implemented flare gas recovery.

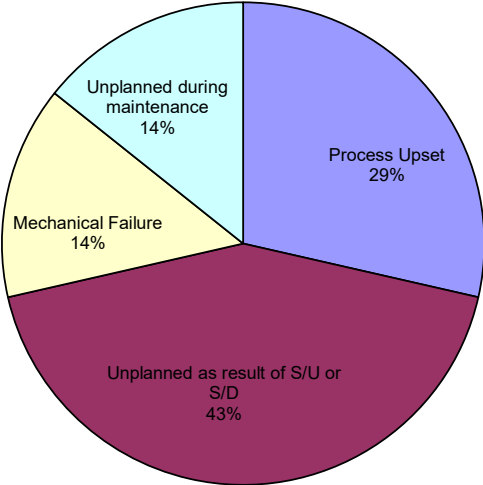
FIGURE 2008-4

OPCEN HC Flare- Cause of Flaring 11/1/06 - 6/1/08
7 Events

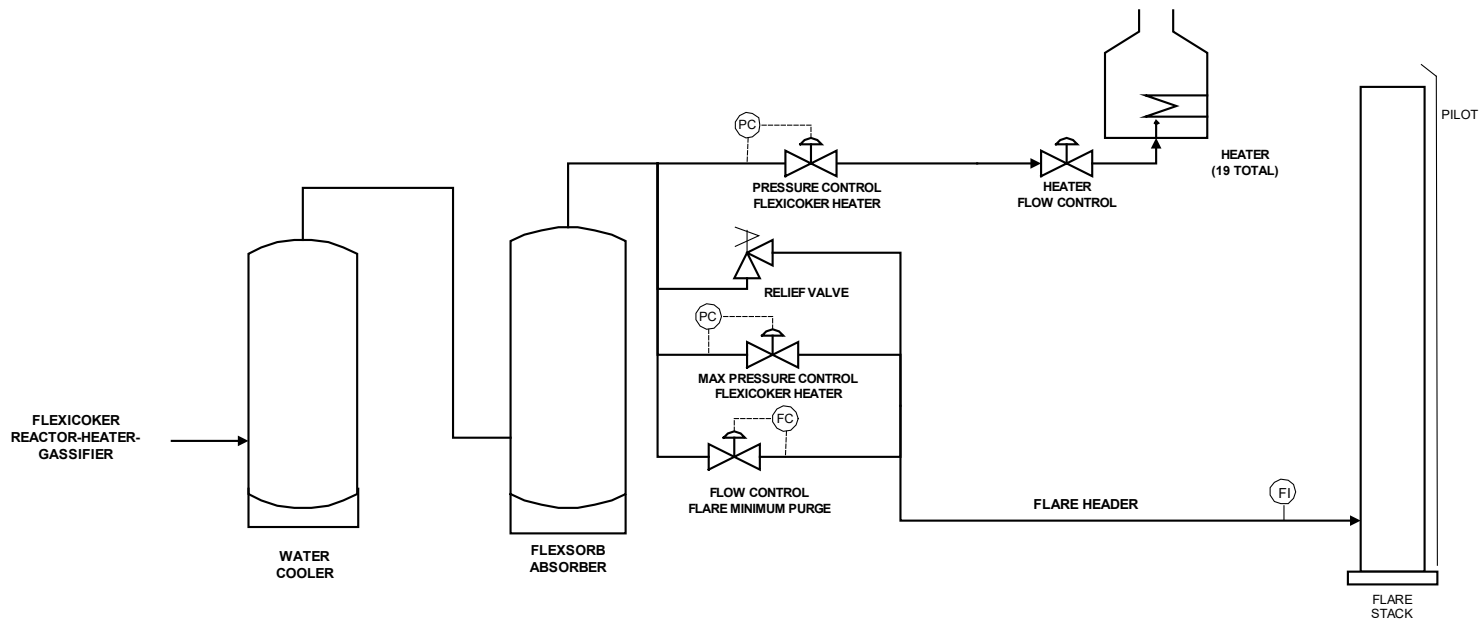
FIGURE 14. FLEXIGAS SUPPLY SYSTEM PROCESS SKETCH

The OPCEN Flexigas flare is a dedicated flare serving the Flexicoker Reactor/Heater/Gasifier. The Flexigas flare only combusts flexigas (FXG). This flare differs significantly from all other process flares serving Bay Area refineries for reasons described below. A simplified process sketch is provided in Figure 14. Details of the system are provided in Appendix D.

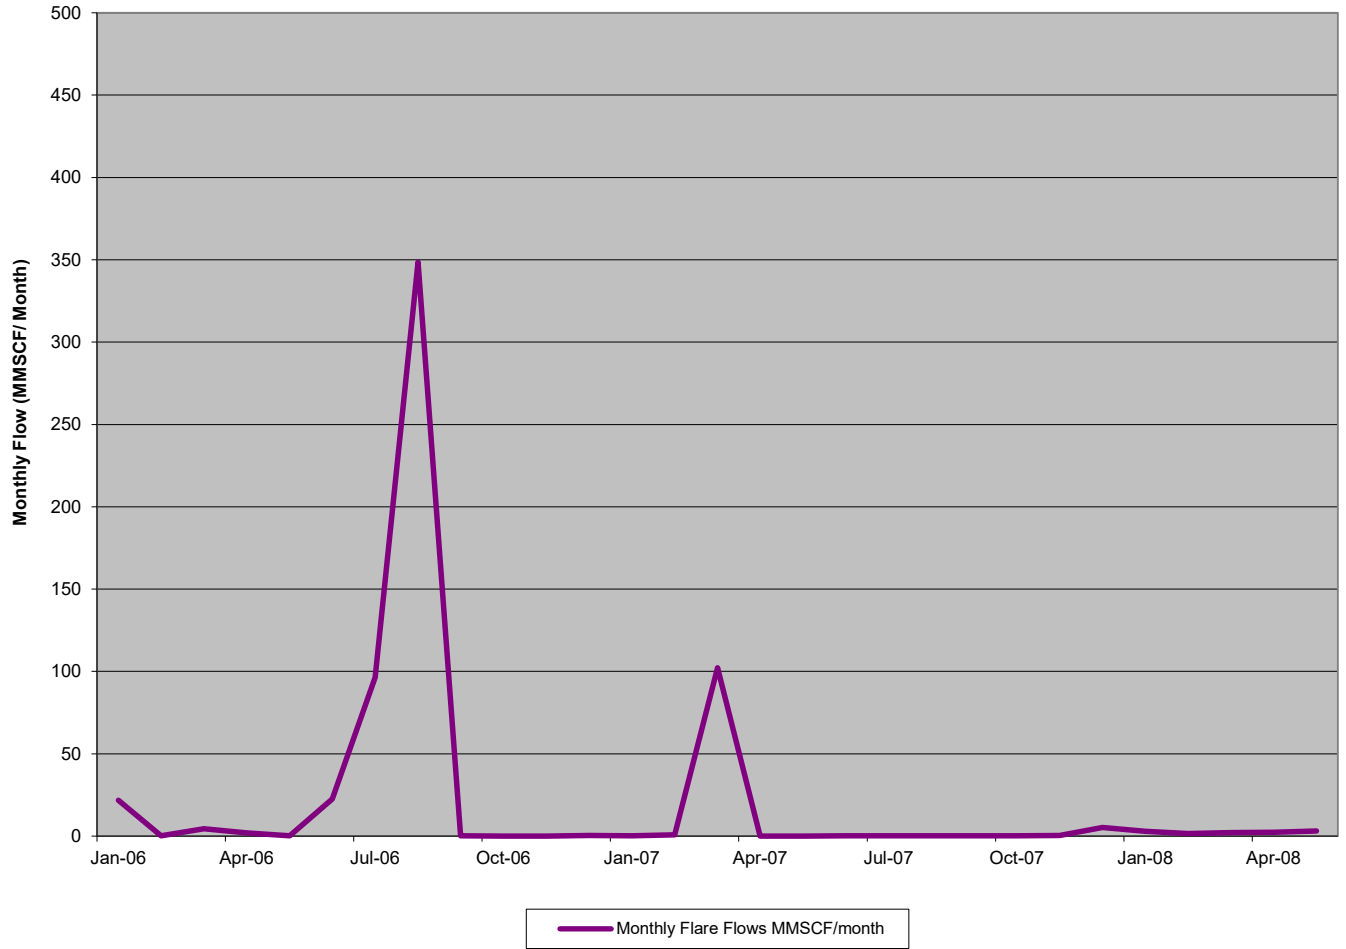
FIGURE 2008-5

FXG Flare Flows 1/1/06 - 6/1/08

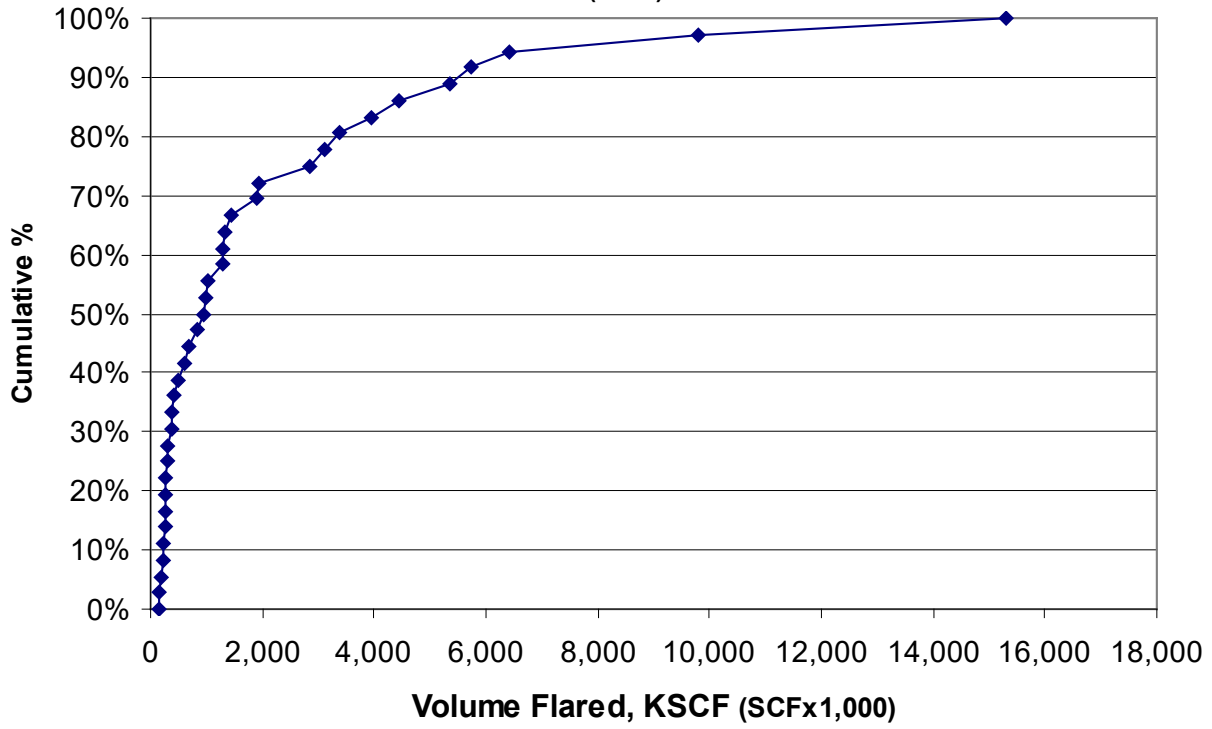
**Figure 16. Flexigas Flare Gas Volumes
(2005)**

Historical flaring at the OPCEN Flexigas flare was reviewed to identify opportunities for potential mitigation. The highest quality data are available for the period from December 2003, to January 2006. This coincides with installation of the flare flow meter and BAAQMD flare reporting. Data for 2005 are plotted in Figure 15 and Figure 16.

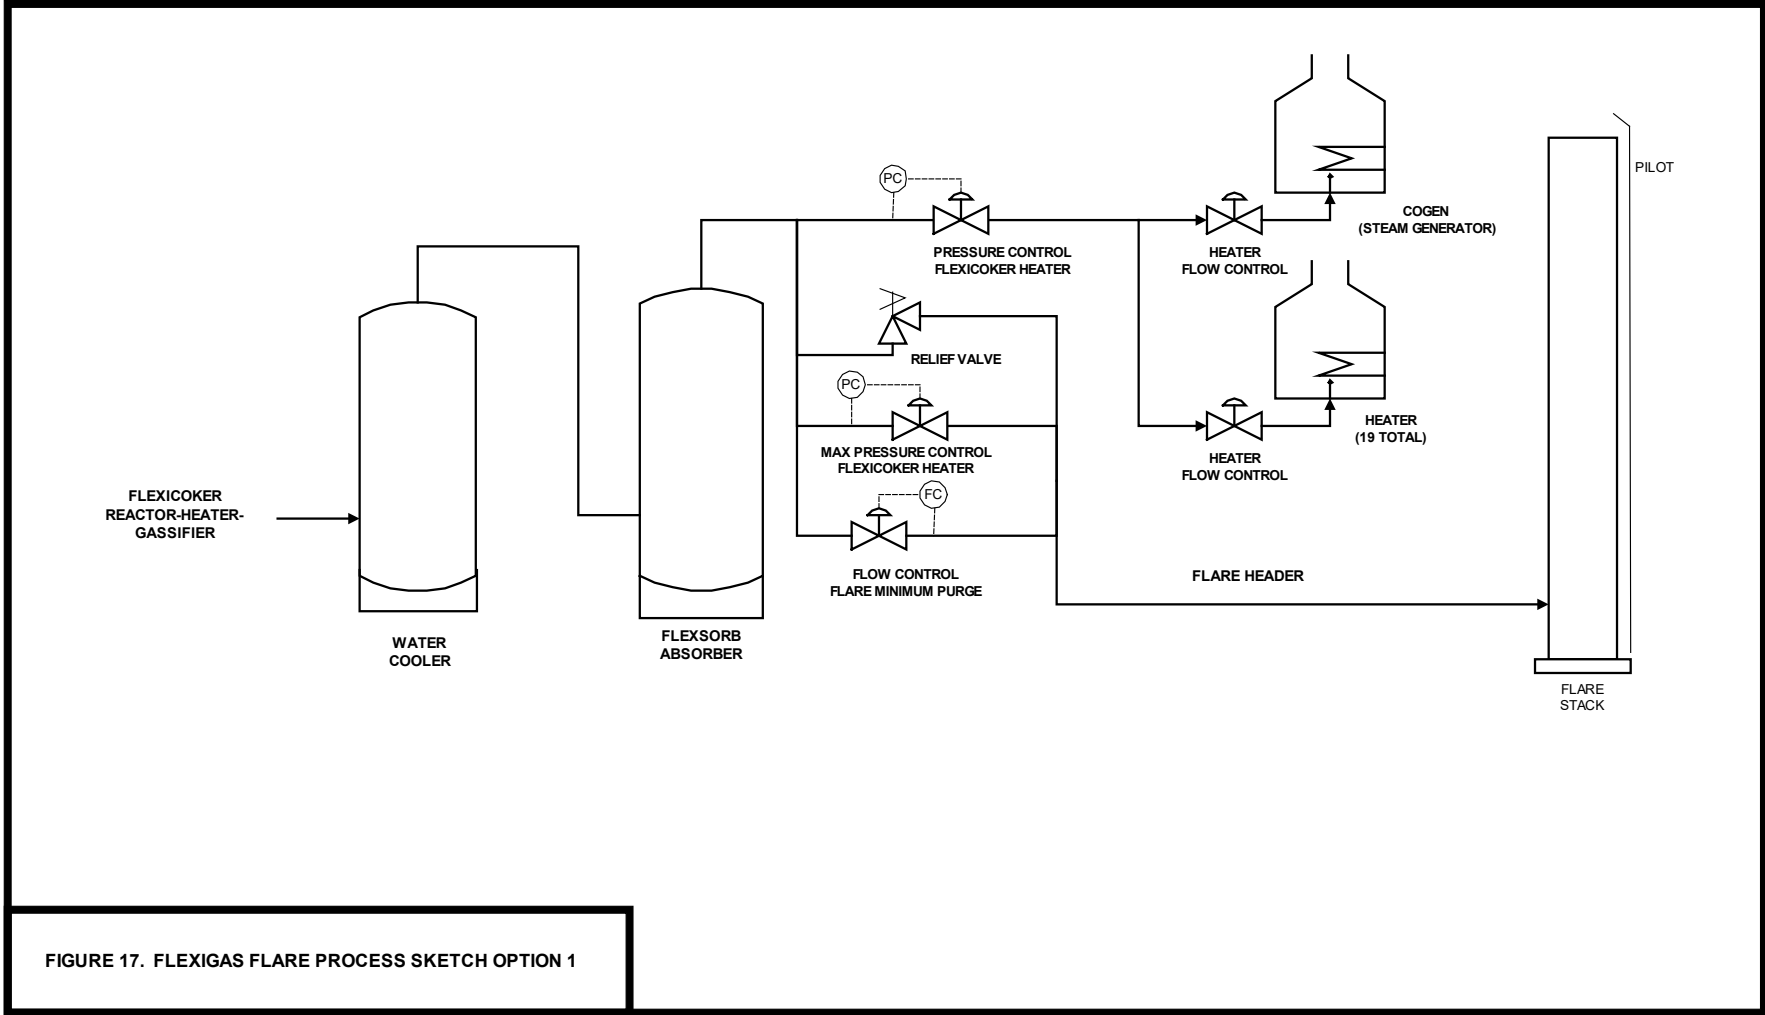
FIGURE 17. FLEXIGAS FLARE PROCESS SKETCH OPTION 1

OPTION 1: PROVIDE ADDITIONAL FLEXIGAS CONSUMERS (see Figure 17).

The objective of this project would be to provide an additional consumer that can rapidly pick up the Flexigas volumes made available by loss of another consumer (e.g., process heater) for any reason. Because excess Flexigas is available less than 10% of the time (based on the percent of days on which flaring occurred from Figure 16), and the current fuel system is roughly in balance, this consumer must essentially remain in hot standby until needed. This means it must be waiting to burn between 1 MMSCFD and 40 MMSCFD Flexigas when an existing consumer unexpectedly comes off line.

Assuming this eliminates all Flexigas flaring, it would reduce emissions of non-methane hydrocarbon by much less than one ton per year²¹. The cost effectiveness of this project using accepted BAAQMD methods is approximately \$19,000,000/ton for non-methane hydrocarbon and \$1,000,000 per ton of Sox. Table 3 summarizes the economic calculations for these and other criteria pollutants. Details of these calculations are provided in Appendix F of this report. If the refinery fuel and steam systems are in balance prior to the flare event, the actual value of produced steam is small. This more realistic assumption results in an even less cost-effective project. In either case, this project is not cost effective for reduction of flaring. However, as described above in the Prevention Measures section, MRC has implemented this project to minimize the impact of slowing the Flexicoker to balance the FXG system.
