Subject: MRC Flare Minimization Plan – Annual Update October 2024

I certify that based on the information available to me, the 2024 Annual Update of Martinez Refining Company's Flare Minimization Plan dated September 26, 2024 is accurate, true and complete.

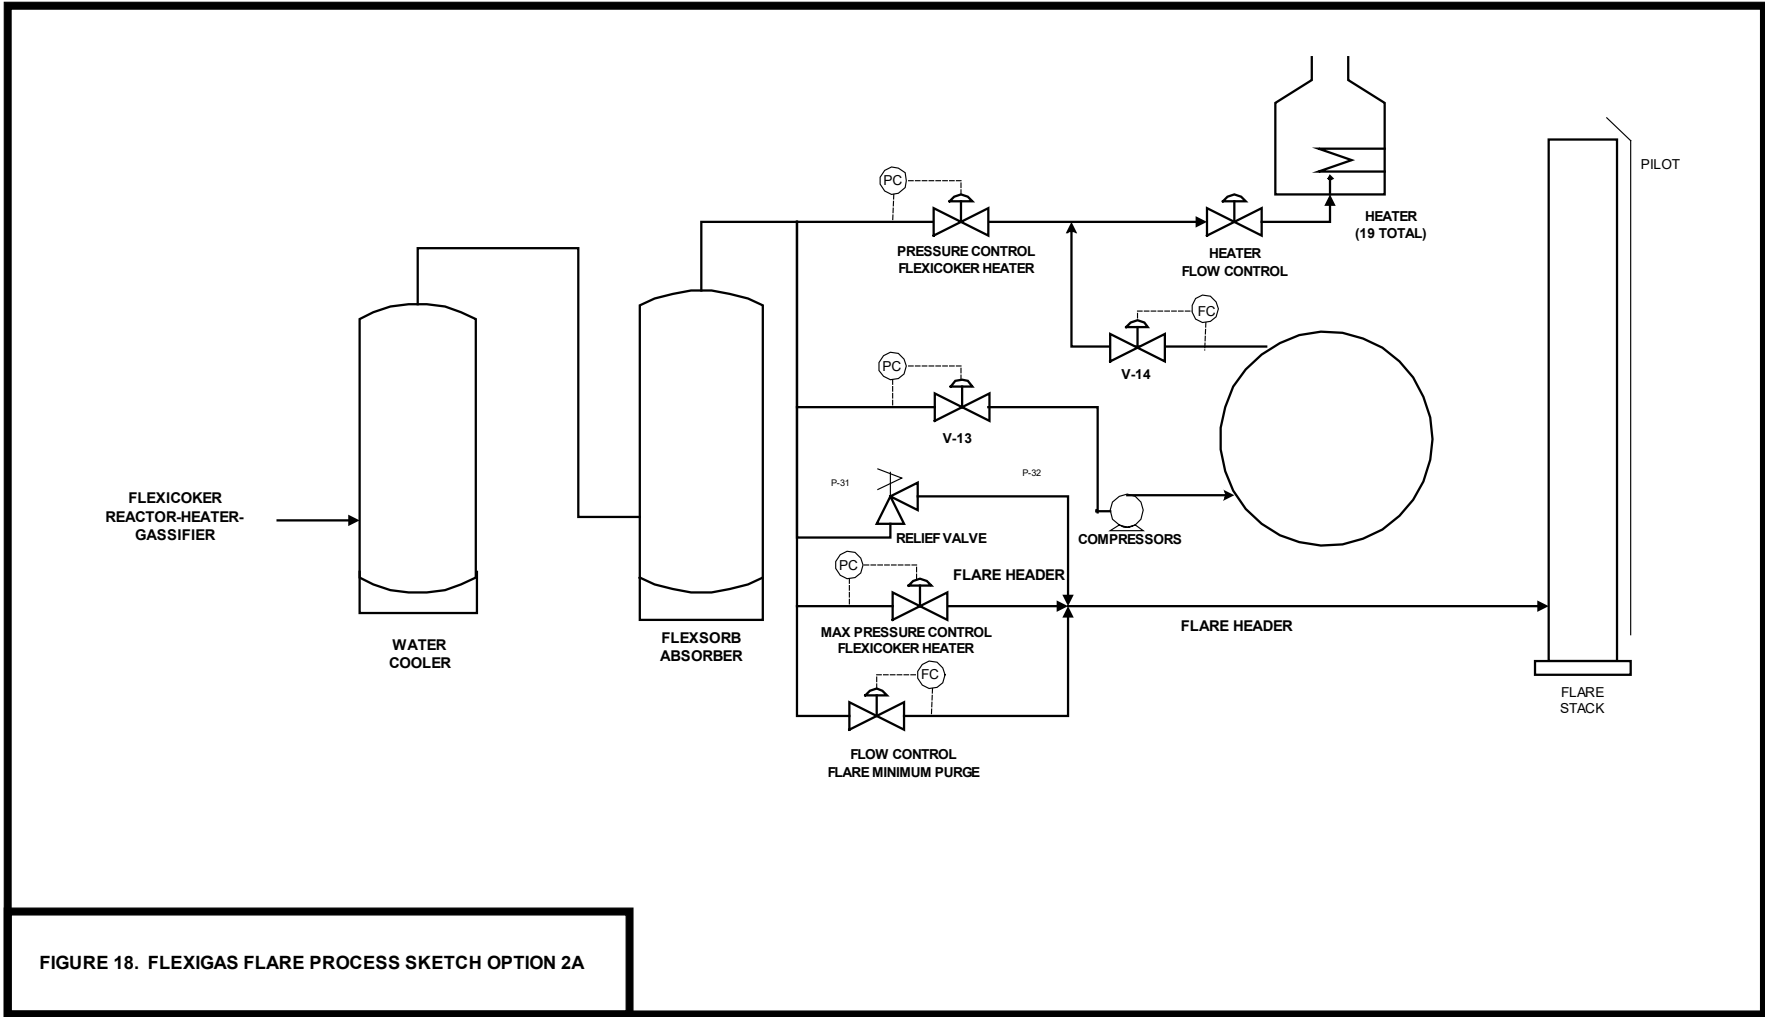
FIGURE 18. FLEXIGAS FLARE PROCESS SKETCH OPTION 2A

Option 2A consists of a pressurized vessel that would require a compressor with capacity ranging between 1 MMSCFD and 10 MMSCFD. This option is depicted in Figure 18. Flexigas in excess of consumer demand is routed to storage via compressor(s). A controlled flow is returned to the distribution system when enough consumers are available to avoid flaring. Due to the limited capacity of this storage, it has no real capability to accommodate prolonged fuel system imbalances. As a result, the expected best-case emission reductions are about the same as those available in 2005. A rough capital cost for the storage and large compressors is about \$27,000,000²². Annual electrical costs for the required compressors add another \$600,000. The annualized capital plus electrical costs to eliminate a ton of non-methane hydrocarbon result in a cost-effectiveness of approximately \$190 Million dollars per ton. Therefore, Option 2A is even less cost-effective for reducing flaring than Option 1.

²² Based on a nominal 1 MMSCF sphere (60' diameter) at 120 psig, and two 4 MMSCFD compressors. This system would handle only minor imbalances while the Flexicoker cuts rate.

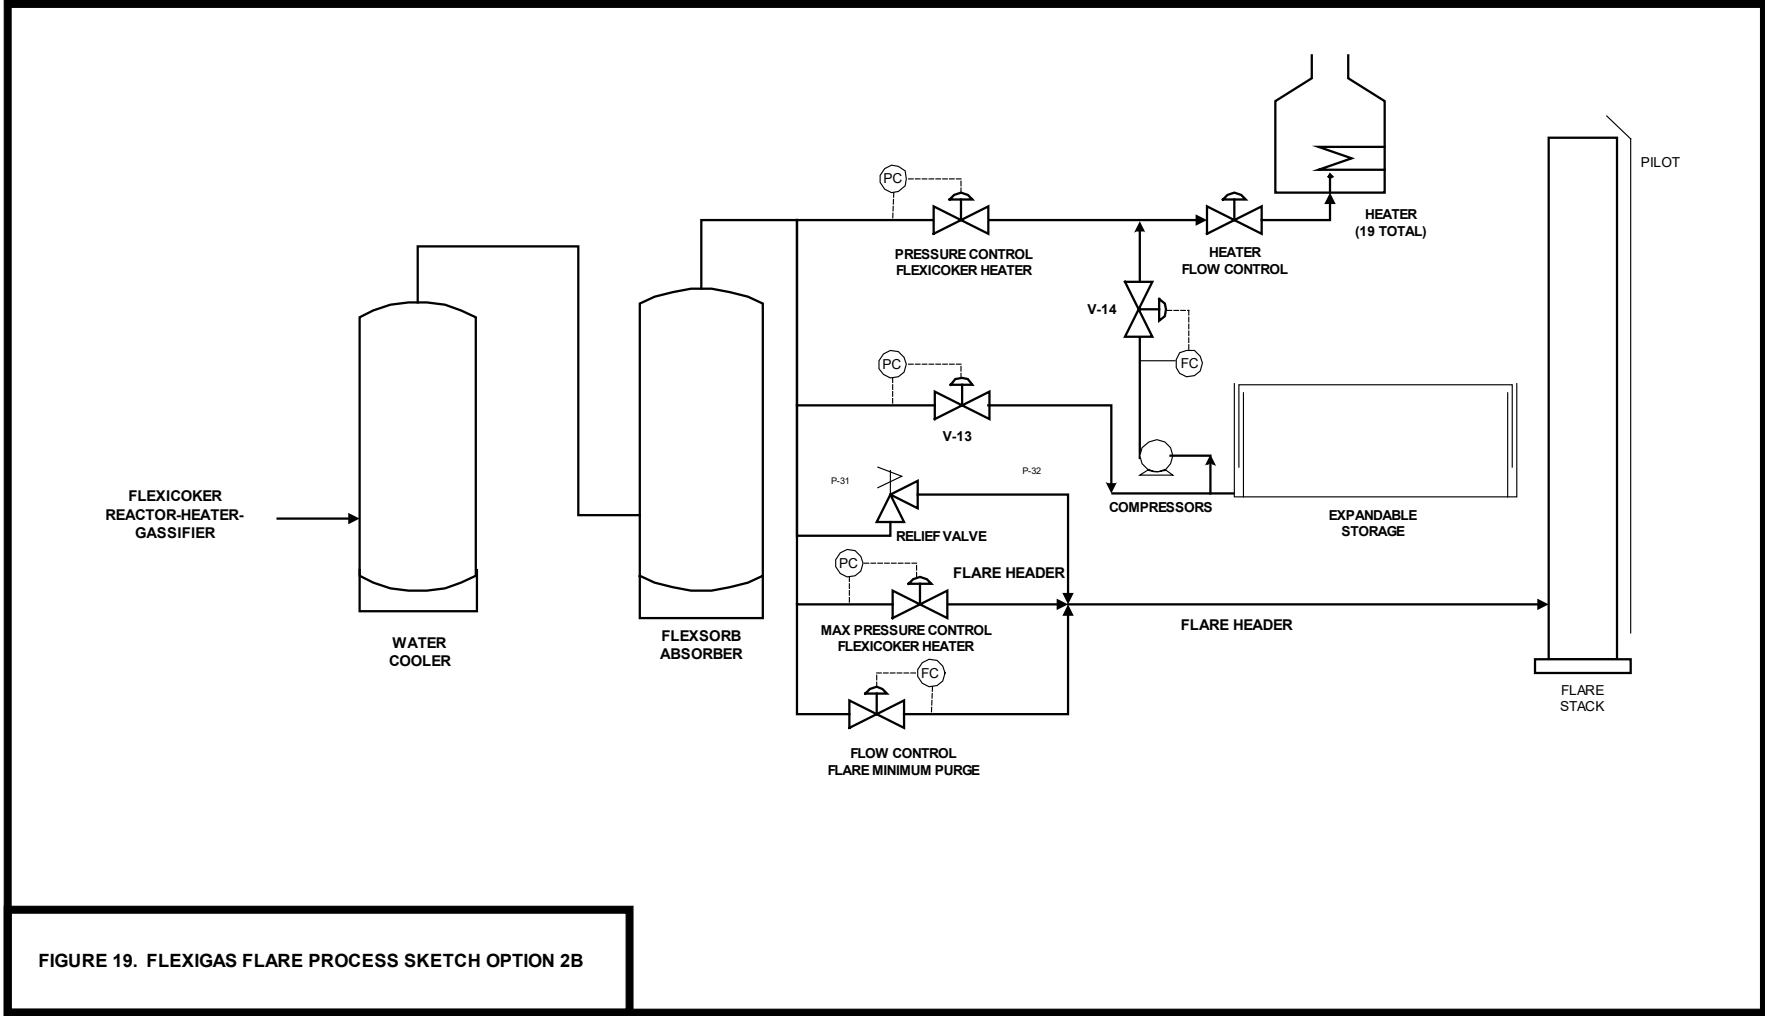
FIGURE 19. FLEXIGAS FLARE PROCESS SKETCH OPTION 2B

Option 2B uses low-pressure expandable gas storage. This option is depicted in Figure 19. This type of storage can be built significantly larger than the pressurized storage used in option 2A, and has the advantage of not requiring compressors in some cases. However, the concentration of carbon monoxide in the gas will likely require use of a water seal to limit leakage, restricting vessel height to a single lift. The requirement for a single lift, combined with low-pressure operation, significantly limits available storage volume²³. In any event, the installed cost is approximately \$21,000,000, providing cost-effectiveness of approximately \$276 Million dollars per ton of NMHC. As was the case for Option 2A, this option is even less cost-effective for reducing flaring than Option 1.

²³ The actual available storage volume is probably on the order of 1 MMSCFD, and will severely limit achievable emissions reductions. A 50% savings is premised for this analysis.
