Shell Martinez Refinery

FLARE MINIMIZATION PLAN

Updated October 1, 2011

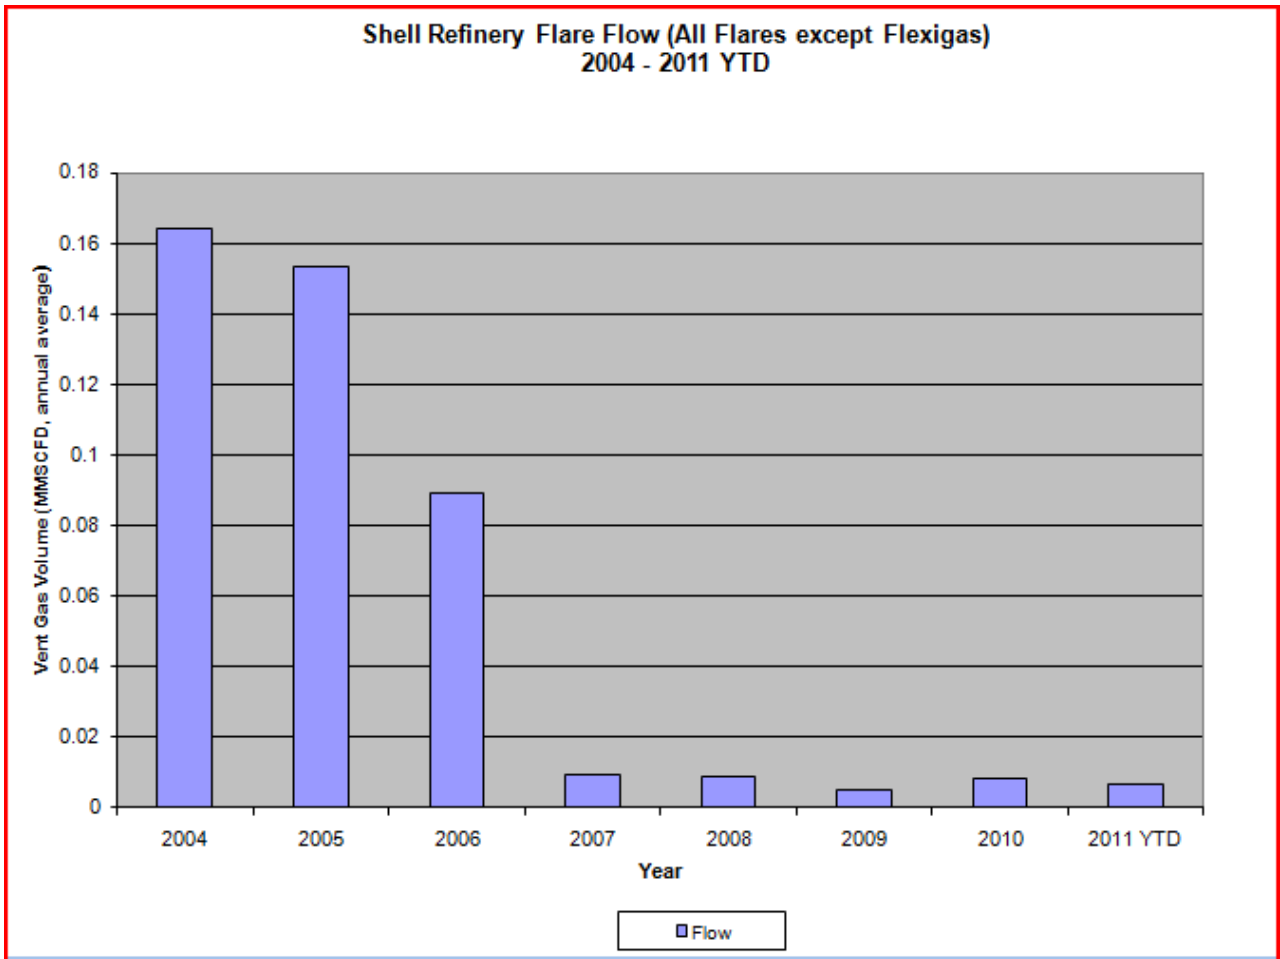
FIGURE ES-2

Figure ES-2 shows the annualized vent gas flow from all refinery process flares except for Flexigas. This figure shows continued improvement in flare reduction. In addition to the flaring reductions achieved in the past, a significant reduction in vent gas flaring occurred in late 2006 when the OPCEN hydrocarbon flare gas recovery system was started up.

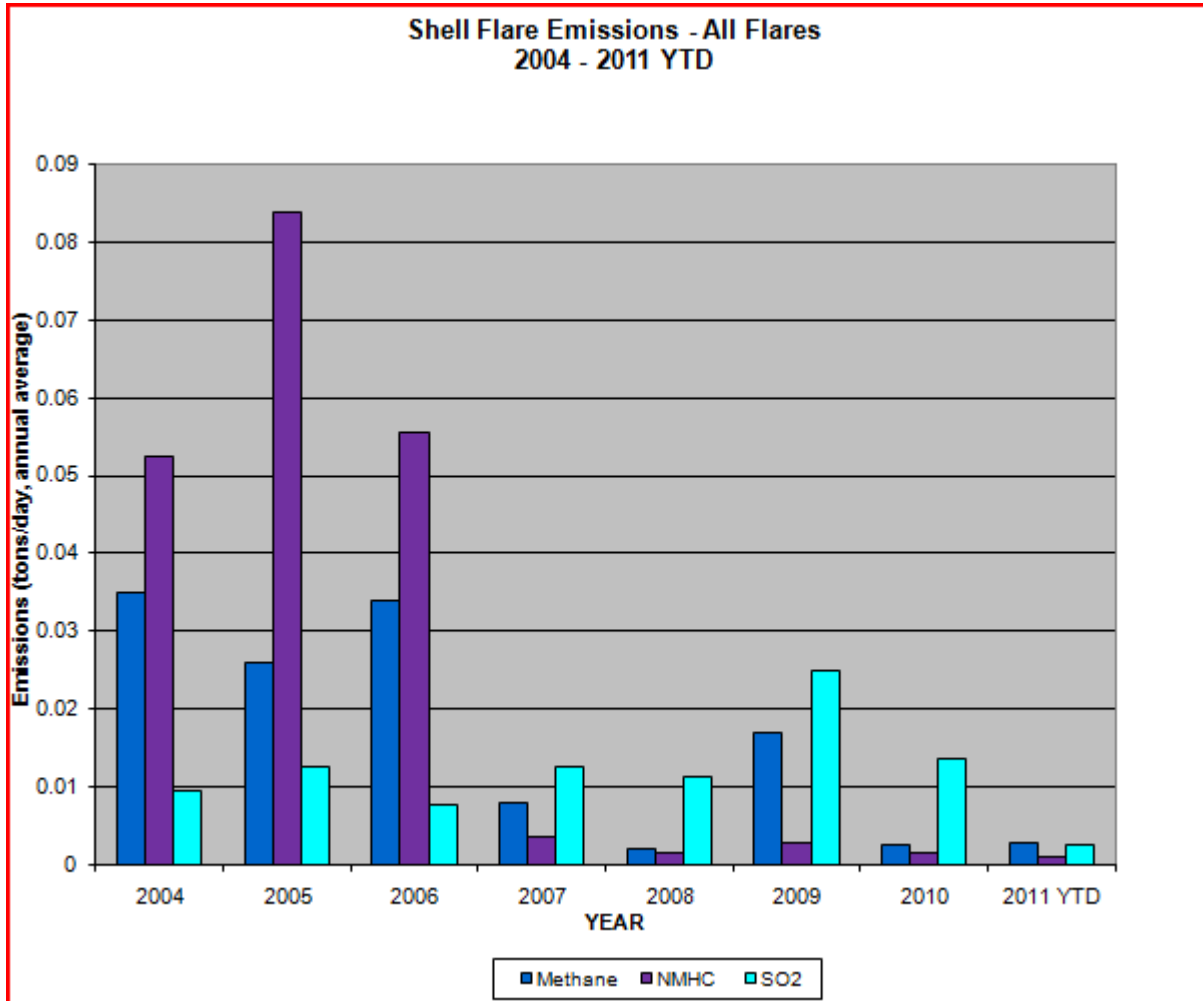
FIGURE ES-3

Figure ES-3 presents the flare emissions from all refinery flares combined from 2004 through year-to-date.

Figure ES-3 shows the significant reduction in emissions that has occurred since the implementation of the Flare Minimization Plan and in particular over the last few years. During the time period covered by this update, there were seven flaring events triggering causal analysis investigation (flaring > 0.5 MMSCF or 500 lbs of SO₂) on three of the four refinery process flares. All of the flaring events were managed per our flare procedures to minimize the amount of flaring and were in compliance with the requirements of BAAQMD Regulation 12 Rules 11 and 12 and Shell's Flare Minimization Plan.

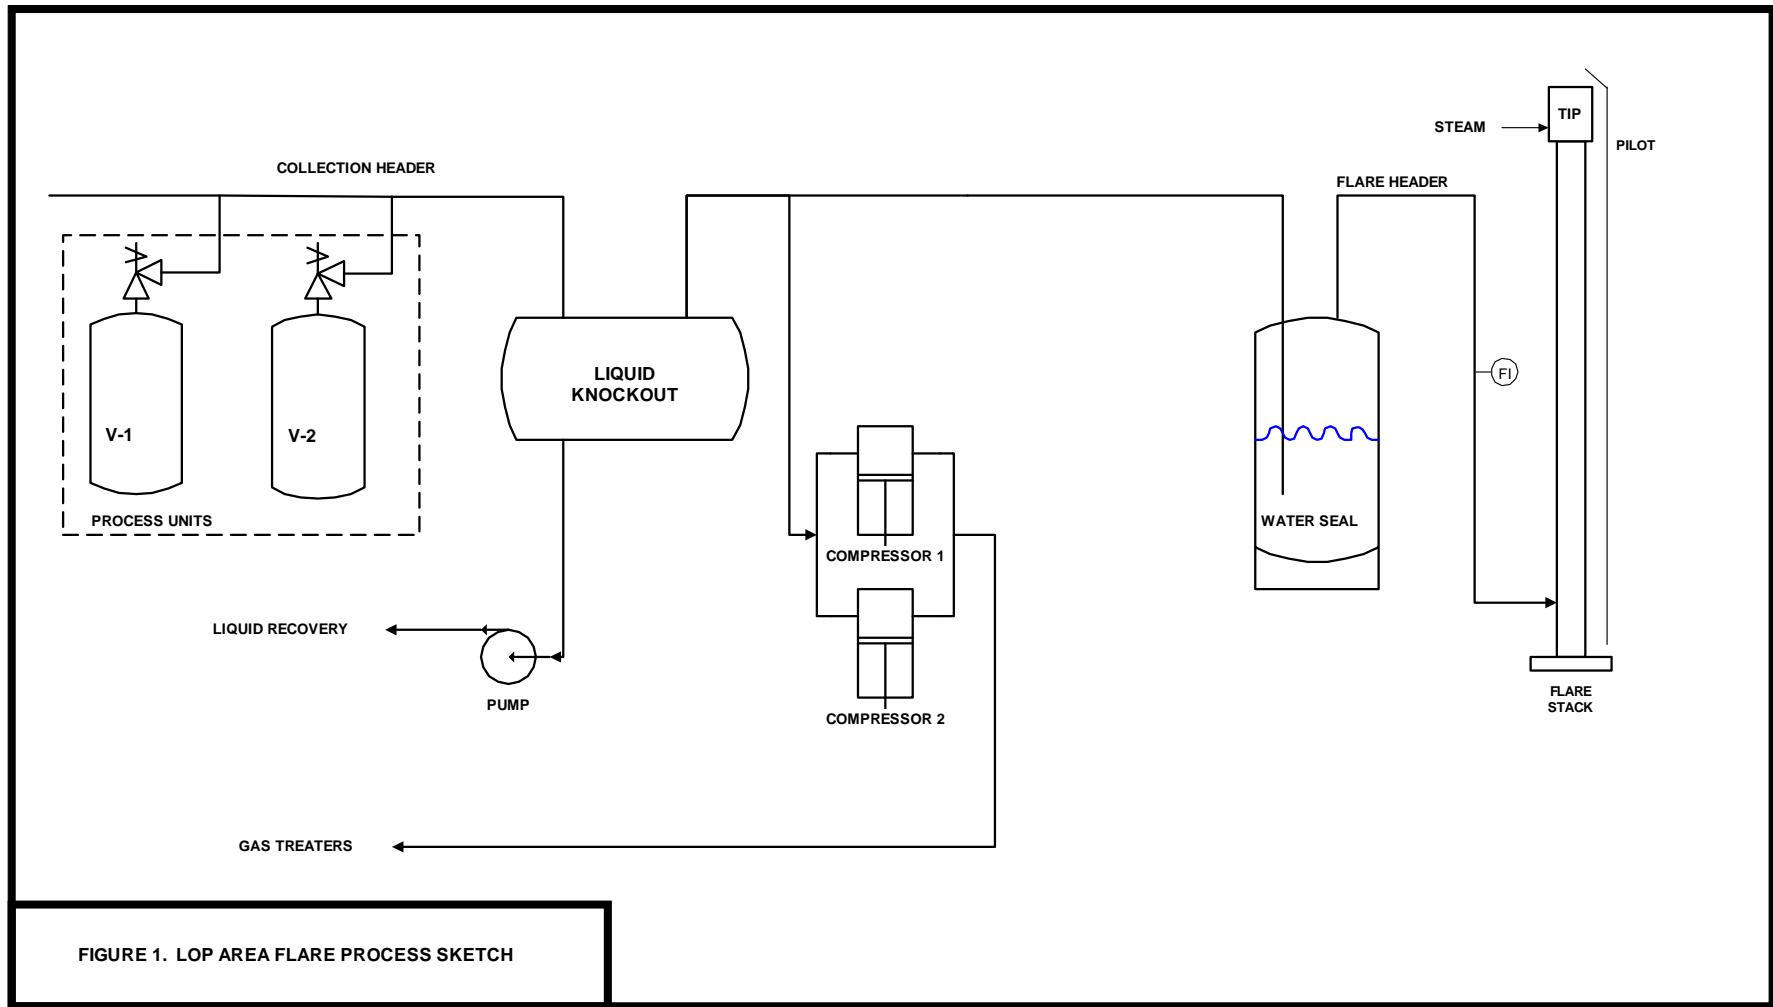
FIGURE 1. LOP AREA FLARE PROCESS SKETCH

The LOP Flare system is comprised of collection headers, liquid knockout vessels, two flare vapor recovery compressors, piping to route recovered gas to fuel gas treaters, a water seal vessel, the flare header proper, and the flare stack. The flare is an elevated, steam-assisted flare with nitrogen purge to prevent air intrusion. Piping provides sufficient flexibility to operate in various configurations, allowing continuous and reliable operation during turnarounds, inspection and maintenance activities. A sketch of the LOP Flare system is provided in Figure 1. Technical details of the system are provided in Appendix A².

Recovered flare gas is treated to remove hydrogen sulfide and condensable liquids. Treated gas is routed to the fuel gas system. The fuel gas treaters typically used for LOP recovered flare gas are located in the Catalytic Cracker Gas Plant (CGP). When this unit is unavailable for any reason, recovered gas may be routed to the Saturates Gas Plant (SGP). Sufficient capacity can be made available in both sets of treaters for the incremental flow up to the total capacity of both compressors of about 6.4 MMSCFD.

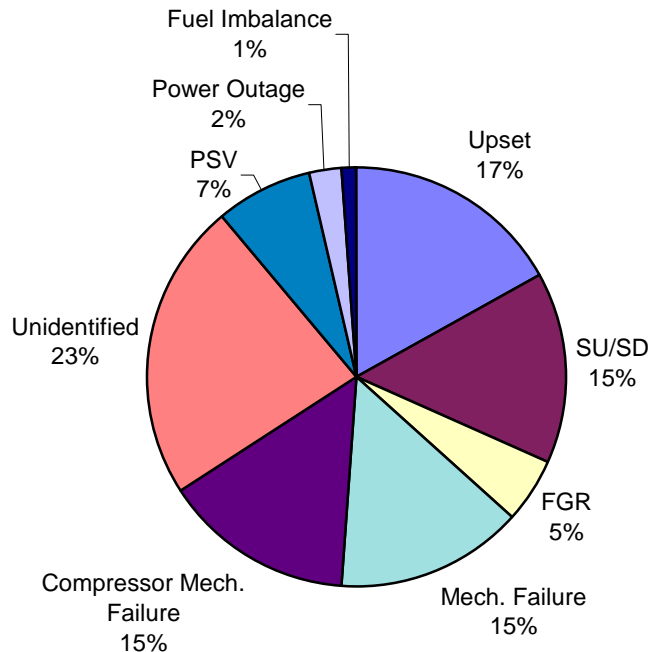
**Figure 2. LOP Area Flare Events
(2000-2005)**

Based on these data, about 65% of the flare events occurring from 2000 - 2005 are essentially evenly divided among the following categories: process upsets, process startup and shutdowns, mechanical failures of compressors and other equipment. Almost one quarter of the time the occurrences where the water seal was broken indicating that flaring occurred were so small, and of such brief duration, no cause could be reliably determined.

Flaring prior to January 2004. Review of flare events prior to January 2004 provided little usable information. Without flow meters, neither durations nor volumes could be accurately determined. In many cases, even the proximate cause of flaring could not be reliably determined due to the limited documentation and time elapsed since the event. With these qualifications, a breakdown of the general cause of LOP flare events for the previous five years is depicted in Figure 2. A description of the various categories listed is provided below:

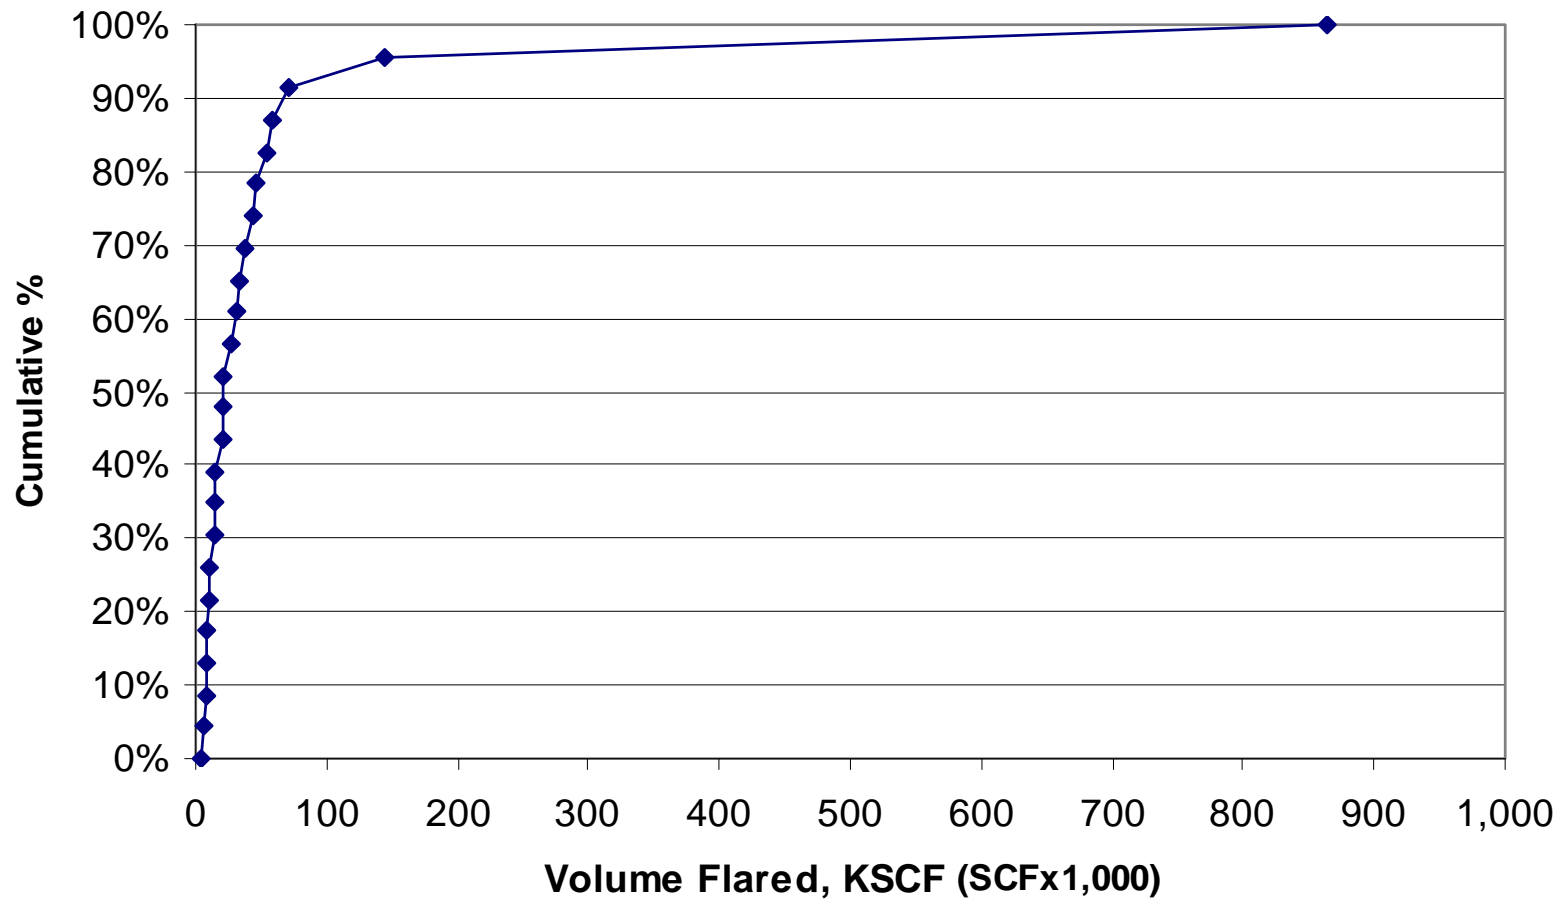
**Figure 3. LOP Flare Gas Volumes
(2005)**

Volumes flared: Figure 3 depicts the amount of material flared during the 25 events occurring in 2005. Each point on this plot represents the total flare volume of gas during that event. The

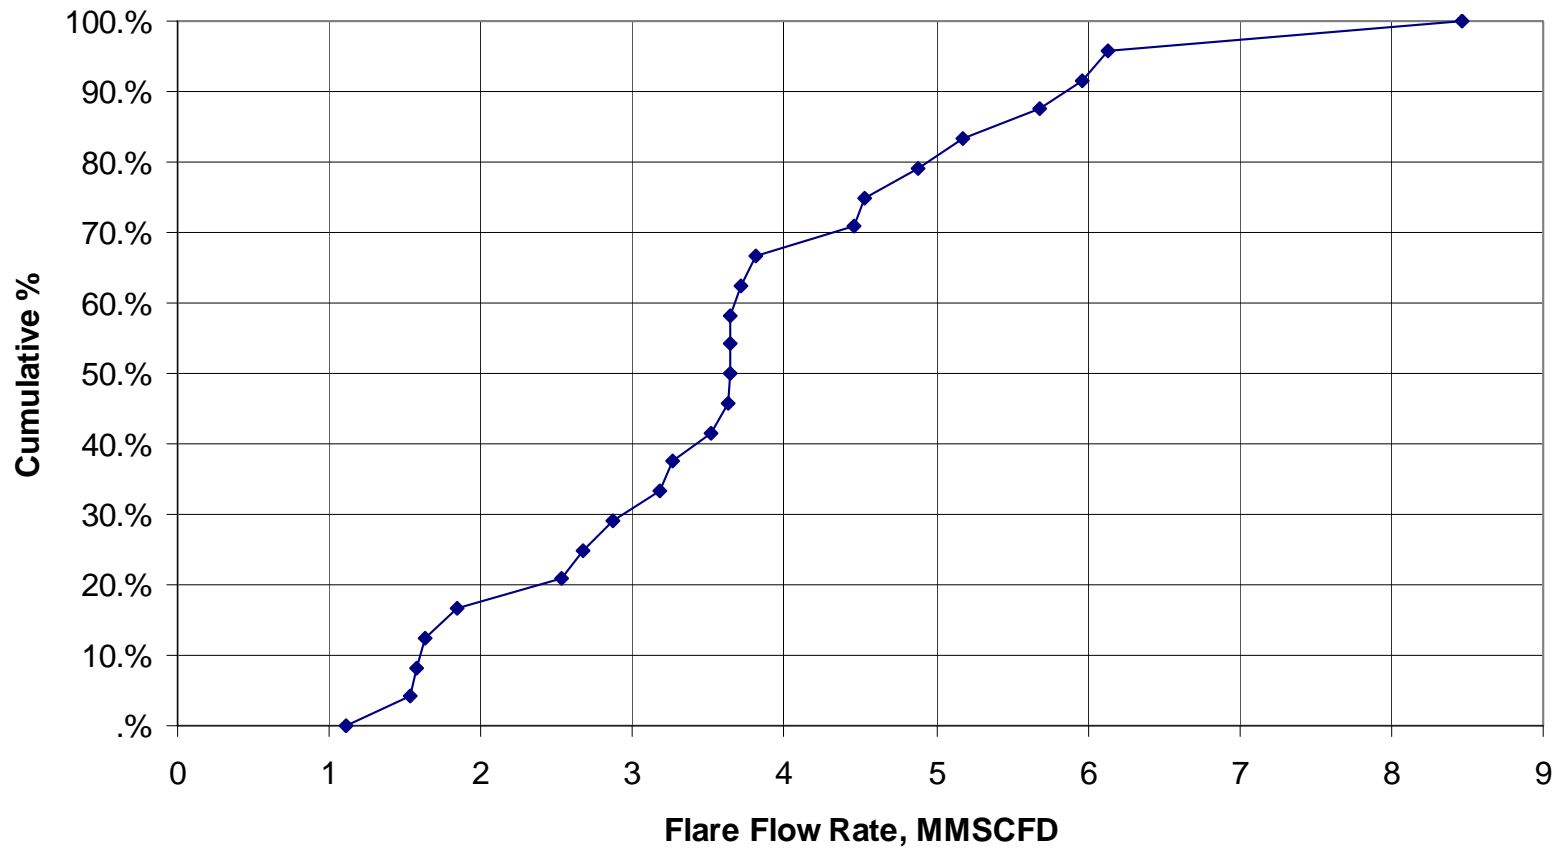
**Figure 4. LOP Flare Gas Flow Rates
(2005)**

Figure 4 depicts the average rates of flow to the flare for events occurring in 2005. These data indicate that approximately 30% of the flare events had event-average flow rates of less than 3 million standard cubic feet per day. Actual instantaneous rates are generally higher – often significantly – than these average rates. This difference between the average rate for an event and instantaneous flare gas rate during an event is important because once the instantaneous rate exceeds the available compressor capacity the water seal is typically broken and flaring occurs. Once flaring begins, backpressure in the flare header provided by the water seal is significantly reduced. Due to the lower header pressure, flare gas recovery rates are typically significantly reduced from their rated capacity.

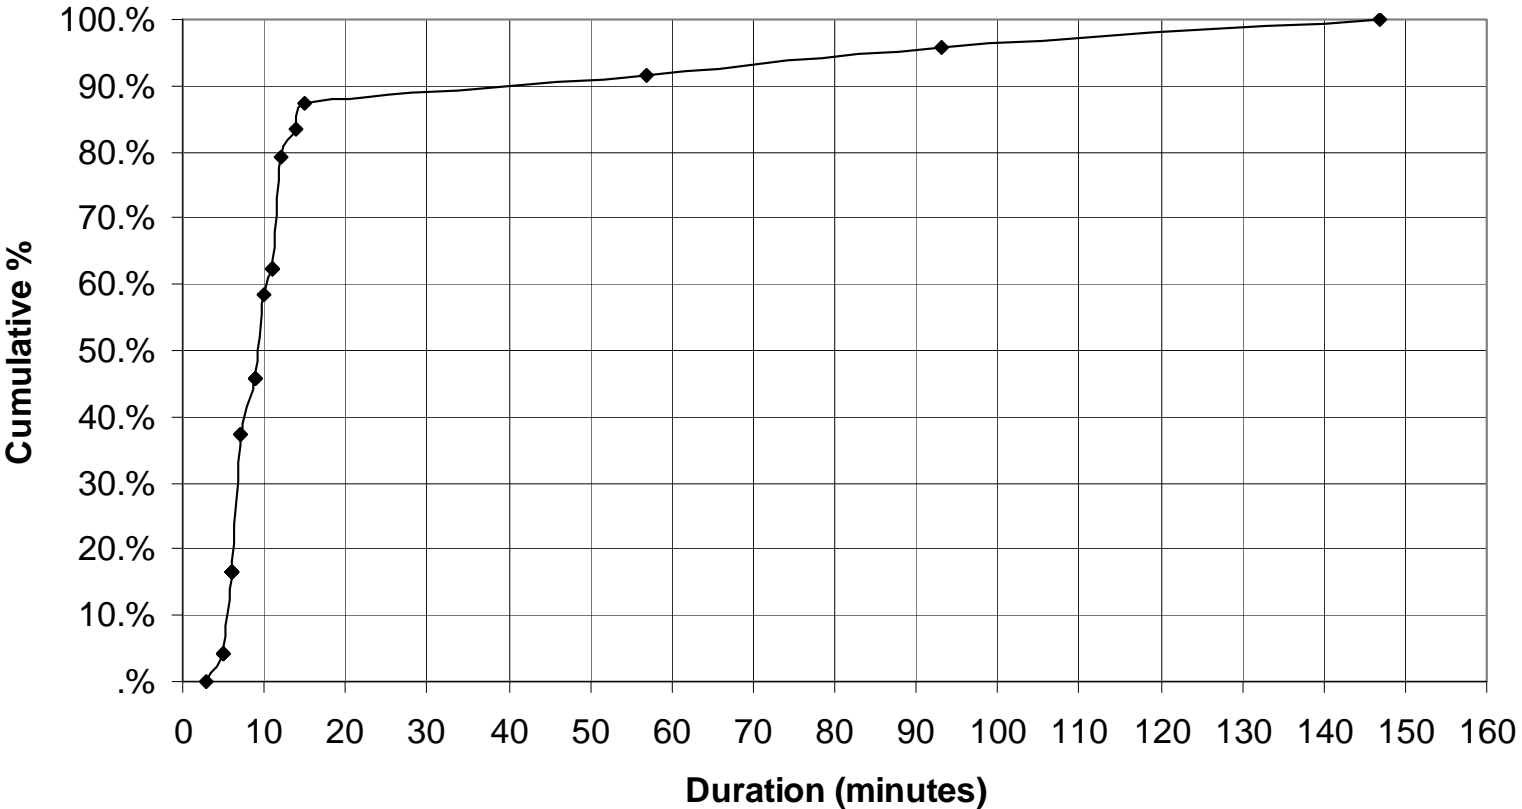
Figure 5. LOP Flare Durations
(2005 - 25 Events)

Figure 5 depicts the distribution of flare event durations for 2005, the year for which these data are available. Most flare events have very short durations with small volumes of gas flared. From Figure 5 it can be seen that half of the flare events had durations of less than 10 minutes. By combining event durations with additional data on the volume flared during each event, it can be shown that the 50% of events with durations less than 10 minutes contributed less than 10% to the total volume of gas flared. The 85% of events which lasted 15 minutes or less contributed less

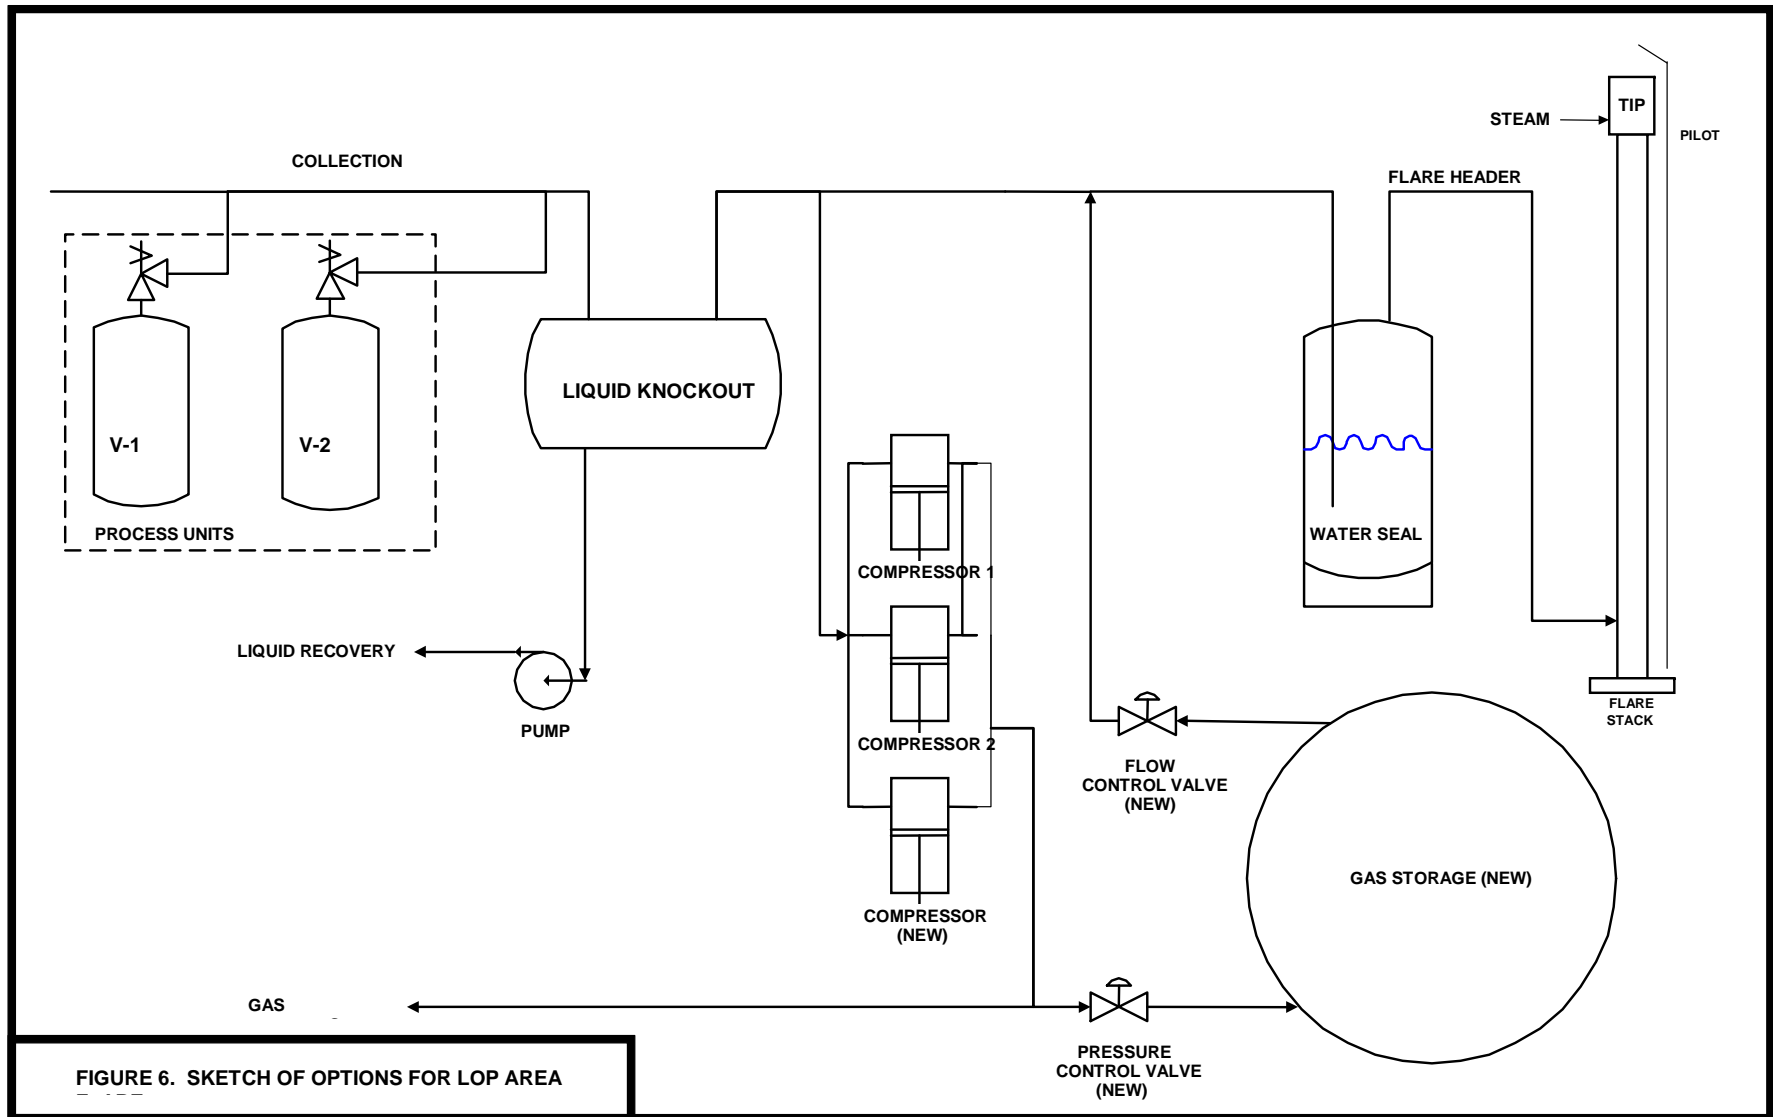
FIGURE 6. SKETCH OF OPTIONS FOR LOP AREA

⁹ The requirement for continuous compressor operation derives from actual data showing that most events in the LOP flare last less than 10 minutes. It is impractical to expect a compressor of this size to go from shutdown to full operation rapidly enough to capture such events.

¹⁰ Presumes use of single stage liquid ring compressors. Power requirements are scaled from a nominal 2 MM SCFD machine provided with a 600 HP motor.

Tables 1A and B depict the increased flare gas recovery and annual costs and benefits for the revised facilities considered. The evaluation makes use of data from actual flare events for calculation of potential benefits and conservatively assumes that all emissions can be eliminated, including those resulting from emergencies. Excluding the emergency emissions would result in even a higher cost per ton reduction. The evaluation below is calculated on the basis of emission reductions using the reported emissions from 2005. Even with the very conservative assumptions used in the calculations, the most cost-effective measure is still not feasible.

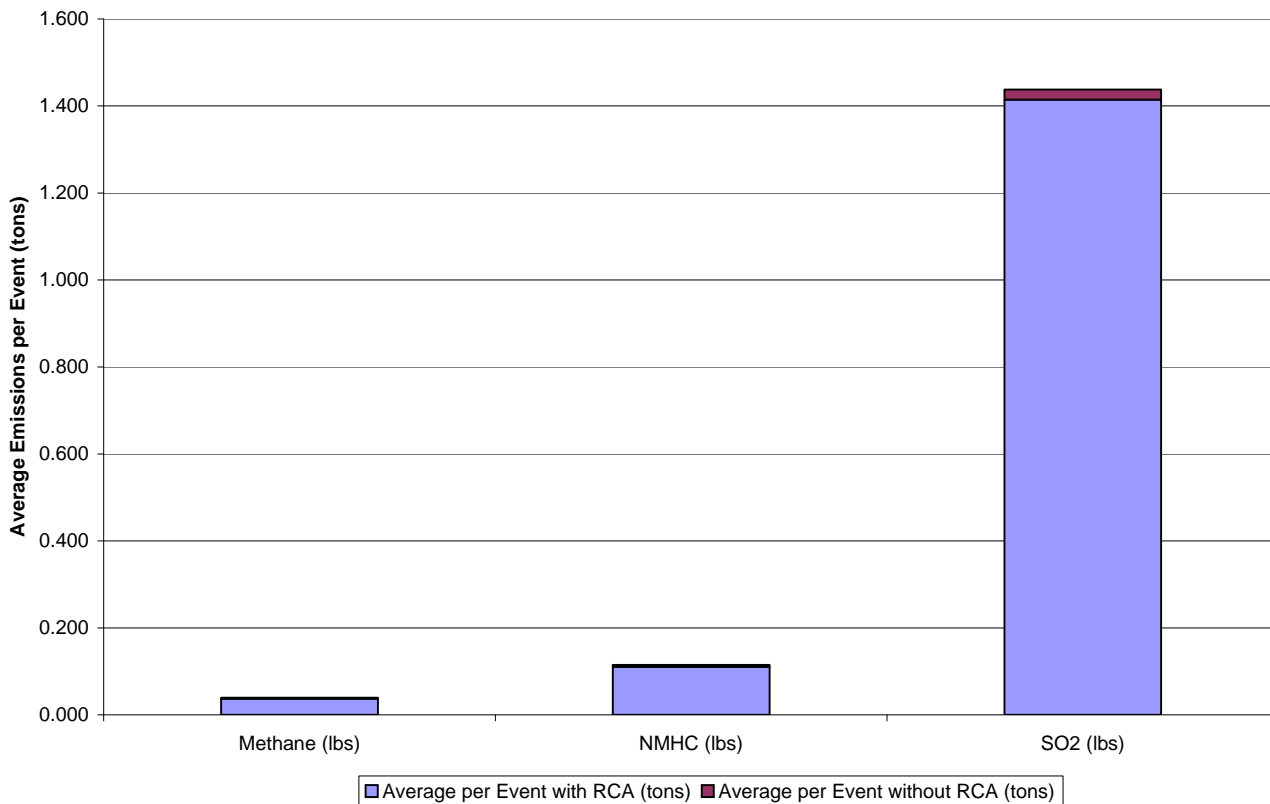
FIGURE 2008-2

**DCU Flare Events w/ Causal Analysis vs. Small Events
1/1/06 - 6/1/08 Without Causal Analysis**

Beginning in November 2006 with the adoption of the Flare Procedures described in the Common Measures Section, pertinent information, when available, was captured immediately after a flaring event to determine the cause of any flaring and what could be done to prevent it from happening again. Total emissions from all flaring during this 30-month period were: 0.17 tons of methane, 0.45 tons of non-methane hydrocarbon and 4.19 tons of SO₂. Figure 2008-2 presents a comparison of the average emissions per large reportable events over this time period vs. the average emissions per small event for the DCU Flare. This figure shows that small events contributed < 6% of the emissions of a large event. Figure 2008-2 reinforces the appropriateness of the causal analysis trigger of 0.5 MMSCF/ 500 lbs SO₂ to ensure the resources to conduct a Causal Analysis are most effectively applied to address high emission events.

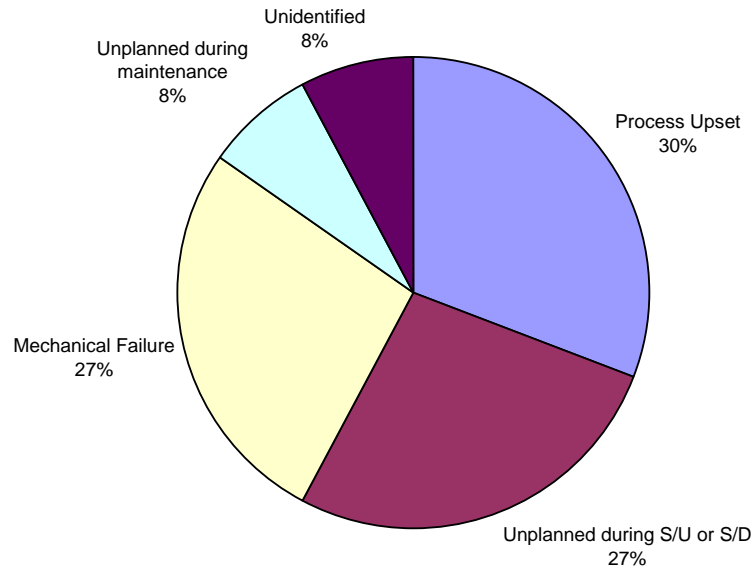
FIGURE 2008 - 3

The DCU flare events that occurred from 1/1/06 – 6/1/08 were categorized by probable cause in Figure 2008-3. None of the flaring was planned. Most of the events were < 10 minutes long. The majority of the events were caused by process upset, mechanical failure or were unplanned during startup and shutdowns.

**Probable Cause of Flaring on DCU Flare 1/1/06-6/1/08
26 Events**

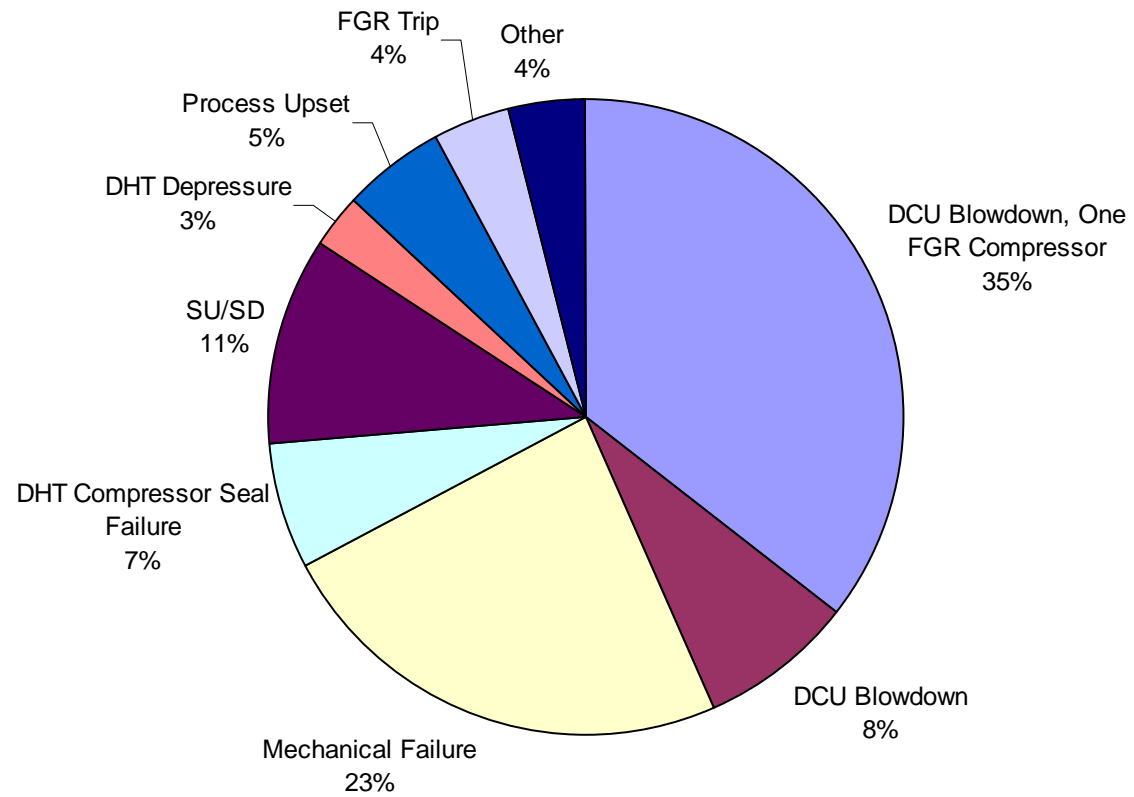
**Figure 8. Delayed Coking Area Flare Events
(2000 - 2005) 76 Events**

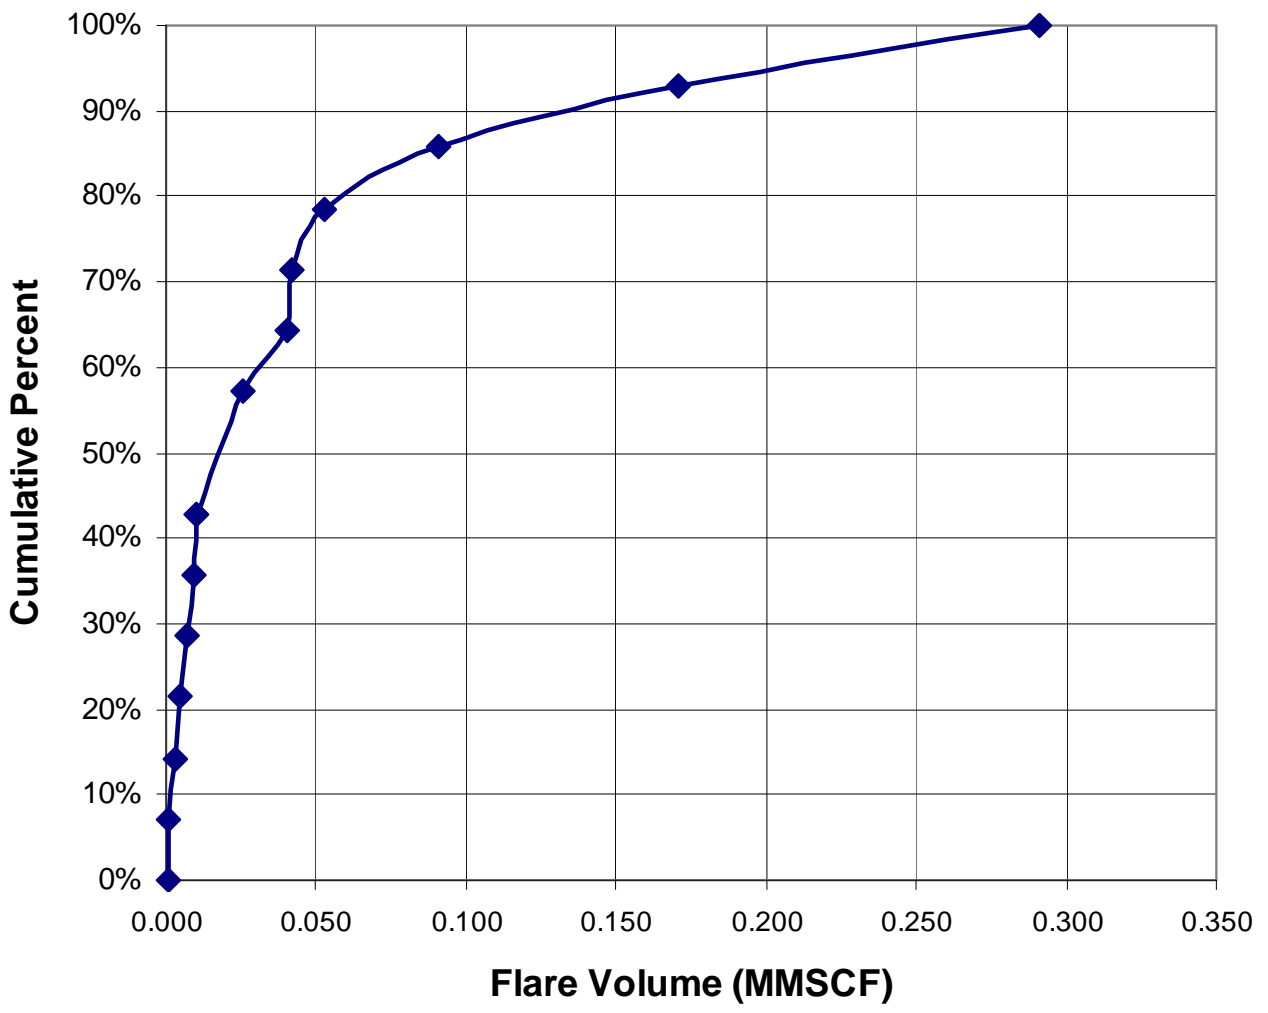
**Figure 9. Delayed Coking Area Flare Gas Volumes
(2005)**

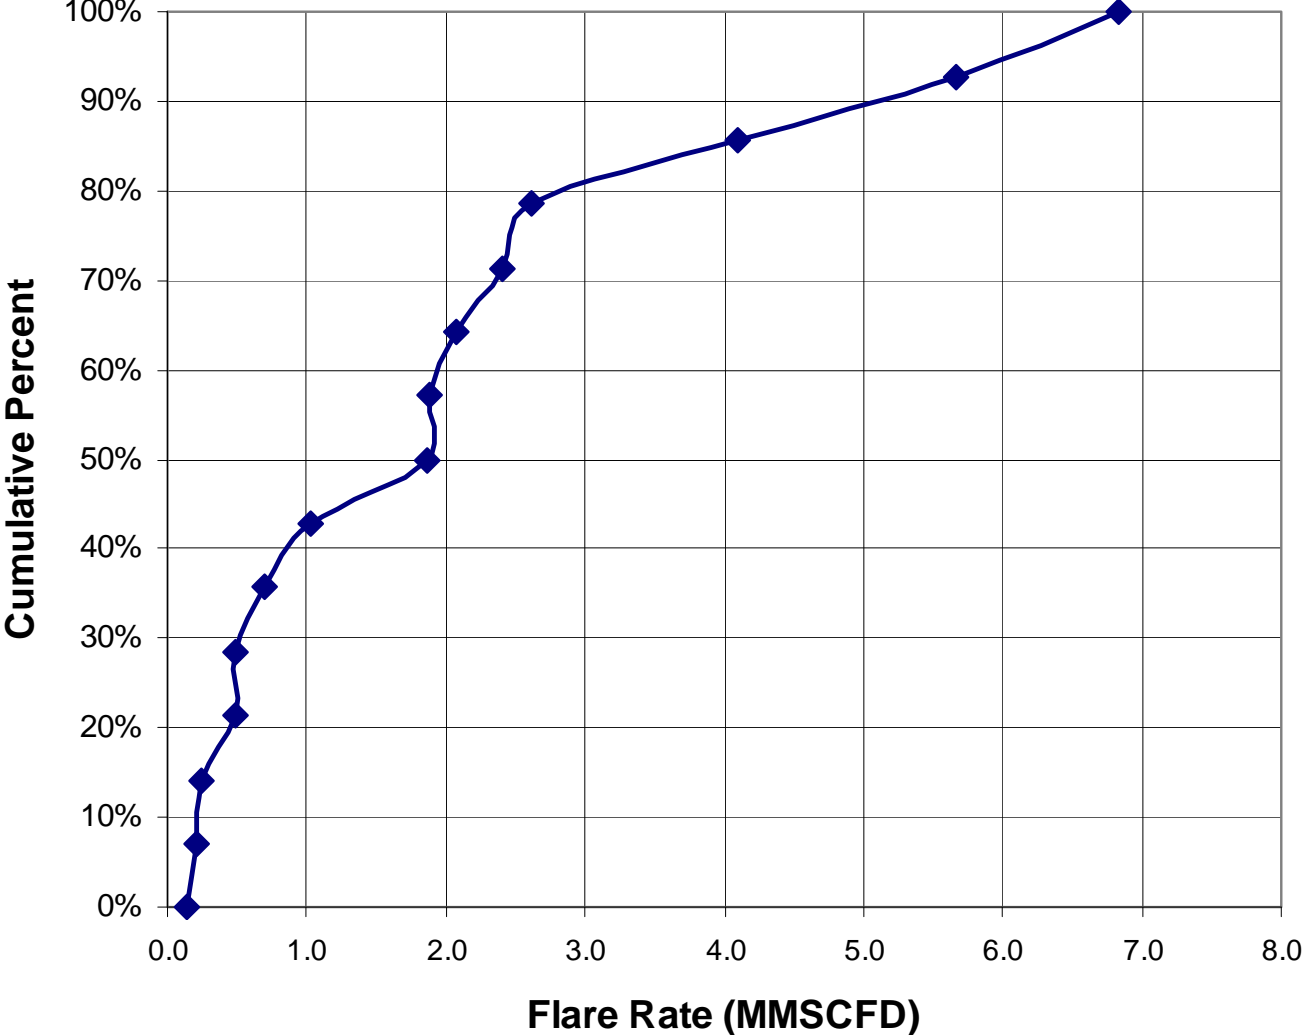
**Figure 10. Delayed Coking Area Flare Gas Flow Rates
(2005)**

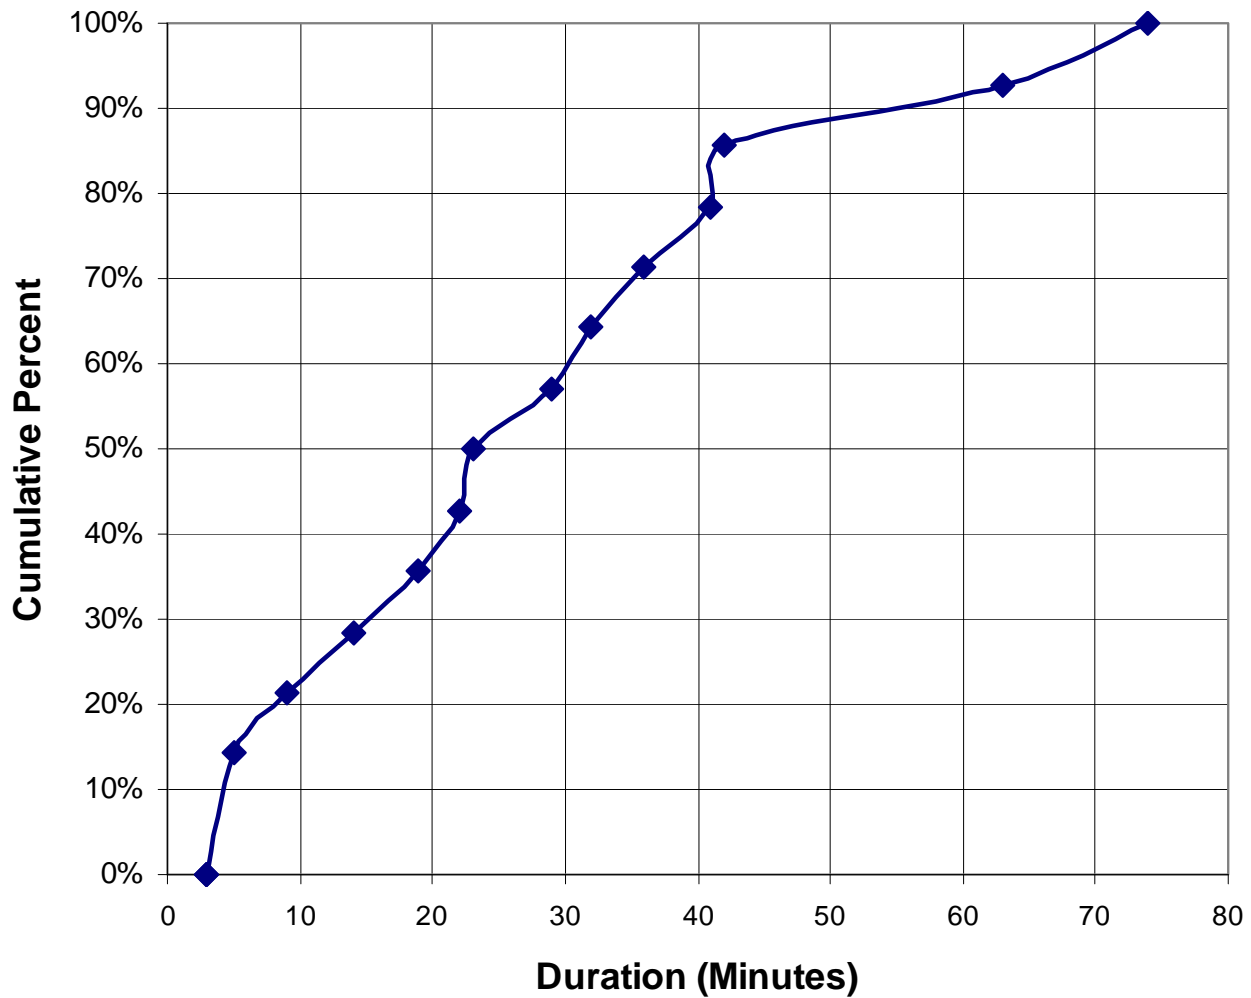
Figure 11 depicts the distribution of flare event durations for 2005 where these data are available. 50% of the events lasted less than 30 minutes. This is consistent with other data characterizing the bulk of flare events being very brief.

**Figure 11. Delayed Coking Area Flare Event Durations
(2005)**

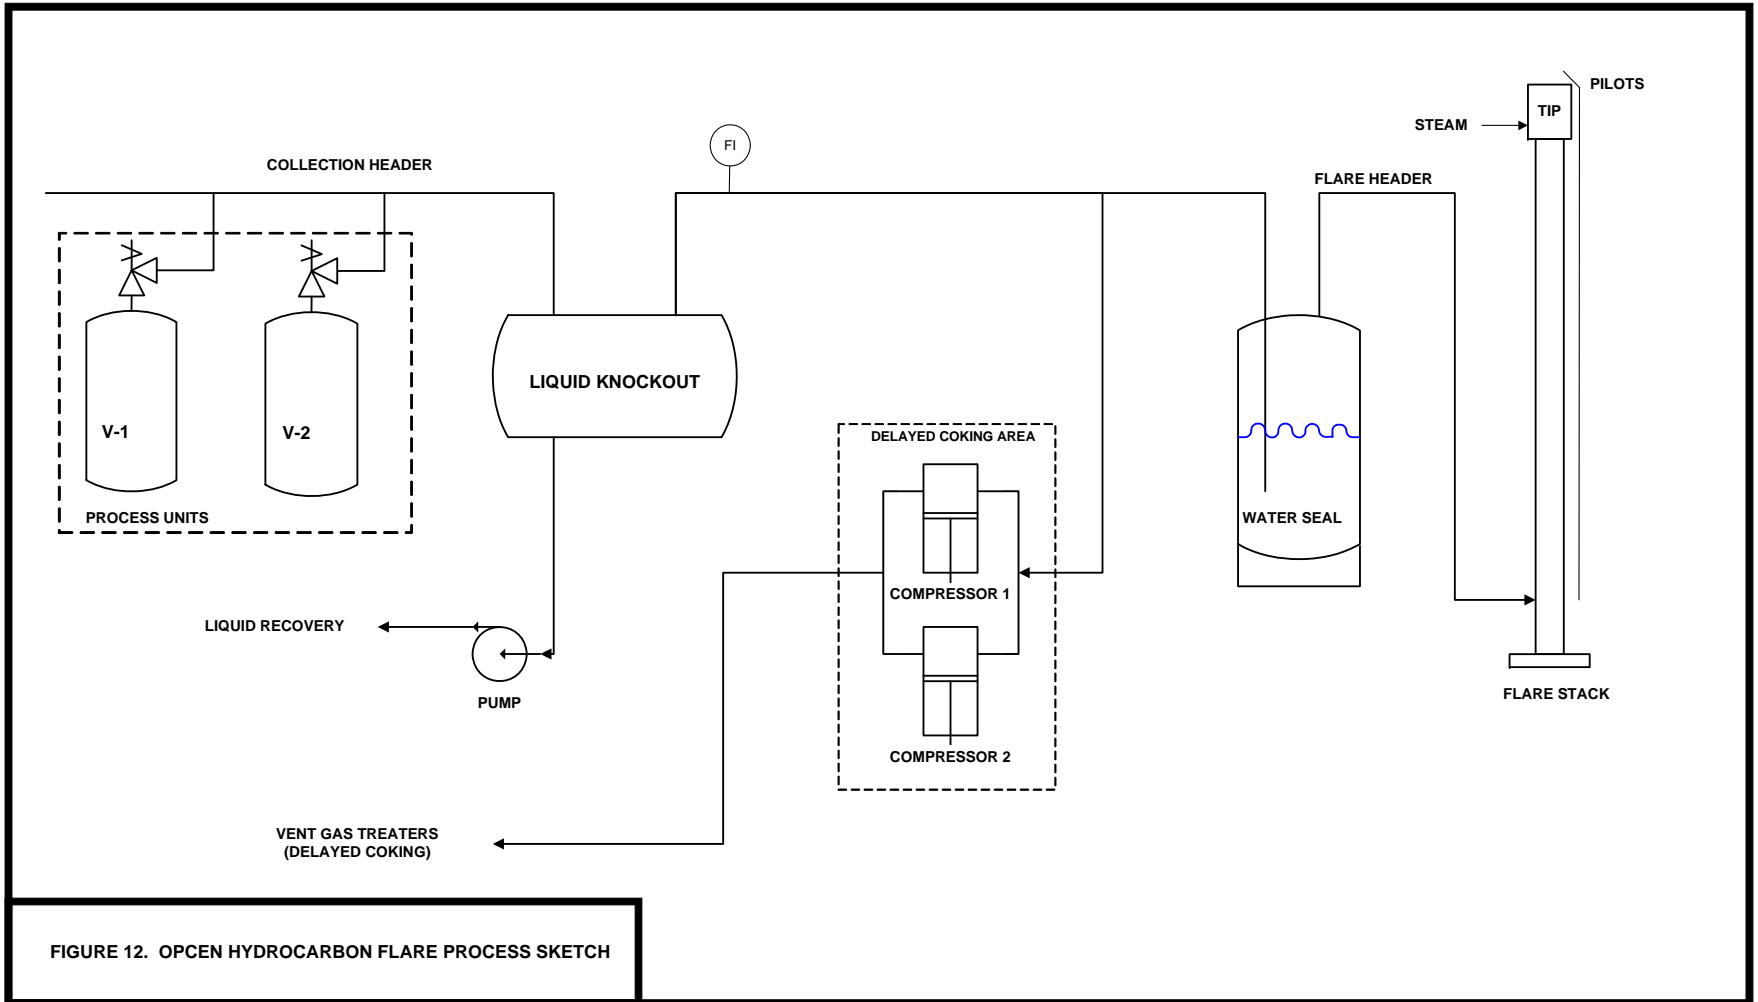
FIGURE 12. OPCEN HYDROCARBON FLARE PROCESS SKETCH

Process units in the OPCEN area are served by a dedicated flare system. This flare was modified by a project to provide flare vapor recovery. The vapor recovery project was operational in November 2006. A sketch of the flare system is provided in Figure 12. The OPCEN HC flare system is comprised of collection headers, a liquid knockout vessel, a water seal vessel, piping to flare gas recovery compressors and gas treating, the flare header proper, and the flare¹⁶. Additional details of the flare are provided in Appendix C.

¹⁶ This figure includes the flare gas recovery system with the modification. Due to the need for a general shutdown of process units in the OPCEN area, the system was not operable in time for the August 1, 2006 original submittal of this plan. Post-project facilities are used as the basis for system description. However, the historical performance of this flare obviously provides little basis for evaluating mitigation options beyond the implemented flare gas recovery.

Recovered gas from OPCEN is treated to remove H₂S and routed to fuel and hydrogen plant feed along with the recovered gas from Delayed Coking. The normal routing for Delayed Coker Area recovered flare gas is the Vent Gas Treater. Sufficient capacity is available for the incremental flow (up to the total recovery compressor capacity of about 8 MMSCFD).

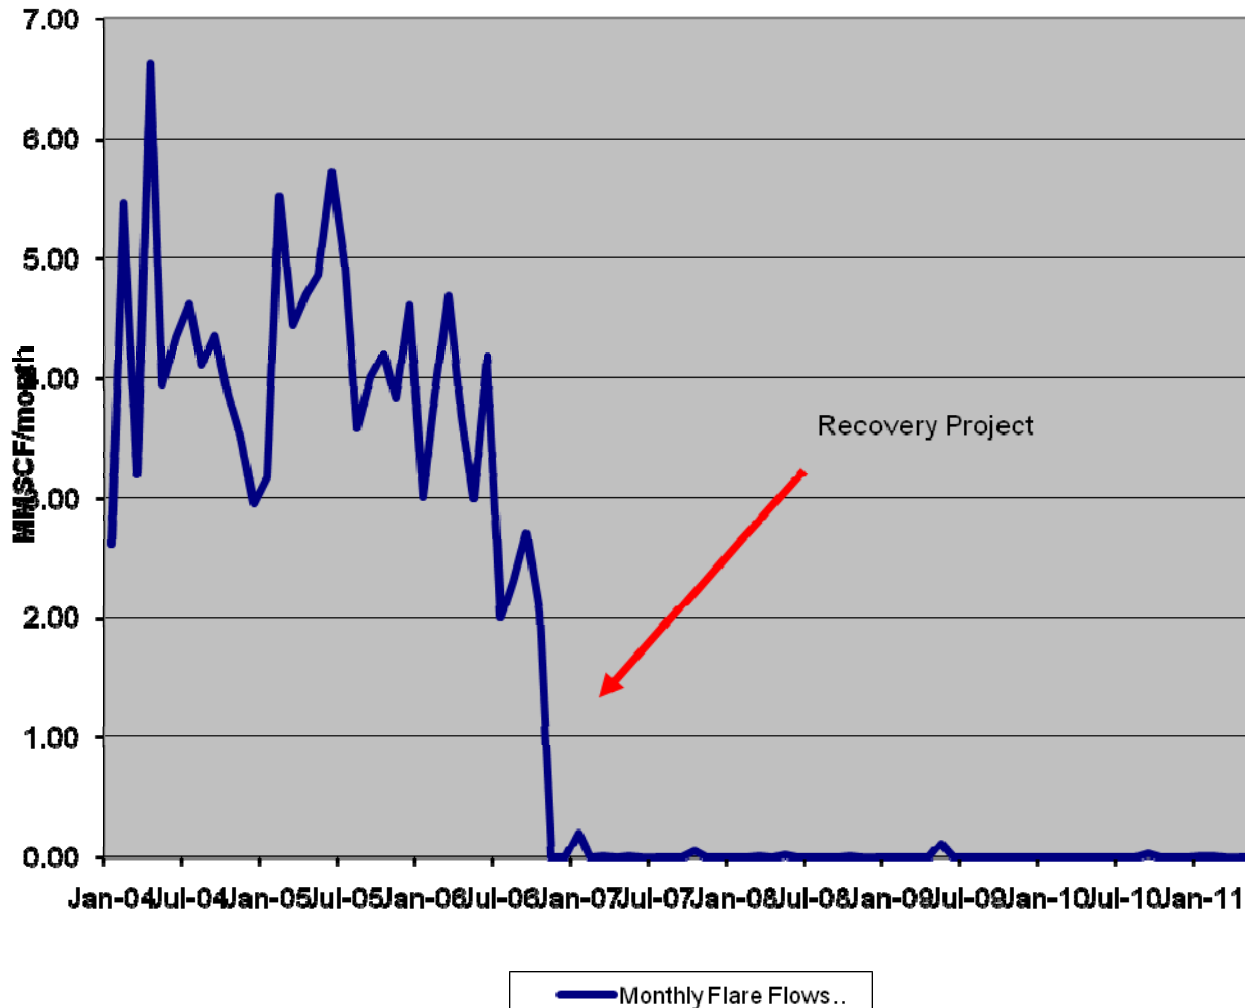
FIGURE 1

The graph in Figure 1 shows the reduction that occurred in the flare flow after the implementation of the recovery project.

OPCEN HC FLare Monthly Flare Flows 1/1/06 - 7/1/11

There were no reportable flaring events requiring causal analysis on the OPCEN HC flare during this 12-month period and three very small flaring episodes that were all caused due to flaring on the DCU flare. When flaring occurs at the DCU flare, the OPCEN flare system is automatically isolated from the DCU flare recovery system. This can result in a small amount of flaring on the OPCEN HC flare. Figure 1 below has been updated through 7/1/11 and shows the continued success of the implementation of the flare recovery project in 2006.
