Shell Martinez Refinery

FLARE MINIMIZATION PLAN

Updated October 1, 2011

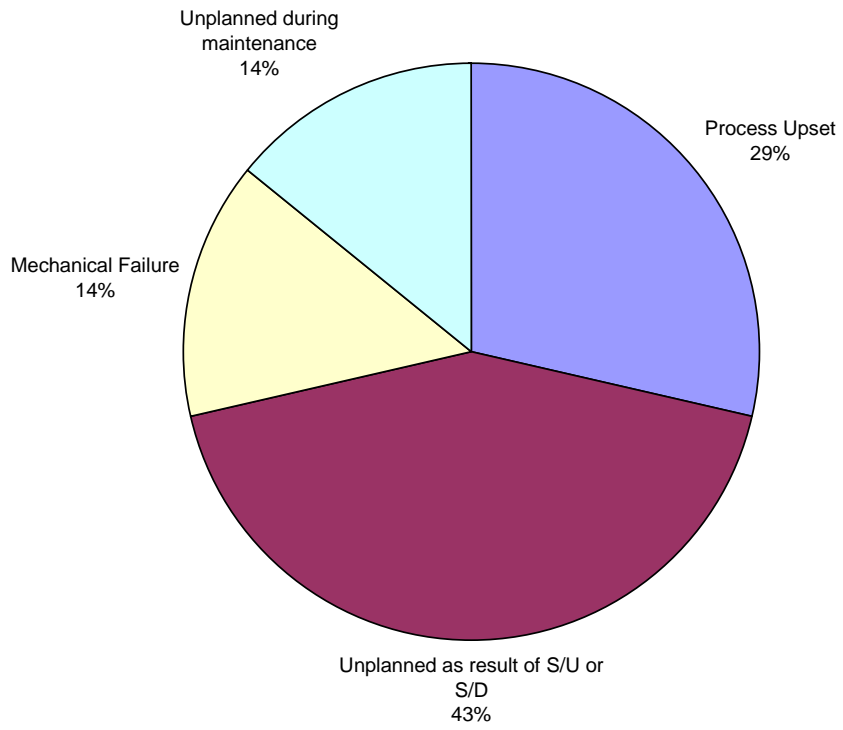
FIGURE 2008-4

The OPCEN HC flare events that occurred after the implementation of flare recovery from 11/1/06 – 6/1/08 were categorized by probable cause in Figure 2008-4. None of the flaring was planned. The cause of the events included process upset, mechanical failure or were unplanned during maintenance or startup and shutdown.

OPCEN HC Flare- Cause of Flaring 11/1/06 - 6/1/08
7 Events

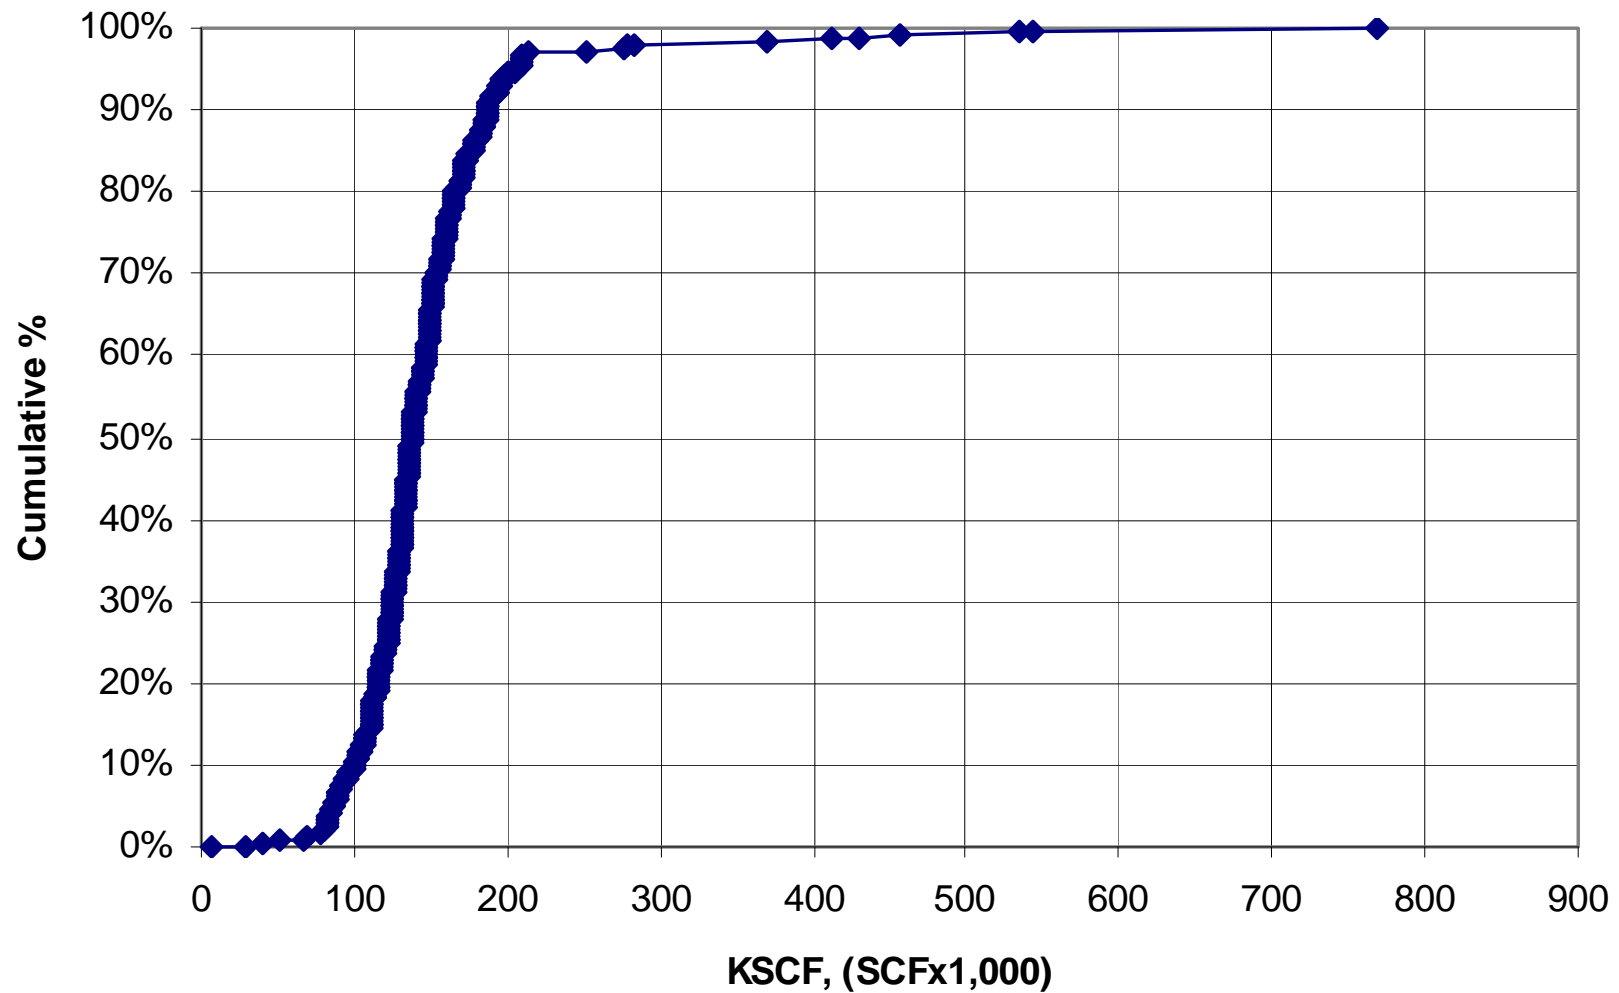
With historical performance profoundly biased by absence of flare gas recovery, this review concentrated on calendar year 2005. Flare data are depicted in Figure 13. Total emissions of non-methane hydrocarbon during 2005 were approximately 30 tons. Emissions of SO₂ in 2005 were 0.3 tons.

**Figure 13. OPCEN Hydrocarbon Flare Gas Volumes
(2005)**

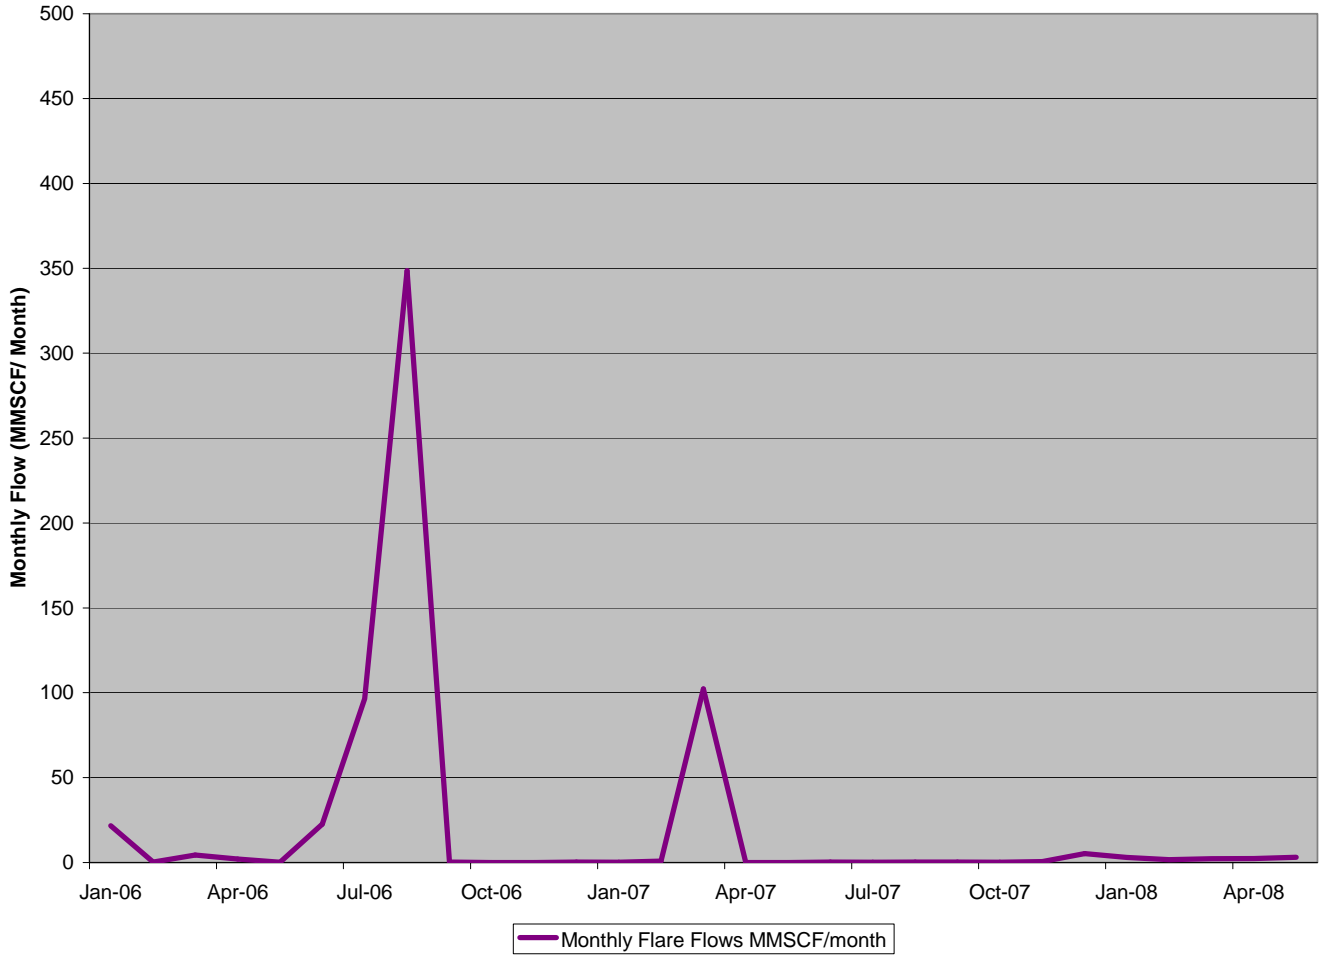
FIGURE 2008-5

FXG Flare Flows 1/1/06 - 6/1/08

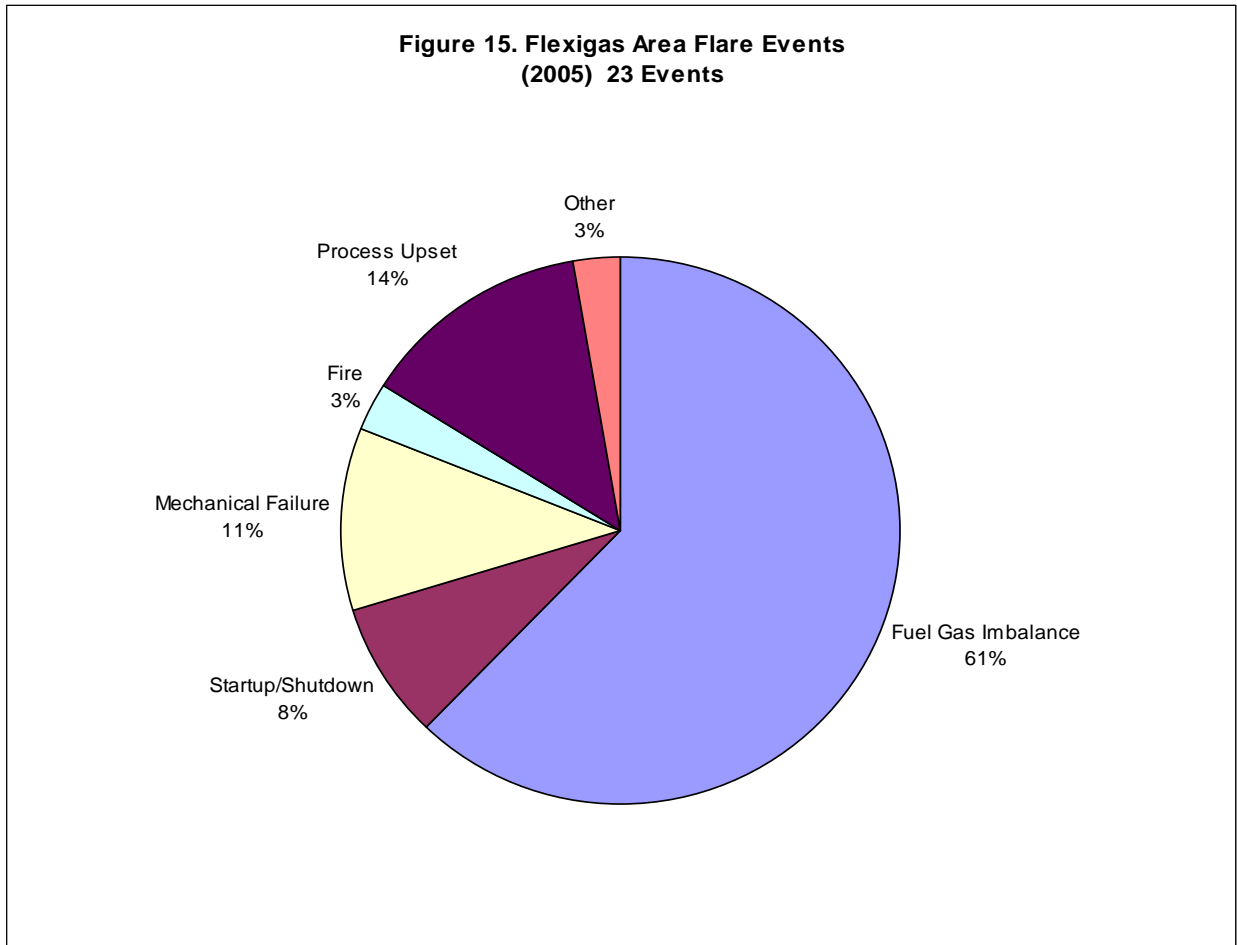
Historical flaring at the OPCEN Flexigas flare was reviewed to identify opportunities for potential mitigation. The highest quality data are available for the period from December 2003, to January 2006. This coincides with installation of the flare flow meter and BAAQMD flare reporting. Data for 2005 are plotted in Figure 15 and Figure 16.

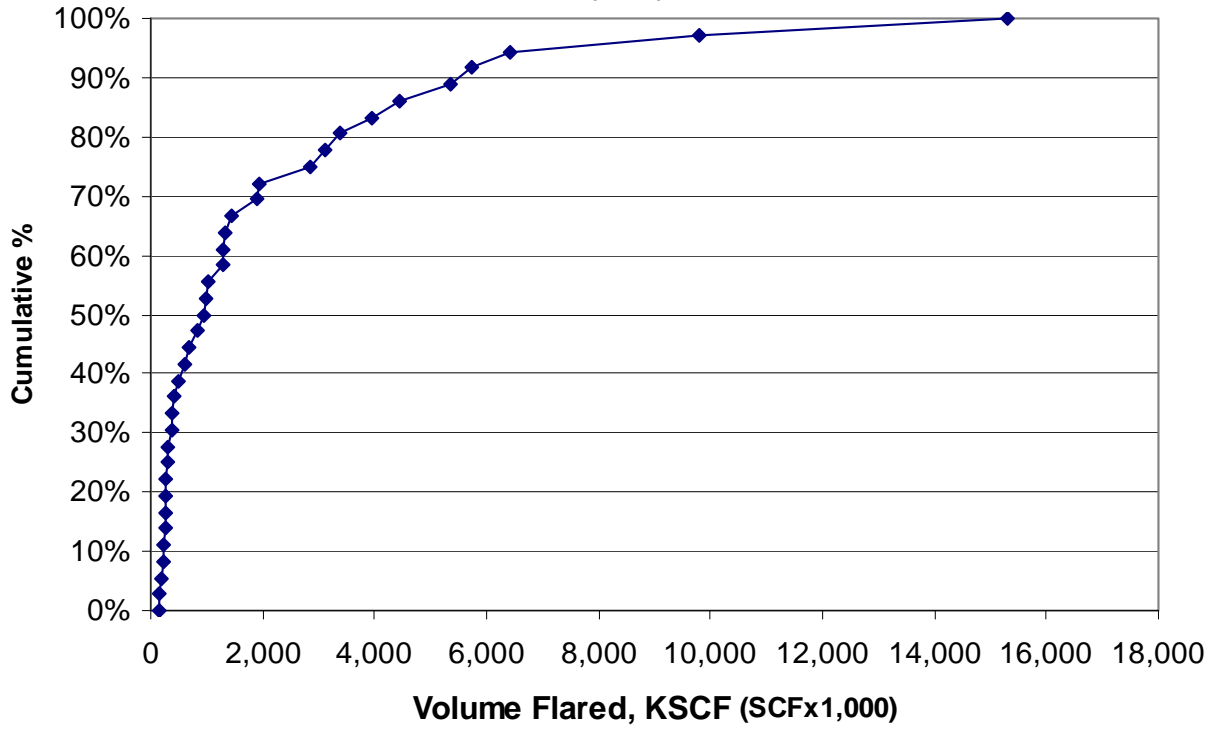
**Figure 16. Flexigas Flare Gas Volumes
(2005)**

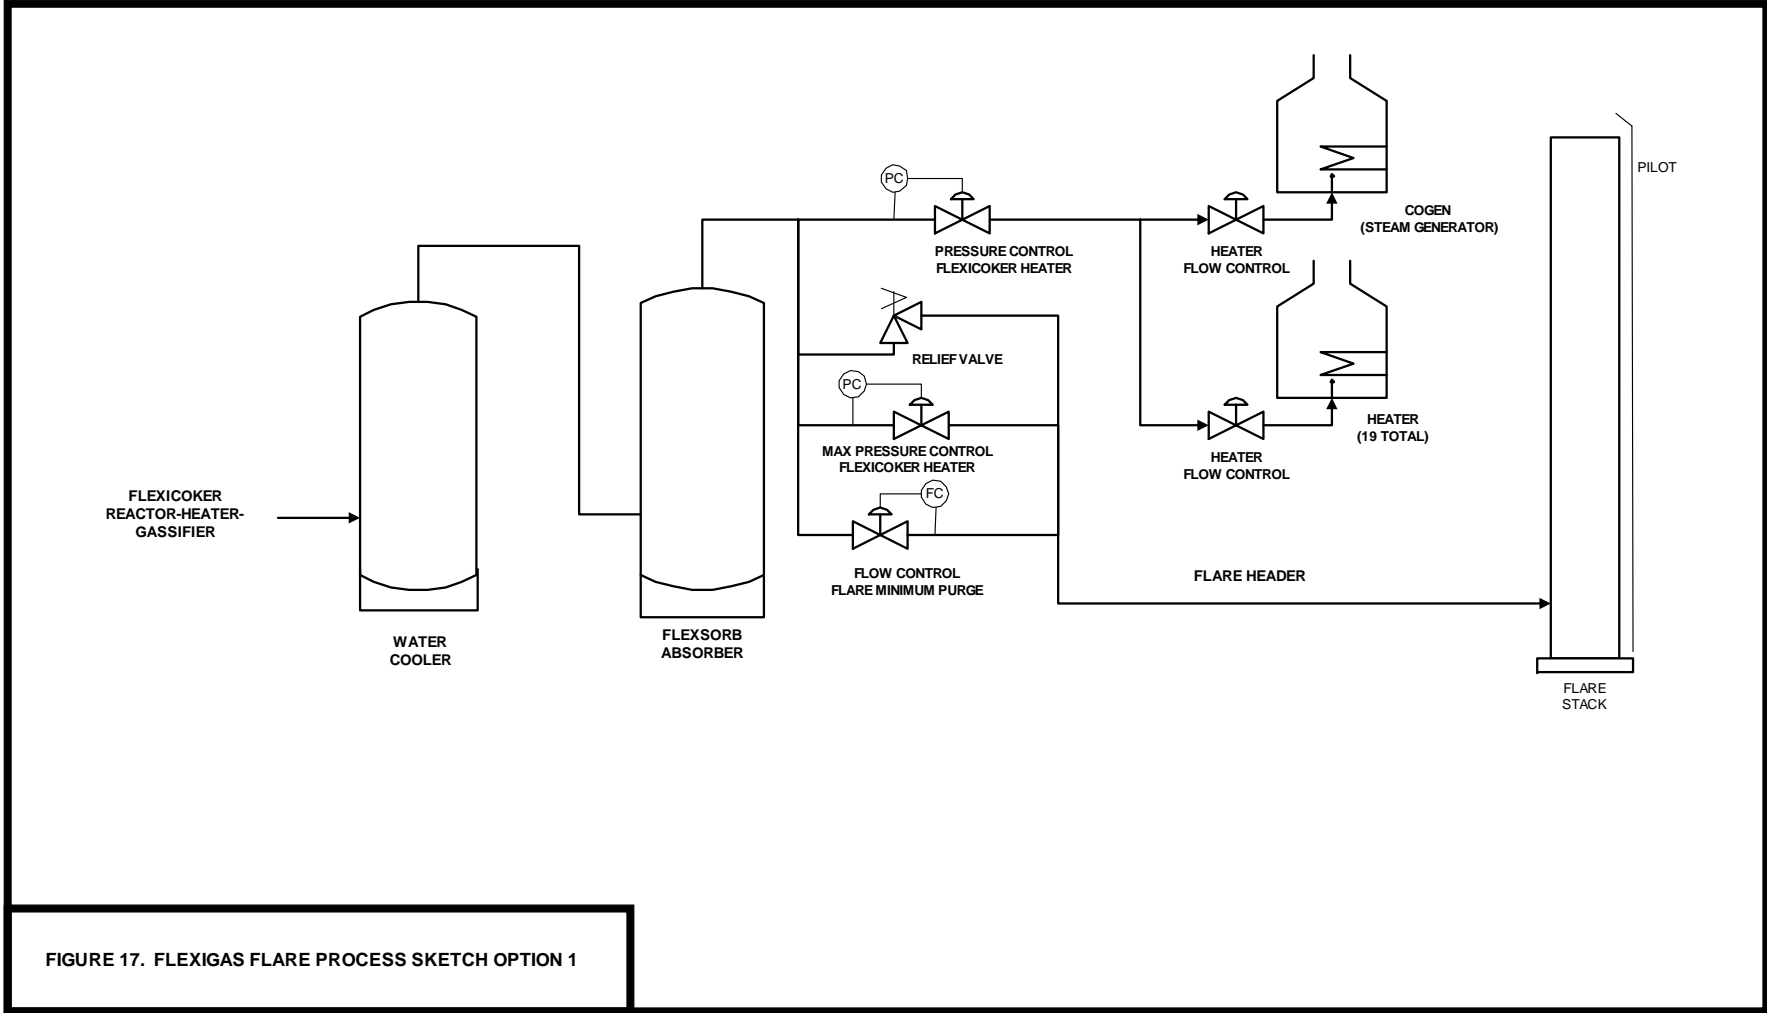
FIGURE 17. FLEXIGAS FLARE PROCESS SKETCH OPTION 1

OPTION 1: PROVIDE ADDITIONAL FLEXIGAS CONSUMERS (see Figure 17).

The objective of this project would be to provide an additional consumer that can rapidly pick up the Flexigas volumes made available by loss of another consumer (e.g., process heater) for any reason. Because excess Flexigas is available less than 10% of the time (based on the percent of days on which flaring occurred from Figure 16), and the current fuel system is roughly in balance, this consumer must essentially remain in hot standby until needed. This means it must be waiting to burn between 1 MMSCFD and 40 MMSCFD Flexigas when an existing consumer unexpectedly comes off line.

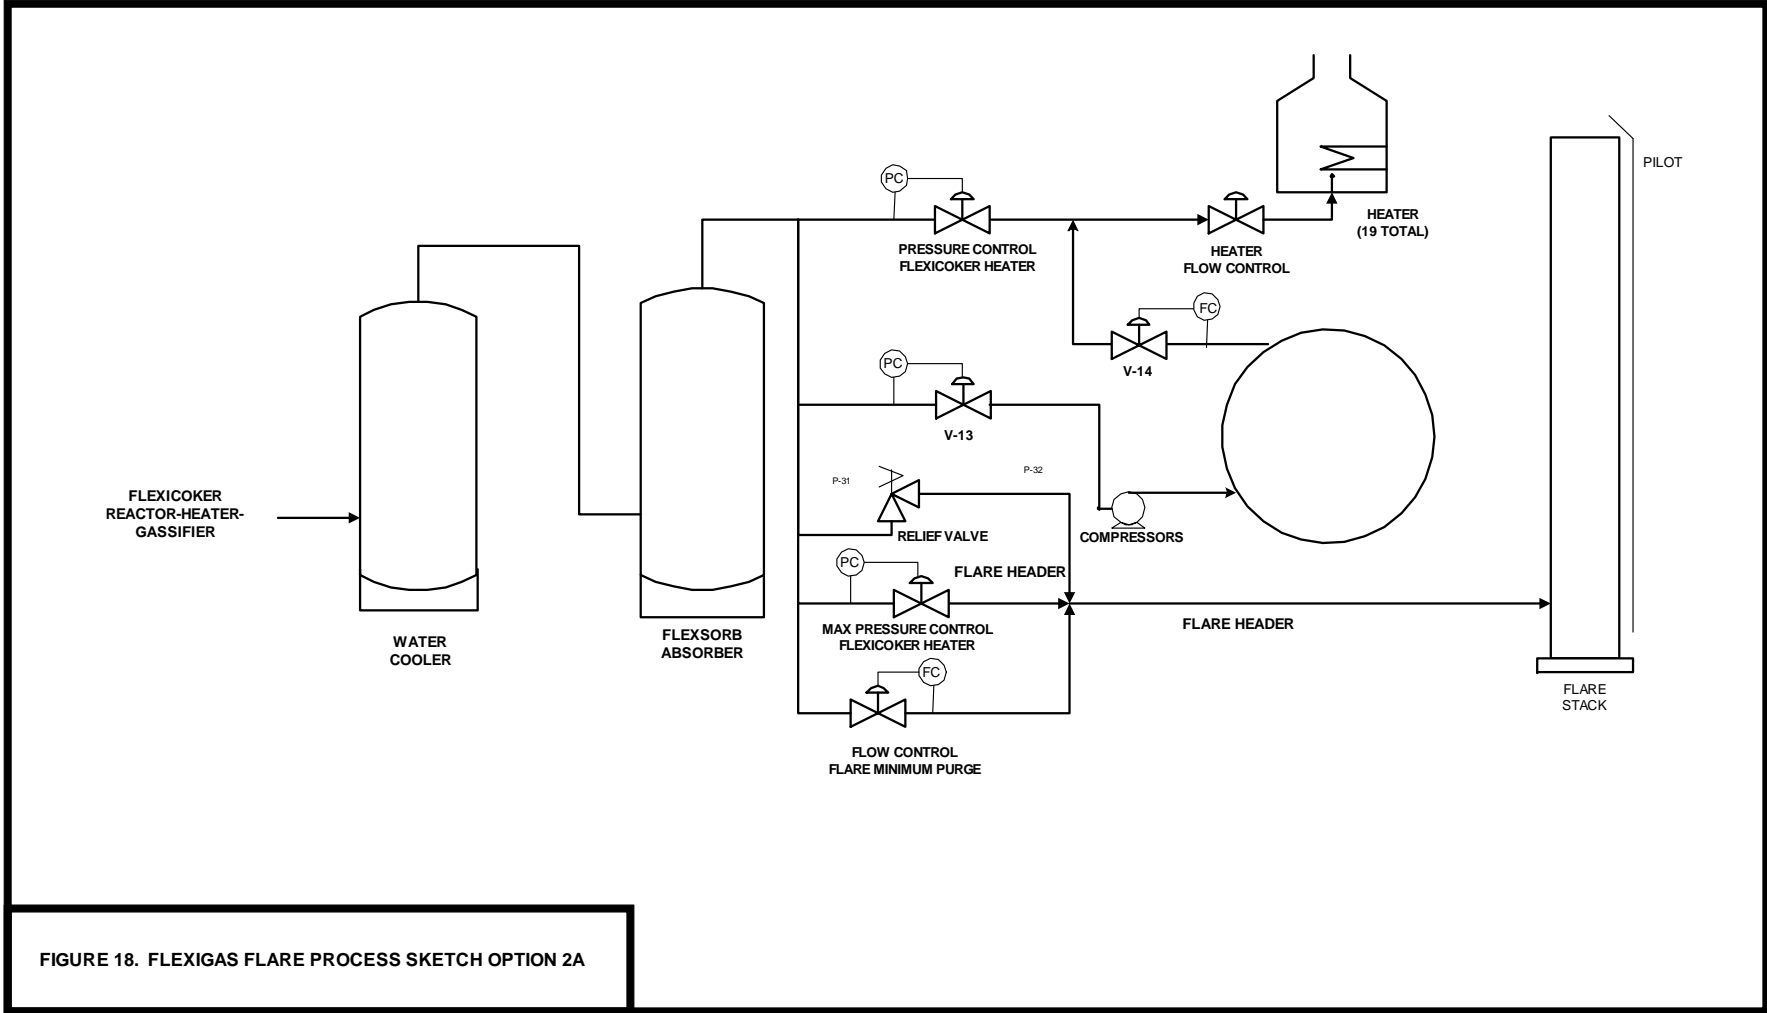
FIGURE 18. FLEXIGAS FLARE PROCESS SKETCH OPTION 2A

Option 2A consists of a pressurized vessel that would require a compressor with capacity ranging between 1 MMSCFD and 10 MMSCFD. This option is depicted in Figure 18. Flexigas in excess of consumer demand is routed to storage via compressor(s). A controlled flow is returned to the distribution system when enough consumers are available to avoid flaring. Due to the limited capacity of this storage, it has no real capability to accommodate prolonged fuel system imbalances. As a result, the expected best-case emission reductions are about the same as those available in 2005. A rough capital cost for the storage and large compressors is about \$27,000,000²². Annual electrical costs for the required compressors add another \$600,000. The annualized capital plus electrical costs to eliminate a ton of non-methane hydrocarbon result in a cost-effectiveness of approximately \$190 Million dollars per ton. Therefore, Option 2A is even less cost-effective for reducing flaring than Option 1.

²² Based on a nominal 1 MMSCF sphere (60' diameter) at 120 psig, and two 4 MMSCFD compressors. This system would handle only minor imbalances while the Flexicoker cuts rate.

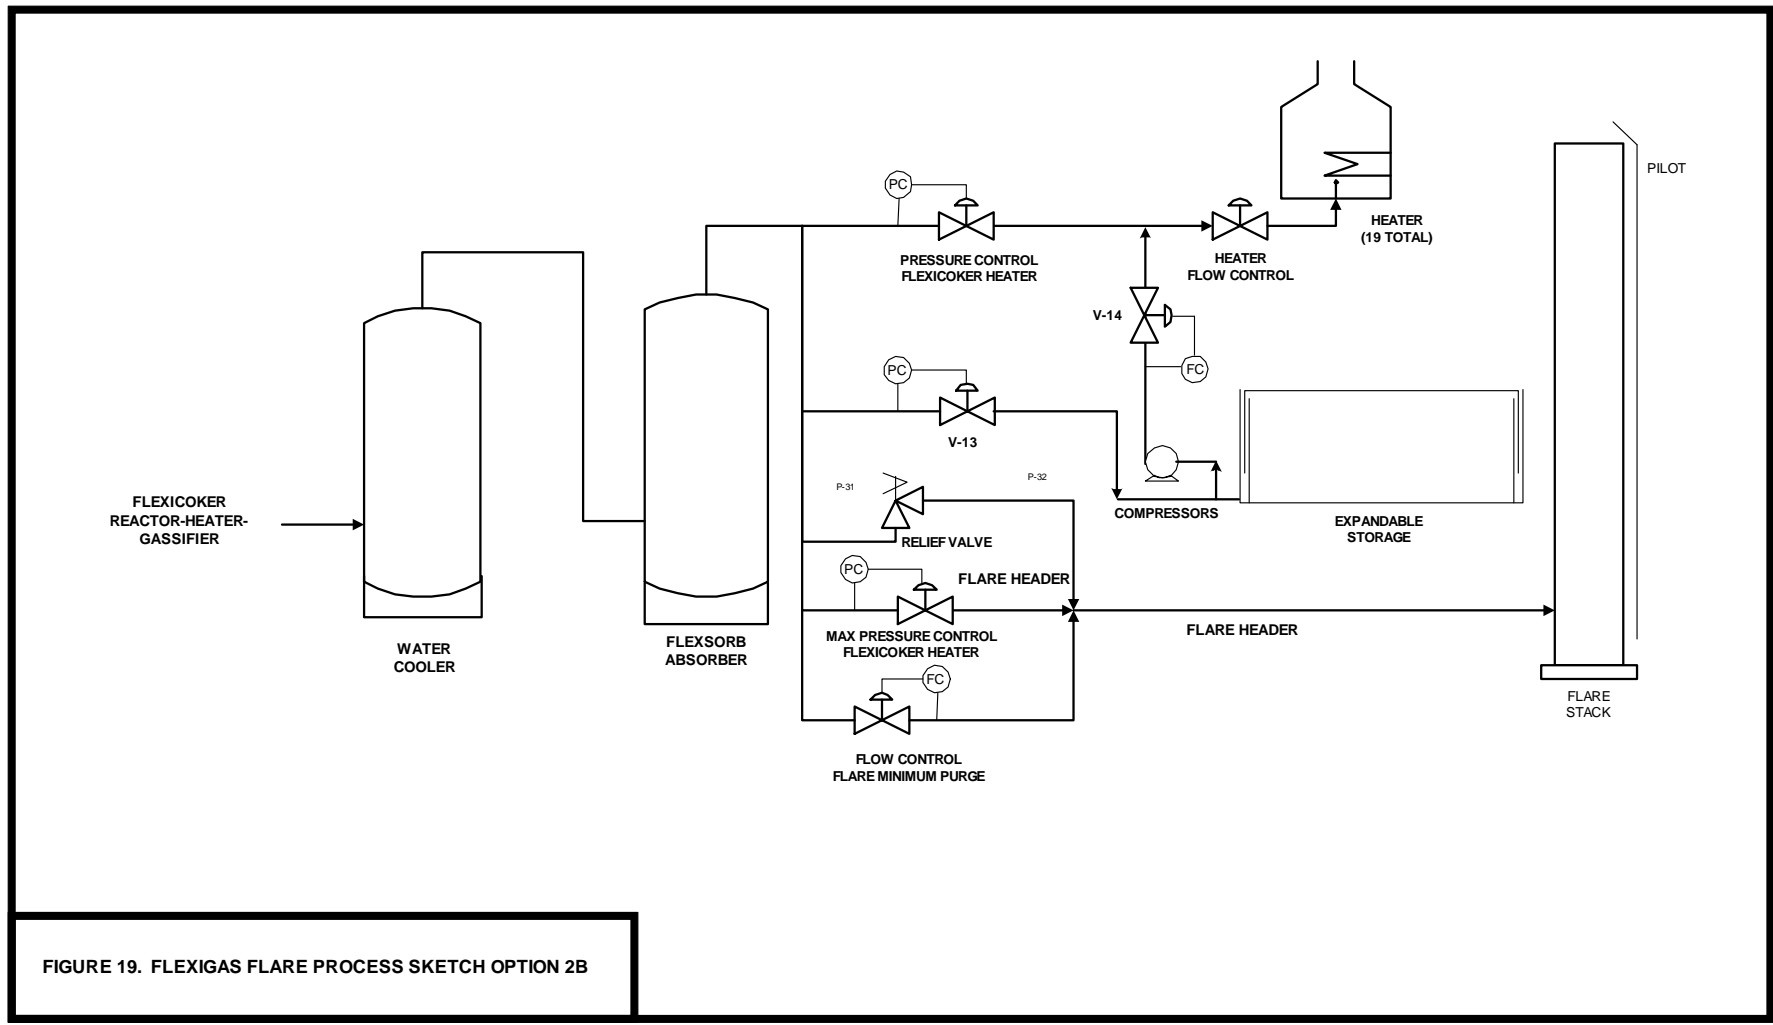
FIGURE 19. FLEXIGAS FLARE PROCESS SKETCH OPTION 2B

Option 2B uses low-pressure expandable gas storage. This option is depicted in Figure 19. This type of storage can be built significantly larger than the pressurized storage used in option 2A, and has the advantage of not requiring compressors in some cases. However, the concentration of carbon monoxide in the gas will likely require use of a water seal to limit leakage, restricting vessel height to a single lift. The requirement for a single lift, combined with low-pressure operation, significantly limits available storage volume²³. In any event, the installed cost is approximately \$21,000,000, providing cost-effectiveness of approximately \$276 Million dollars per ton of NMHC. As was the case for Option 2A, this option is even less cost-effective for reducing flaring than Option 1.

²³ The actual available storage volume is probably on the order of 1 MMSCFD, and will severely limit achievable emissions reductions. A 50% savings is premised for this analysis.
